## Forest Road Assessment in Ulu Muda Forest Reserve, Kedah, Malaysia

Mohd Hasmadi, I, and Kamaruzaman, J. (Corresponding author)

Department of Forest Production, Faculty of Forestry

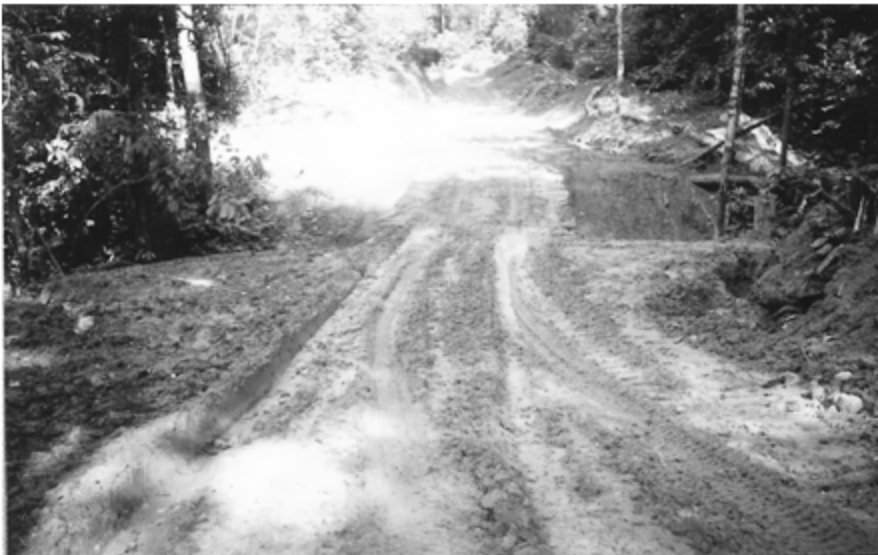
Road failures occur by several causes. The major causes of road failure were categorized to six factors which were shown in Figure 4. The failure caused by the small crown opening is 32% or 21 sections of the road failure. The minimum value of crown opening is 7.5m and the average is 14m. The minimum width of crown opening was blocked light intensity to reach ground that enable drying the road surface. A higher humidity is needed to allow evaporation process which air velocity is limited in contributing to the drying process on the road surface. Figure 5 showed the example of the failure caused by insufficient crown opening.

Figure 5. Road failure caused by insufficient crown opening

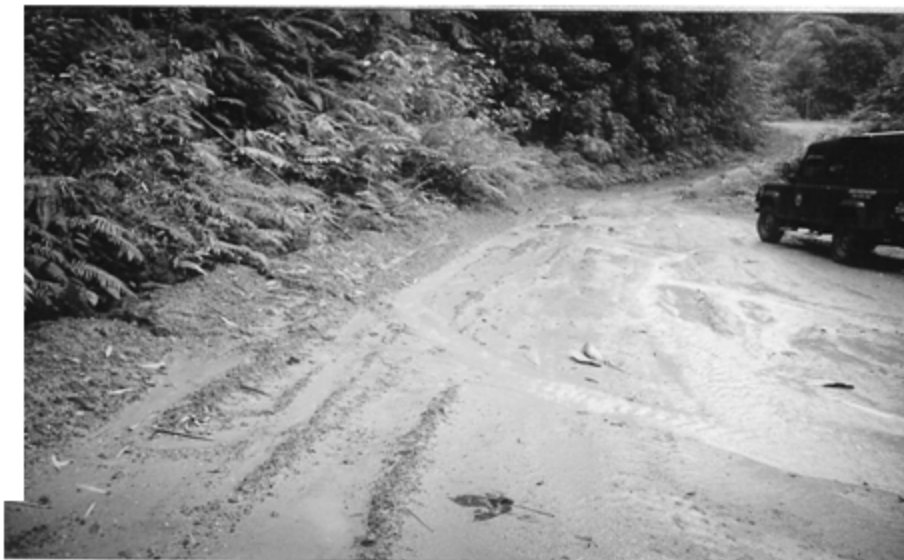
Side ditch is the main component in controlling water direction to avoid damages on the road surface. The absence of side ditch was observed at 8 places out of 25 sections, represented about 12%. The total of side ditches that complies with the specification is 68%. This revealed that the side ditch was constructed according to the specification but the rate of 68% was still lower because sometimes damaged can occurs by a high rate of water flow and erosion. Surface flow from several sources collected into small natural drainage, were not capable in handling the increased volumes of water. Figure 5 showed consequences of improper maintenance of the side ditch that caused high rate of water flow on the road surface.

Figure 6. Consequences of improper maintenance of the side ditch caused water flow on road surface.
