Thermal Imaging as a Non Destructive Testing Implemented in Heritage Conservation

The San Juan Bautista’s Parish church is located at the Independence Square, downtown of San Juan del Río, 67 km from Queretaro City. The construction background dates from 1689 when the clergy and the local residents requested the Parish building permission to the Viceroy Don Gaspar de la Cerda Sandoval Silva. In earlier times, the indigenous natives received catholic doctrine and attended mass commonly in a chapel roofed with tejamanil (from nahuatl tlaxamanilli), meaning wood shingles roof, where the Spaniard parish church was finally built. The structure is a neoclassical construction with stylish and spacious lines by distinguished architecture (Instituto Nacional de Antropología e Historia, 2003). Nowadays in this site is adored the Virgin of Guadalupe which is the most iconic belief tradition in México. The former construction materials used were stone basement alike of the walls, and adobe bricks and stones widely used for walls and arched roofs of masonry forming domed chambers, sheltered with stuccos used as interior and exterior finishes, applied in thin layers where the last one was color

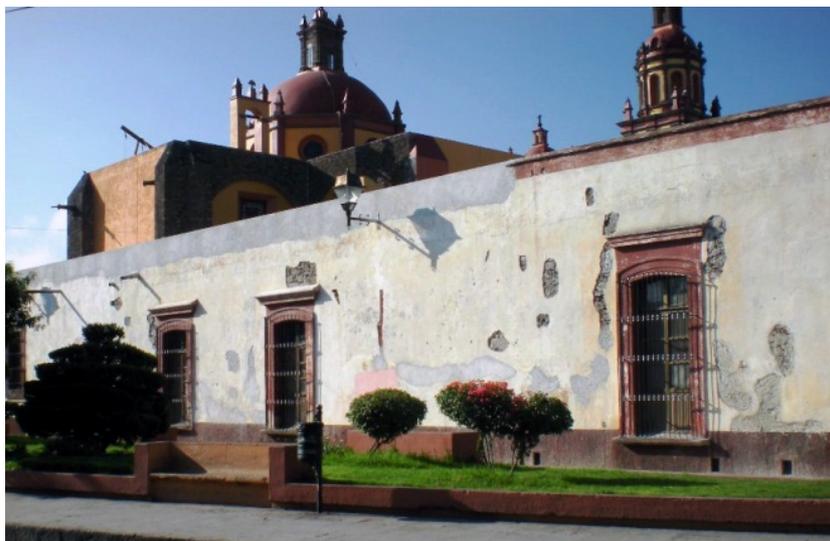
Figure 1. The wall shows damaged areas where plaster sections were missing

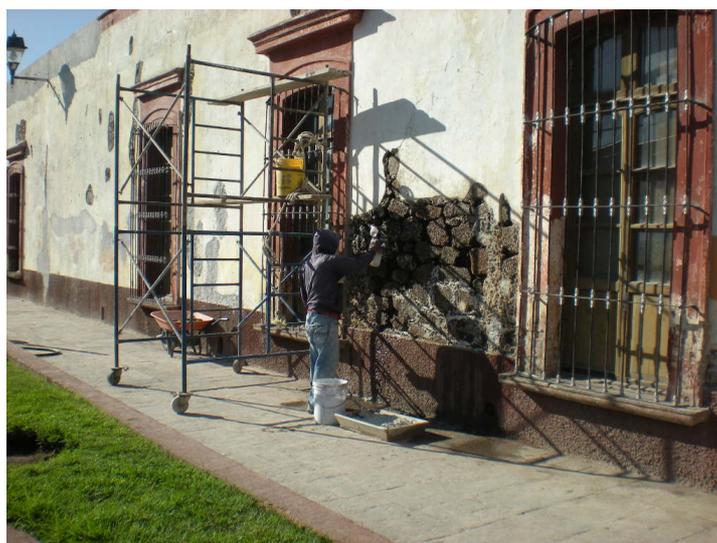
Figure 2. Application of the lime putty-sand-pozzolan mixture proposed in the restoration process

One of the main problems in the case of restoration is to develop materials with similar characteristics of the original ones (Figures 2 and 3). A practical procedure to achieve similar grain-size distribution like the former was developed. Plaster was collected from the walls of the building and paint (vinyl paint, fraction of the original lime paint) removed manually; 150 g of plaster free of paint was milled and stirred for 30 minutes in a 500 ml beaker with 250 ml of distilled water, in order to separate the sand particles, organic particles, and the calcium carbonate fraction. The calcium carbonate particles were then separated by gravity removing the water several times. With this technique is possible to obtain a corresponding sample to approximately the same lime/sand ratio used in the original plaster. The binder-aggregate ratio of plaster samples were in the range of 1:2-1:3. Particle sizes that are greater than 1180 μm composed the largest sizes of the total aggregates, and aggregates were composed of Quartz, Albite and Anorthite.

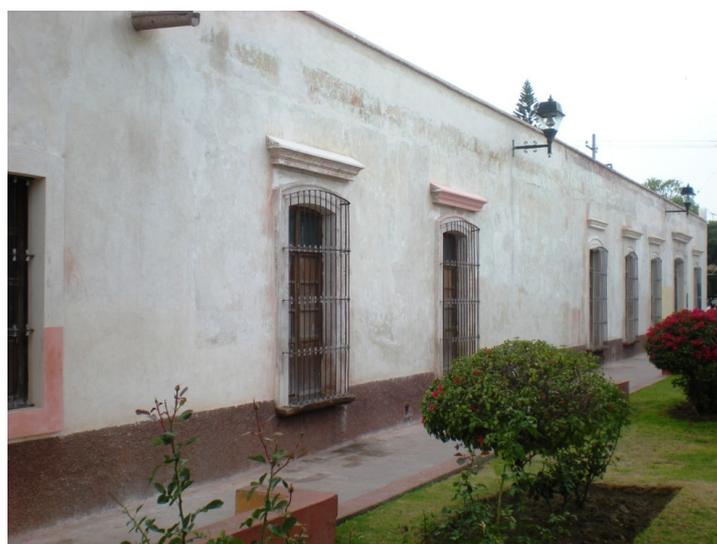
Figure 3. View of restoration process. Facade after the proposed plaster application on damaged areas, before the final colored stucco layer

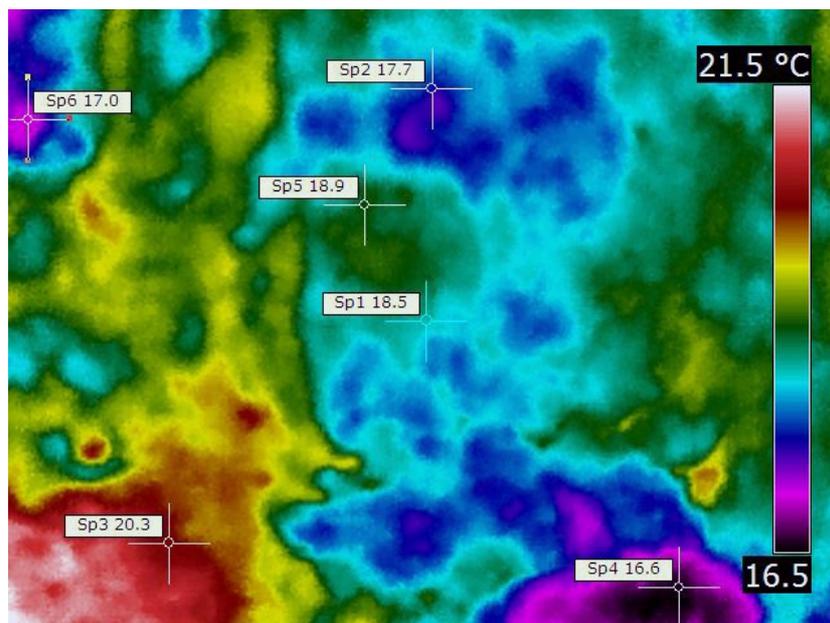
Figure 8a. Thermal IR image from a wall at Parish House, Morelos Street, San Juan Bautista Parish

The chemical composition and surface roughness or appearances are also variables that can influence on emissivity. The IR color patterns observed in the image of the Figure 8a shows dissimilar emissivity from the constituent materials on a portion of the wall surface. When this image was compared to the conventional image portrayed on Figure 8b without using TIRI, the differences are remarkable. The Figure 8a shows a passive approach with the intention of compare the natural thermal gradient on the surface. To optimize the resolution on the thermal variation, the measurements were done perpendicularly to the wall surface.

This image showed temperature varied in the wall surface from 16.6 through 20.3 °C. This temperature variation was produced mainly by the differences in chemical composition between the original material constituents in the wall and the applied restorative materials.

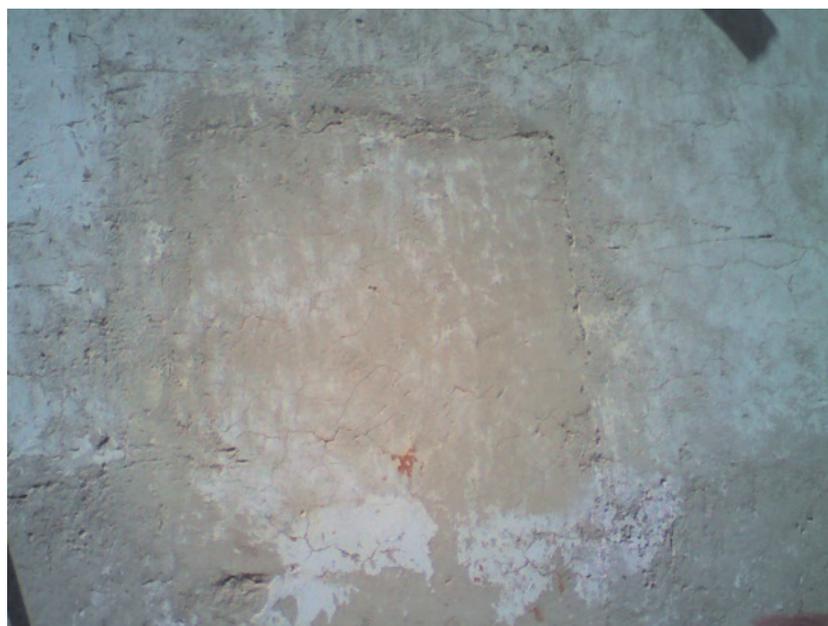
Figure 8b. Digital image was obtained with the same IR camera position matching with Figure 8a. There is strong evidence of former inappropriate intervention on this area

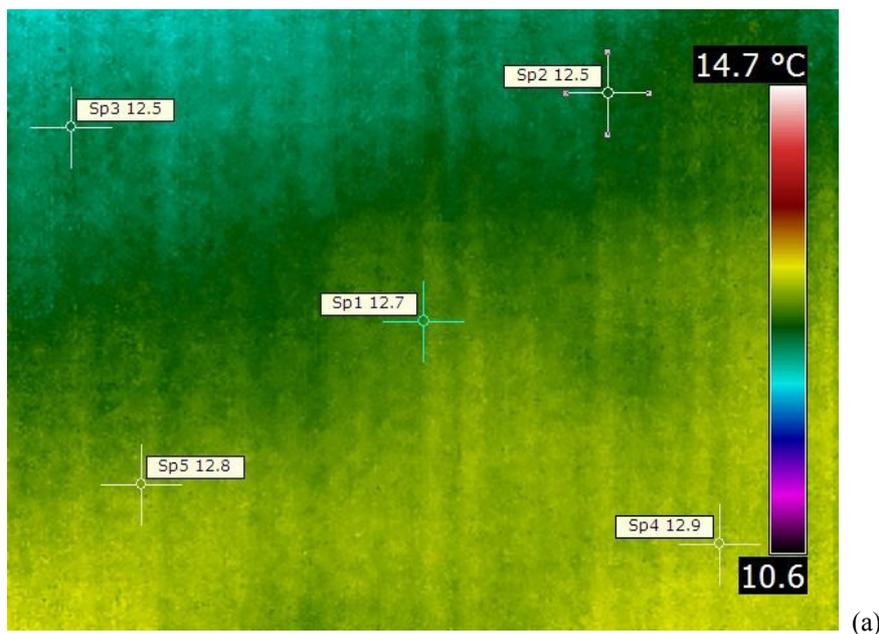
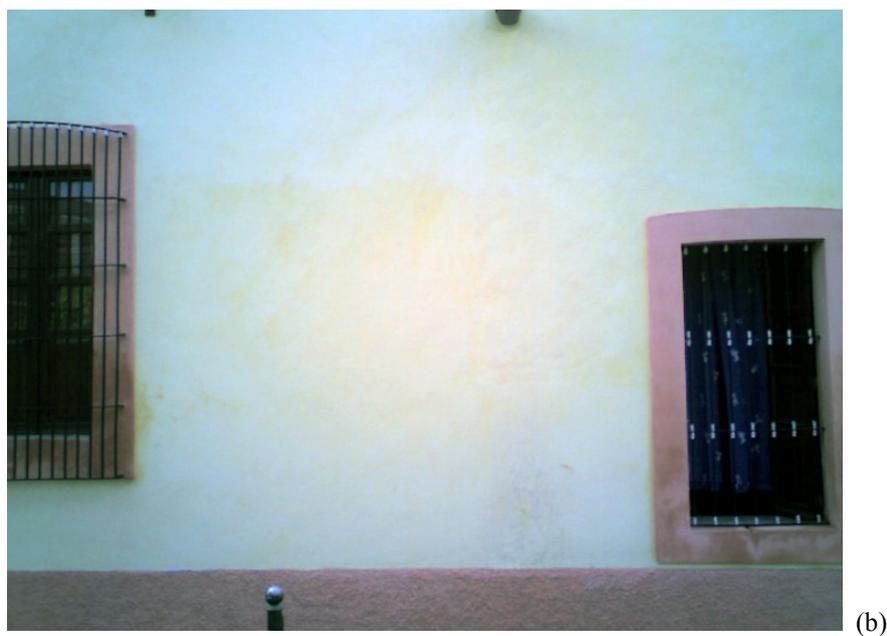
Figure 9a shows a thermal photograph after 6 months of the application of the plaster prepared using the formulated material which contains lime, sand and pozzolan in an analogous composition than that in the original. The image also showed that the temperature variation on the wall was from 12.5 °C to 12.9 °C.

Figures 9. (a) and (b) were taken from similar position in the location of interest, linking thermal and digital images

The emissivity was 0.96, with a reflected temperature 20 °C, an atmospheric temperature 16 °C, and relative humidity of 0.4. The distance was 4 m. Figure 9b shows the same spot without the TIRI effect.

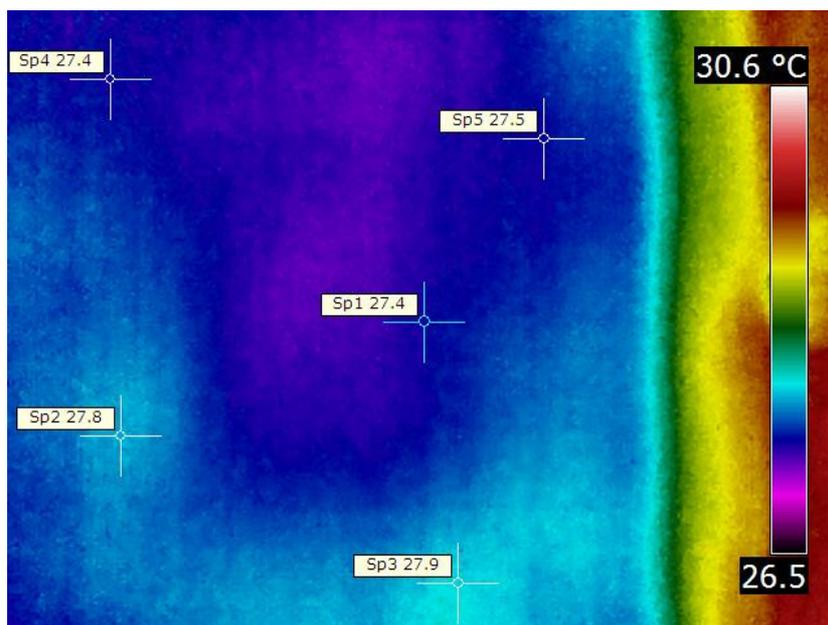
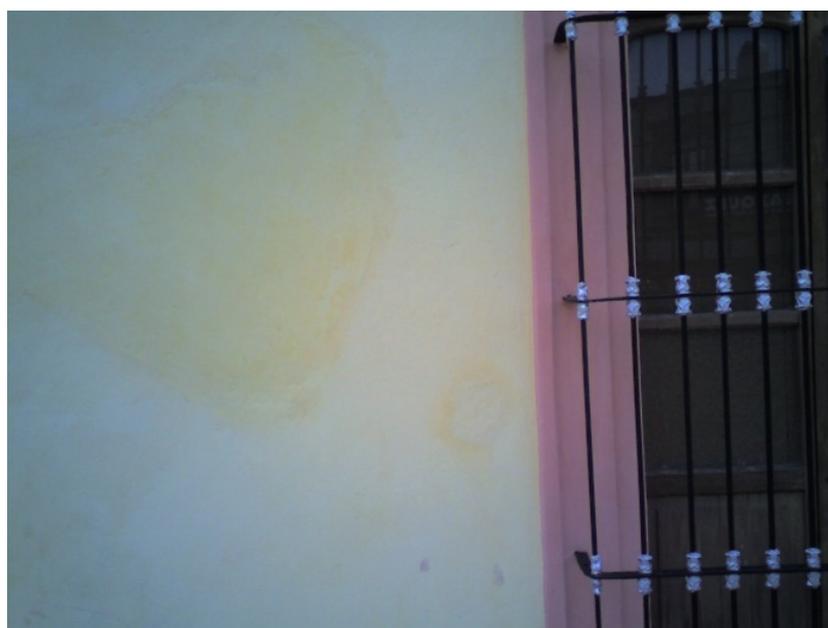
Additionally, in Figures 10a and 10b, the window frame was a good reference to make easier the correlation between the digital image and the appeared thermal image. It is relatively easy to identify the window edge in the thermal image by its different energy emission compared to that from the restored area. Once again, the thermal image shows a small temperature variation on the wall surface from 27.4 °C to 27.9 °C, and this is evidence of the similar chemical composition of the restored sites and the original ones. All these images were obtained under identical condition, position and using the same camera in thermal and digital modes respectively. Note that the scales show a discrepancy. Nevertheless, the area could be clearly recognized from side to side beside the window edge.

Figures 10. Matched thermal and digital images of similar restored zone after six months of the proposed formulated plaster-stucco application
