# Non-Destructive Testing in the Strategic Research on the Performance of Bridges

## Abstract

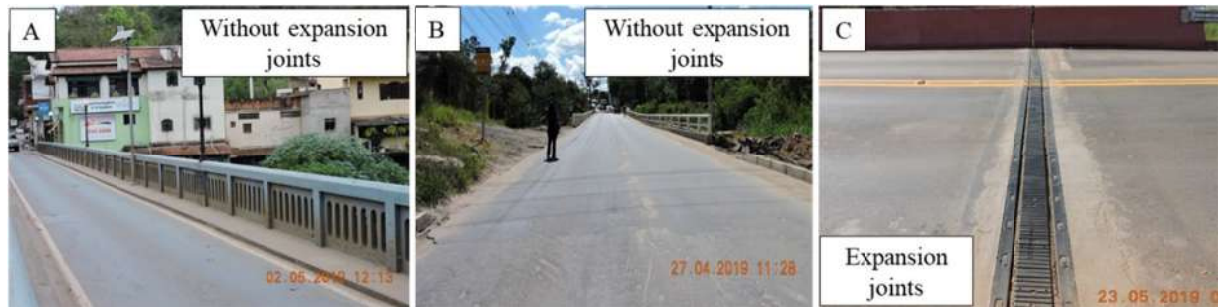
Transverse joints are intended to transfer the vertical and horizontal load from the vehicles to the beams, which can adapt to the displacements of the bridges (Ma et al., 2020). HB A and B showed a lack of such joints, Figures 5 and 6, and this compromises the structural system, as well as compromises their life cycle, since it favors the development of cracks and allows the infiltration of residues and other hazardous agents (Shi et al., 2019; Allard et al., 2018; Karthik et al., 2016). HB – C showed a good state of conservation. It is important to consider that inefficient joints and encounters facilitated the appearance of cracks that allow the percolation of water through concrete structure (Figures 6 and 7).

Figure 5. Expansion joint: lack of expansion joint in (A) HB-A and (B) HB-B; and the presence of expansion joint in (C) HB-C

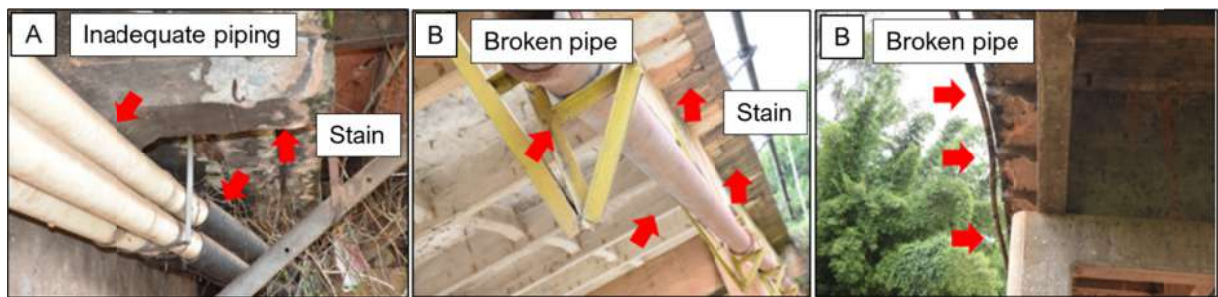
Figure 6. Drainage system: (a) HB-A; (b) HB-B

The lack of suitable: database, design, building and maintenance of the HBs, drip pans and drainage systems (Figures 5 and 6) generated leaching of the composite concrete and, consequently, efflorescence (Figure 7), due to the combination of leaching and carbonation processes (Hüthwohl, Lu, & Brilakis, 2019; Sañudo et al., 2019). These anomalies occurred due to the deterioration of the material, concrete batching or production mistakes,

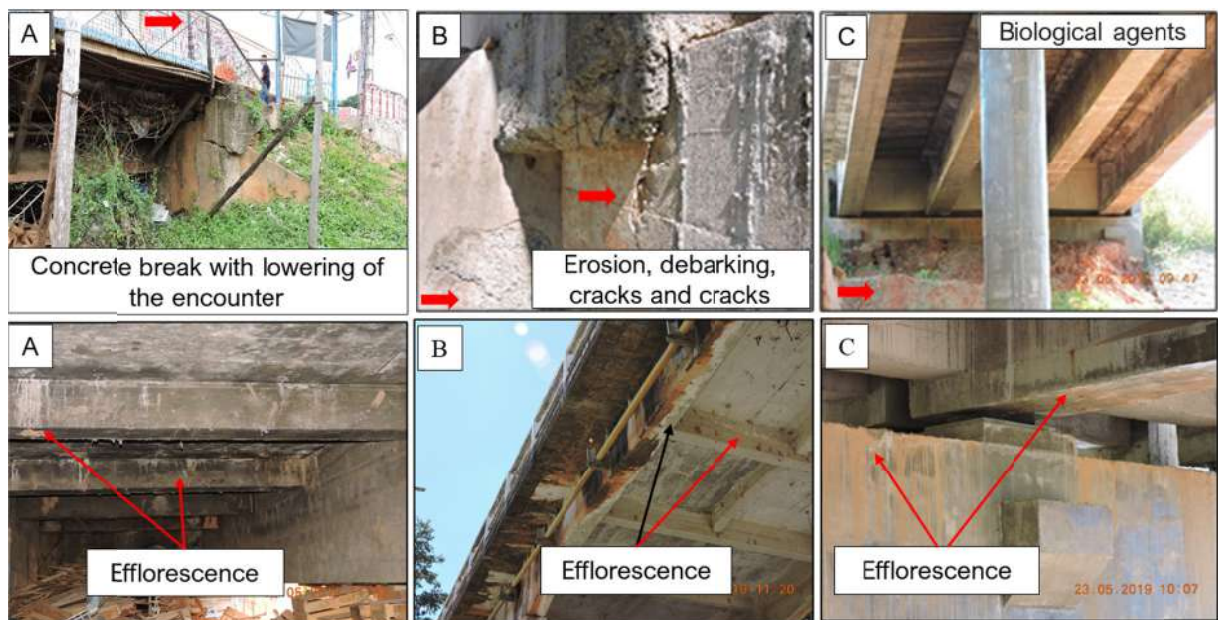
Thus, in the river's border/HB, it was possible to observe the rupture, in HB-A and HB-B (Figure 7), in the concrete next to the metallic support of the sidewalk, displacements, cracks in the beam supporting the sidewalk and failures in the concreting on the slab. These cracks occurred mainly in the rainy season due to drainage failures, which led to leaching of the concrete and, consequently, to efflorescence, Figure 7 (Zhang et al., 2020; Xue et al., 2018; Huthwohl et al., 2019).

Figure 7. Efflorescence HB A, B and C

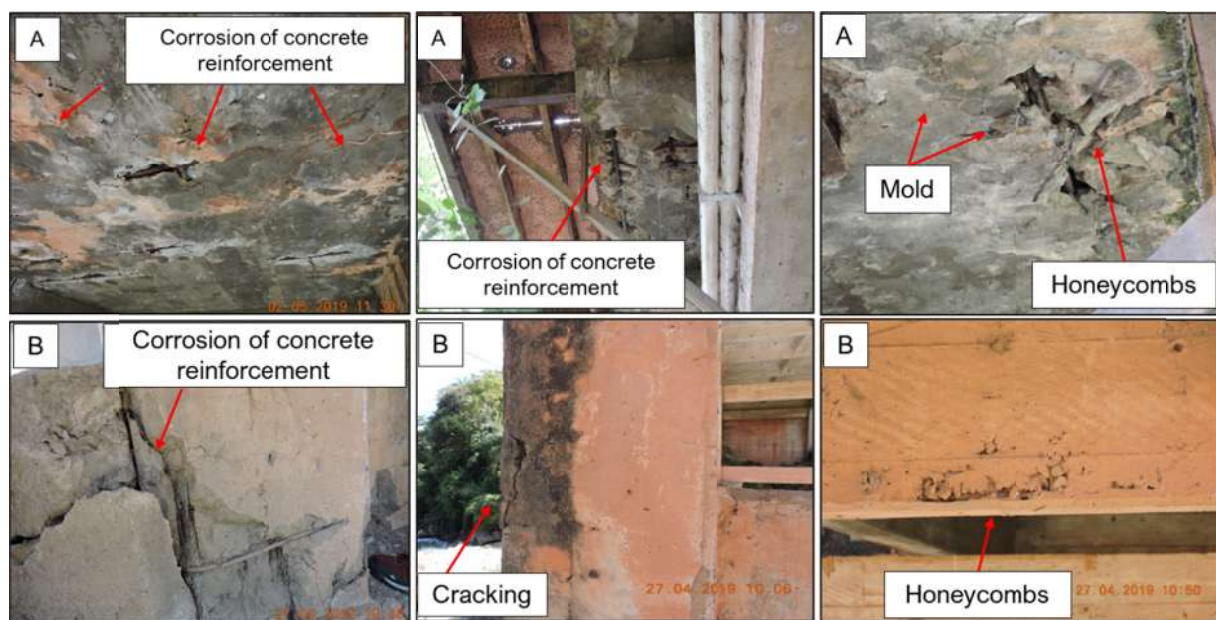
The following were found in the concrete structure: honeycombs, exposed reinforcement, corrosion of the reinforcement, cracks, patches in the concrete, insufficient cover (Figure 8, Tables 4 and 5). Carbonation tests were carried out on structural elements (beams and pier) and on infrastructure elements (foundation blocks) (Figure 9).

Figure 8. Pathological manifestation

Analyzing Figure 9 and Table 4, it can be seen that the HB-A, built in 1927, shows a high carbonation index, the decks and stringers presented exposed reinforcement (Figures 5, 6, 7 and 8) and concrete flaking (Figures 5, 6, 7 and 8) due to corrosion products. Since 2003, the Brazilian standard defines a coating thickness for reinforced concrete dependent on the correlation with the environmental aggressiveness, whereas, before that year, 20 mm was the measure adopted for all concrete structures. HB-B is located in an urban region characterized by heavy traffic; it shows a high carbonation level, Table 5, and the corrosion of the reinforcement was evidenced through the columns of the bridge. HB-C, the most recent (3 years old), shows few defects and complies with the requirements of the current Brazilian standard, however, it is very important to have preventive maintenance services (ABNT, 2019).

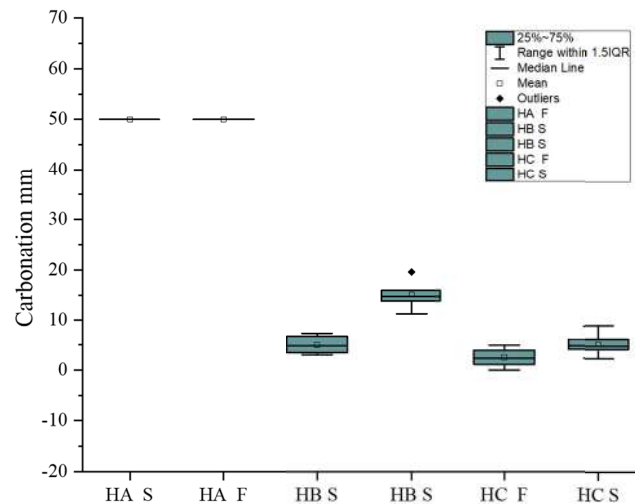
Figure 9. Carbonation index

The HB-A is the oldest of the three and the results concerning it were as expected. There is high carbonation in a significant cover thickness (50 mm). However, there is no carbonation in the foundation block (HA F) or in the central column (HA S), but they presented cracks resulting from being in a low region (inside the river or submerged). Regarding the HB-B, the beam shows an average of 4.94 mm of carbonated depth and, for the foundation block, the depth value is 15.07 mm. The beam is not located near the river and did not present any cracks, but it is influenced by the variation of the river level, i.e., the wetting and drying cycle. The HB-C is the most recent of the three bridges analyzed, and in which the foundation block shows an average of 2.46 mm of carbonated depth, while, as regards the connection beam of the block, this value is 5.15 mm.

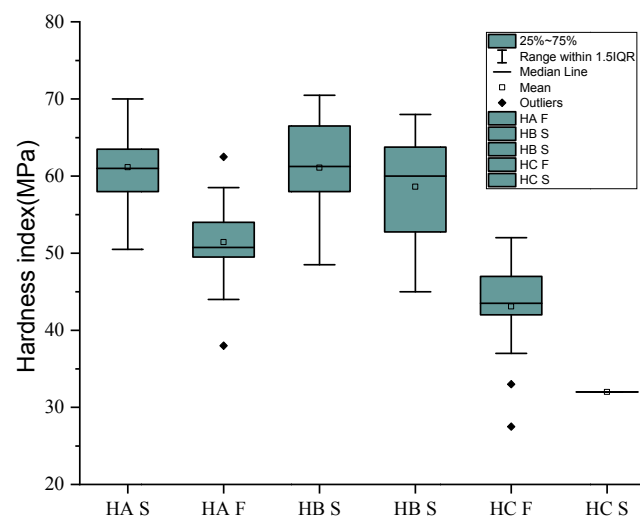
Figure 10 shows the hardness values of the concretes of the three bridges. The hardness of the concrete for the HB-A is 51.4 and 61.2 MPa, regarding the foundation block (HA F) and the pier (HA S), respectively; as for bridge “B”, the beam (HB S) presented an average of 61.1 MPa and the pier (HB F) presented 58.6 MPa (HB F), regarding the hardness of the concrete; as for bridge “C”, the foundation block (HC F) presented an average hardness of 43.1 MPa, and the beam (HC S) 32.0 MPa.

Figure 10. Hardness index

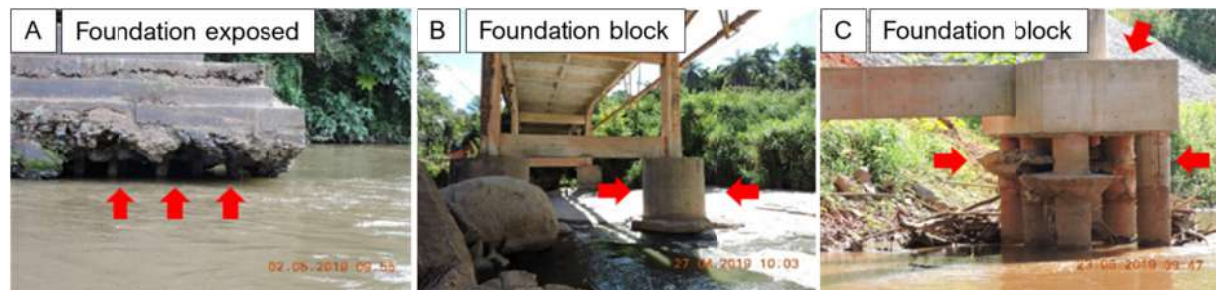
As can be seen in Figure 11, foundation blocks (and, in this case, in the three HBs assessed) were detached from the soil and exposed the piers to the environment. Moreover, there was a reduction in the structural section

caused by floods and erosion, chemical agents aggressive to the concrete and lack of maintenance services, among others (Skrzypczak, Słowik, & Buda-Ozóg, 2017; Gega & Bozo, 2017).

Figure 11. Pathological manifestations – HB-A

In the foundation block facing the city of Nova Lima, the wooden piers are fully exposed, and some of them present an advanced stage of decay and considerable section loss. Regarding the HB-B and HB-C, the beam close to the encounters has deteriorated due to contact with water. The deterioration was hard due to the rainy season in the region (rainfall season), Figure 11. In the case of the HB-A, wooden piers were used, although the use of this material in the foundations of special structural buildings is not recommended, due to several restrictions, nevertheless, it would be an appropriate alternative in 1927 (Bettiol et al., 2016). Figure 6 depicts the non-compliance of these foundations, which are exposed to environmental degradation processes (caused by microorganisms) that compromise the strength and lifespan of the columns.

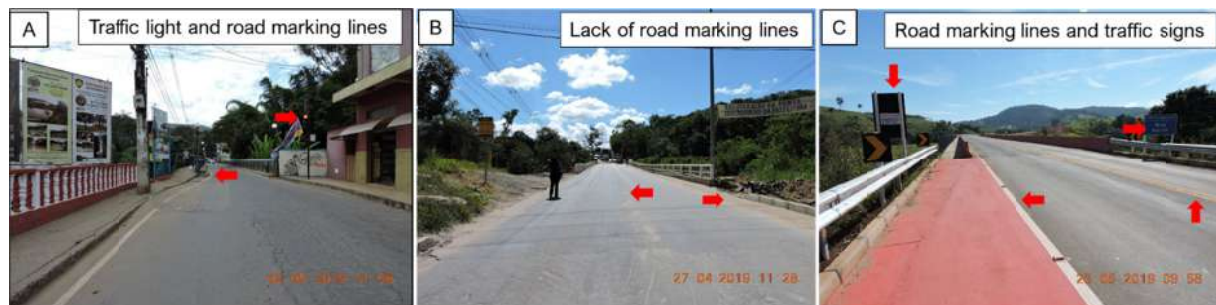
The permanent signage (road safety signs) is part of a fixed traffic control system designed to order traffic jams, and to alert and guide users (DNIT, 2010). HB-A has a traffic light at each of its extremities because there is only one lane for both directions of traffic; however, there were no signposts to signal their presence, as shown in Figure 12, also, it is necessary to carry out maintenance services on the road marking signs, due to wear. HB-B does not have a sidewalk for pedestrians, so it is necessary to include a signpost pointing out the direction, i.e., “pedestrian, walk on the right/left”, as well as there is the need to delimit the lane (regulating the opposite-flow directions). HB-C is well signposted, it has the mandatory signposts; however, it needs a sign indicating that it is forbidden to overtake – this procedure is mandatory on bridges. Table 6 presents a summary of the survey on the items that ensure the safety of users and pedestrians.

Figure 12. Traffic signs and road marking lines on bridges A, B and C

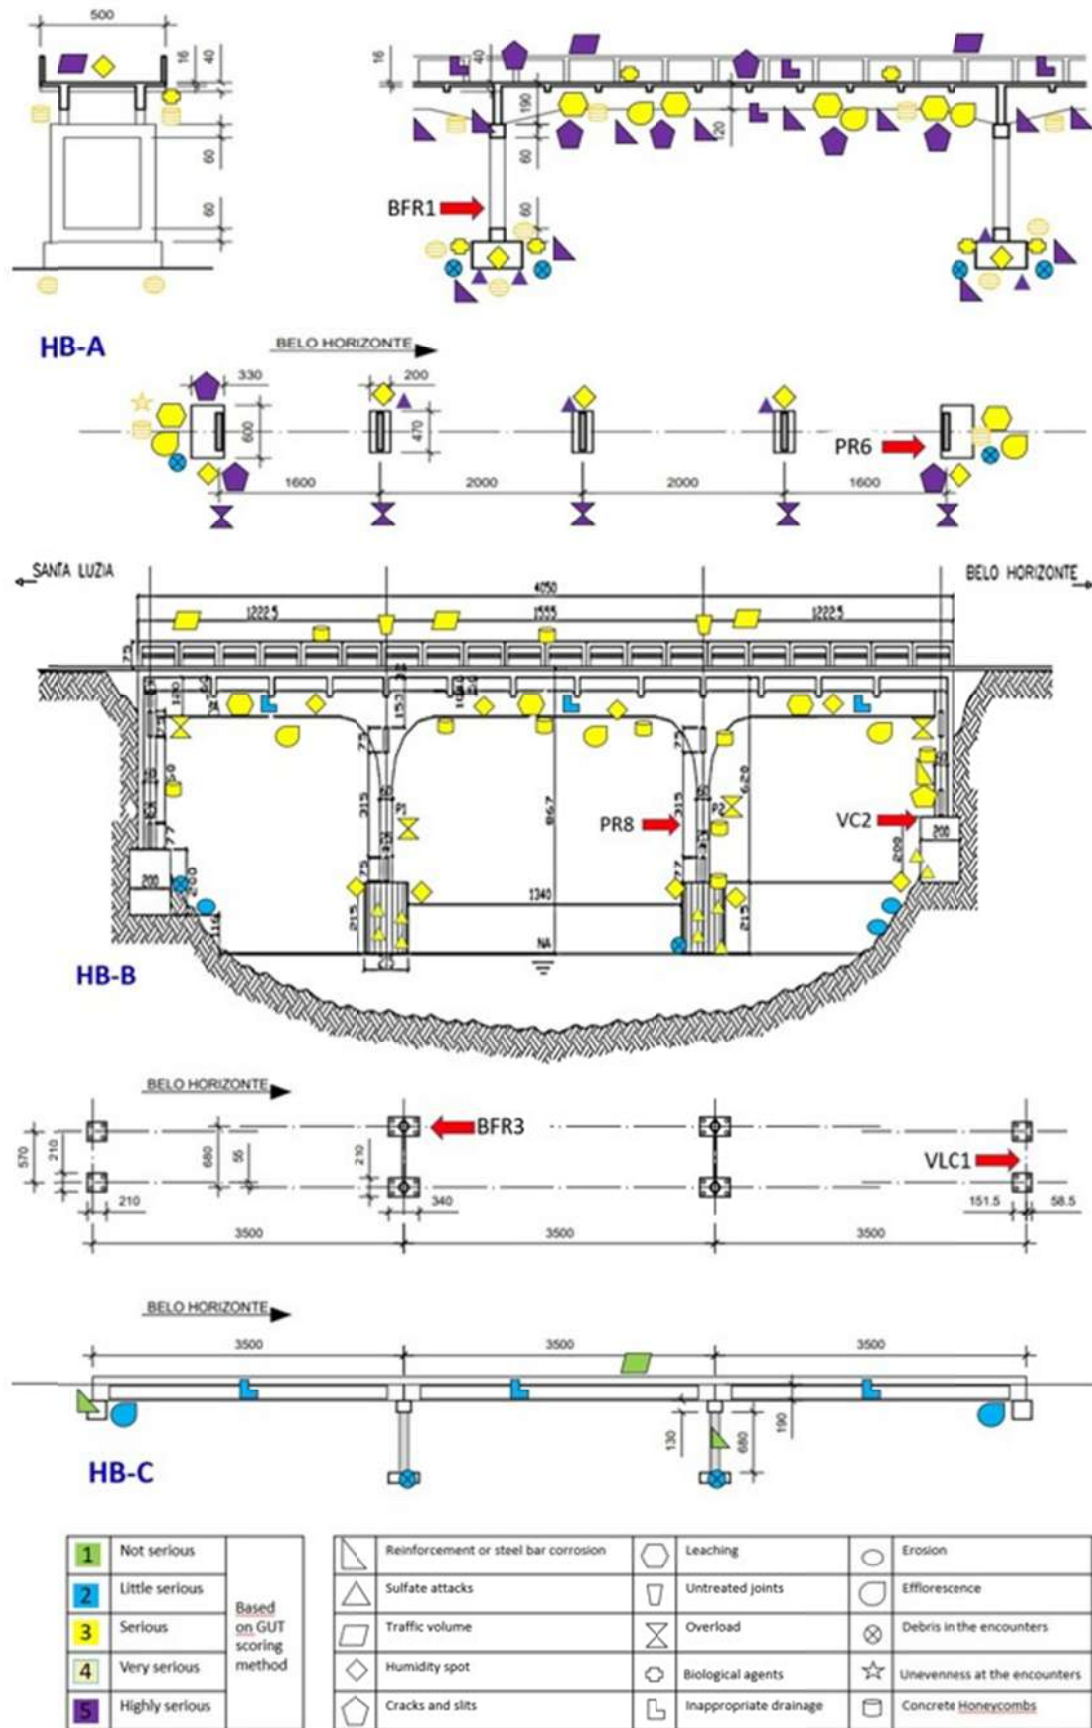
Figure 21. Main pathological manifestations observed in the HBs

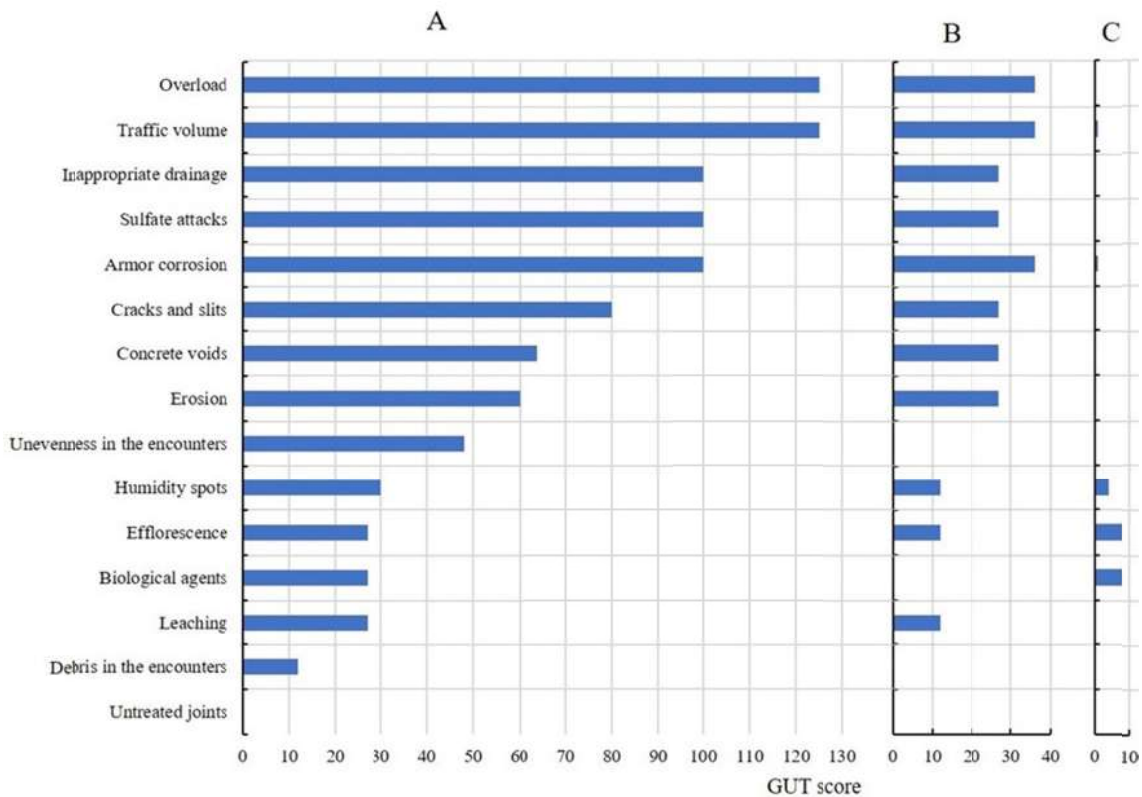
Figure 22. GUT results recorded for HB-A, HB-B and HB-C.

HB-A showed a high number of issues related to anomalies, which means a great urgency for an intervention. In addition, it was possible to order the priorities regarding the pathological manifestations, namely: Traffic volume – Excessive load – Reinforcement corrosion – Sulfate attacks – Inappropriate drainage – Cracks and slits – Concrete voids – Erosion – Unevenness in the encounters – Humidity spots – Leaching – Biological agents – Efflorescence – Debris in the encounters – Untreated joints.
