Multi-Method END Study in the Search for 'Defects' in an Aeronautical Radar Element

Gaston Sanglier¹, Jose Miguel², Jose Antonio Penaranda² & y Gabriel Del Ojo²

¹Central Laboratory of Remote Sensing. Instituto Nacional de Técnica Aeroespacial (INTA), Crta. Ajálvir Km.4, 28850 Torrejón de Ardoz, Madrid, Spain

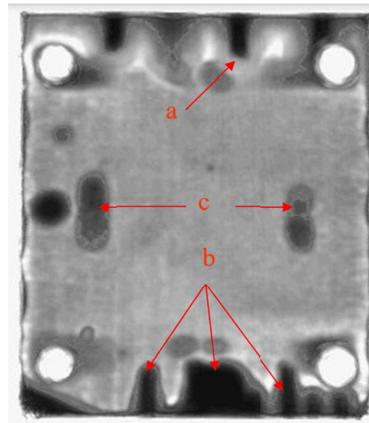
First, the specimen was inspected with ultrasound transmission in total immersion. The image shown in figure 2 was obtained, where it can be seen that all the discontinuities (dark areas) existing in the upper and lower bands of the test tube have been detected, as well as other discontinuities, located in the central band of the test tube, which were not suspected. In the image you can see four holes (light circles) located in the corners, around which there are also areas with detachments.

Figure 2. Image of a specimen with discontinuities obtained by transmission ultrasonic inspection

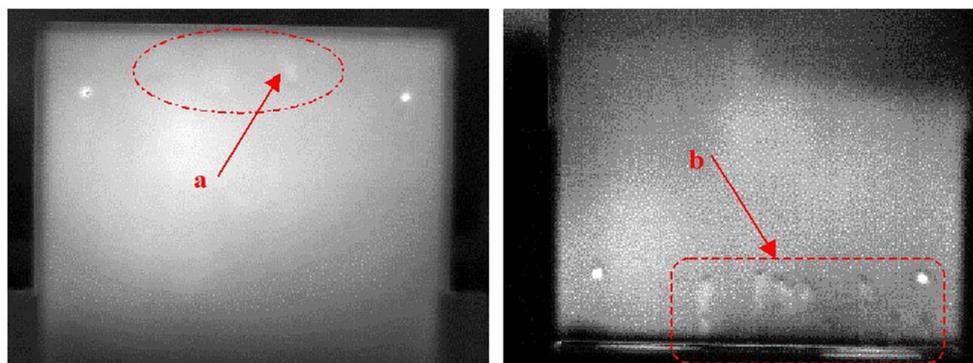
Using the transmission thermography technique (Sanglier et al., 2020; Cielo et al., 1987), the images in figure 3 were obtained, which correspond to the upper (left image) and lower (right image) bands of the pattern. From the examination of the left image, it can be seen that only a light color indication is visible at the top, just to the right of the center line (arrow a). This indication corresponds to a peeling off at the junction "skin"-core and appears as a dark rectangular area (arrow a) on the ultrasonic image (figure 2). In the lower band of the pattern, the agreement between ultrasonic and thermographic methods is greater, as can be seen by comparing the lower areas (arrows b) of the images represented in figure 2 and on the right side of figure 3. On the other hand, the ultrasonic test provided a series of indications due to discontinuities in the central band of the pattern (arrows c) that could not be obtained by thermography.

As we have just seen, thermography is not very effective in detecting flat discontinuities in this material, the reason being the low contrast of the discontinuities obtained in thermographic images, the high power of thermal insulation of the core, which means that heat transmission is hardly affected by the existence of the take-offs, since the capacity to transmit heat is very similar in the core and in the take-off.

Figure 3. Thermographic image of the upper (left) and lower (right) parts of the specimen shown in figure 2

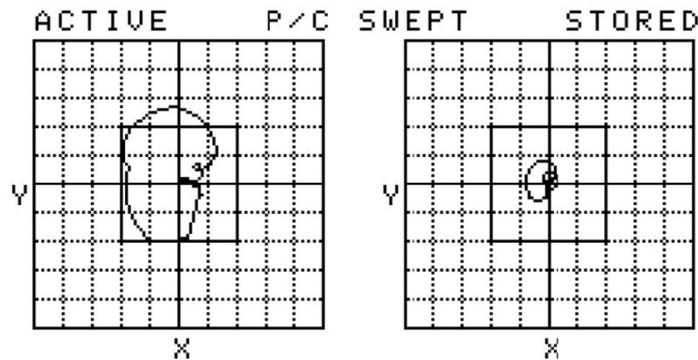
Based on the previous paragraph, we proceeded to test a sonic technique (Spanner, 1974; Dunegan & Tetelman, 1987; Briggs, 1985; Pollock, 1998) that works by scanning, between 2 and 70 KHz, with continuous Lamb wave in emission-reception on the same side of the piece. This technique has the advantage that operating from one side of the radome is able to reveal discontinuities located on both sides of the radome. Moreover, due to the low operating frequency, it does not require any coupling means, so it is a dry contact technique; being the emitter and receiver probes provided with a Teflon sole that facilitates the displacement through the piece. Other advantages of the technique are: the ease of adjustment from appropriate test pieces and the fact that in the absence of contact of some of the probes with the piece, the signal obtained (becomes smaller) evolves in the opposite direction that when in the presence of a discontinuity (the signal increases in size), which avoids the detection of false positives (Ramirez et al., 1996). Operating from one side, this technique was able to detect all the discontinuities present in the specimen (upper, lower, and central bands) that the ultrasounds had revealed. Figure 4 shows the signals obtained in one of the discontinuities. On the right side of the image is represented the signal obtained in a good area, while on the left side you can see the signal when a discontinuity is present.

Figure 4. Signals obtained with a sonic technique for detecting discontinuities

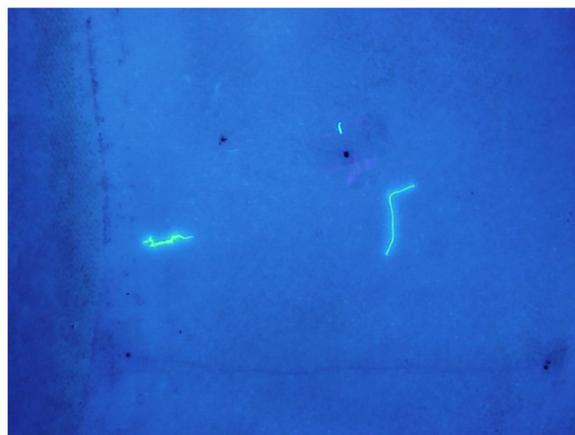
Also included is an image obtained by means of UVA (figure 5) that demonstrates how this band of the spectrum is especially useful for detecting certain types of inclusions and the irregular distribution of the resin on the surface observed (Rosenthal & Trolinger, 1995; Steton & Ferraro, 1993; Erf, 1974).

Figure 5. Image obtained by UVA. In light color, some inclusions are shown in the form of a filament

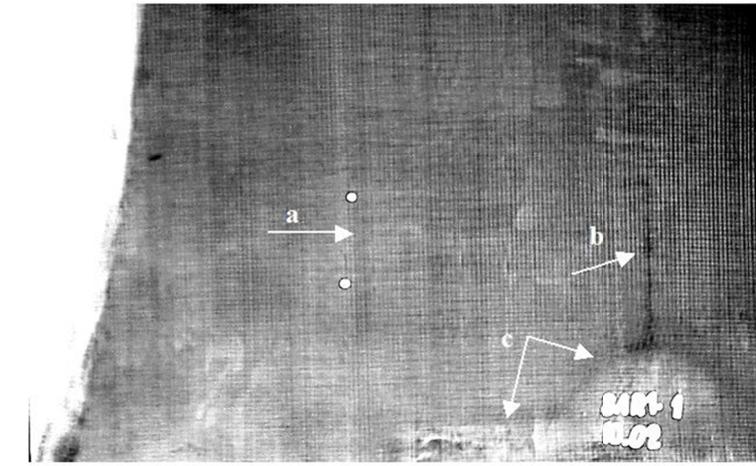
Figure 6a shows an X-ray (Bermúdez, 1963; Sproull, 1946) of an area where a break in the "skin" of the interior of the piece had been visually detected (see photograph in figure 6c). This breakage gives a clear indication (arrow a, figure 6a) between the two white circles. There is a vertical discontinuity (arrow b), probably due to a break in the fabric on the outside that is painted, since this is not visually observed on the inside.

The discontinuities indicated by arrows a and b did not provide indications when inspected by thermography.

Arrows c indicate an area with irregularities in the resin distribution (probably additional resin has been added), whose shape coincides exactly with the indication shown in the thermographic image in figure 6d.

Figure 6a. X-ray of an area showing various discontinuities

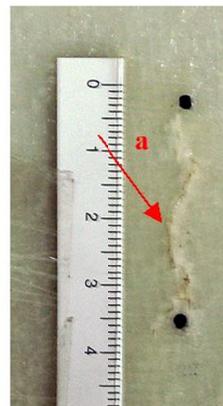
Figure 6c. Visual detail of the discontinuity marked with the arrow b in figure 6a

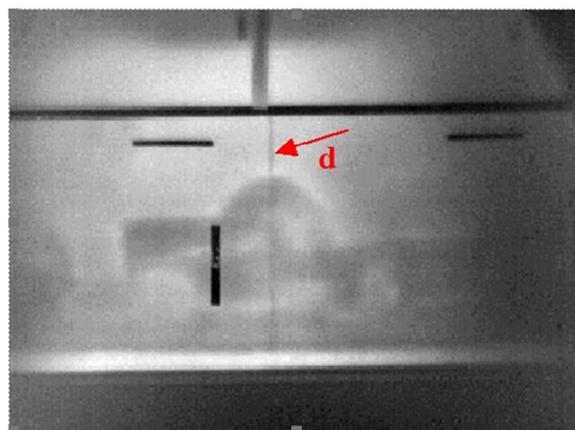
In the thermography there is a vertical indication (arrow d) in the central area that runs along the longitudinal axis of the radome and has no relationship with the radiographic indication indicated by the arrow b in figure 6a. Although the reason for the existence of this indication is unknown to us, it is clear that it is in the manufacturing process itself.

Figure 6d. Thermography of a zone partially coincident with the one shown in figure 6a

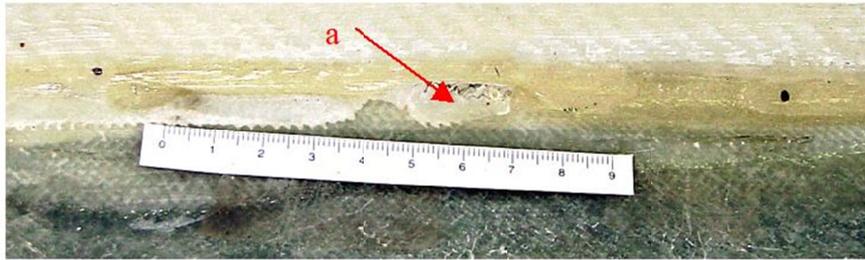
In figure 7a you can see the photograph of an area, located in the agreement between the central sandwich and the side panel, where there are gaps due to lack of resin. The radiographic aspect of the discontinuity is indicated with the arrow a in figure 7b, where discontinuities can also be seen in the fabrics that form the union between the sandwich and the lateral panel (arrows b).

Figure 7a. Visible image of an area with holes due to lack of resin

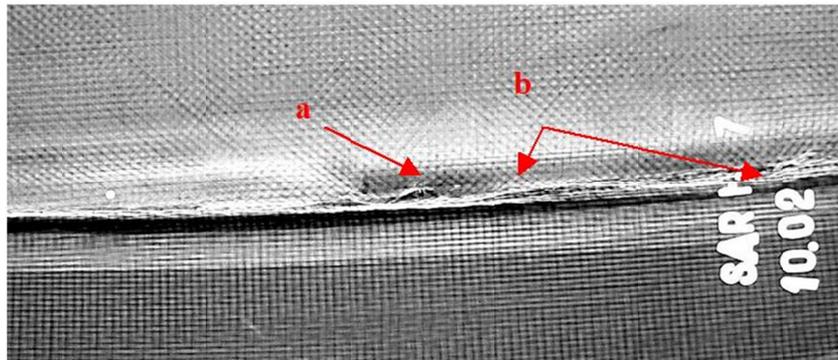
Figure 7b. X-ray of the area shown in figure 7a

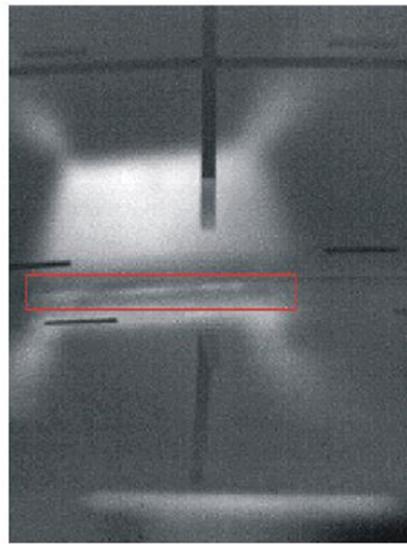
The thermography corresponding to this zone of the agreement is shown in figure 7c, where the zone with holes appears as a narrow vertical band of light color.

Figure 7c. Thermographic image of the area with holes in figure 7

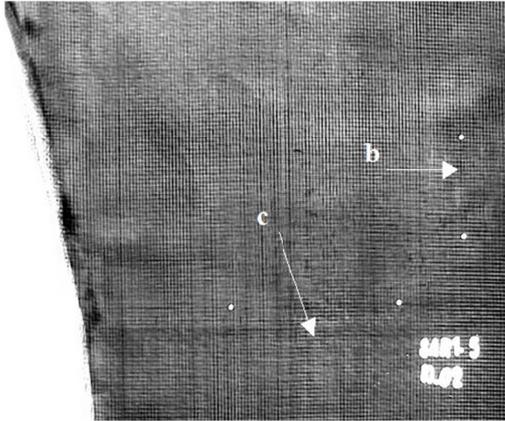
Figure 8a

Figures 8a and 8b show radiographic images of the sandwich covering, with a certain overlap area, the whole width of the piece in one of its curved areas. In them, several discontinuities can be observed that affect the core, the skins and the agreement between the sandwich and the side panel.

Both on the left side of figure 8a and on the right side of figure 8b, there are dark areas caused by cavities and areas with lack of resin, located in the agreement between the sandwich and the side panels. The indications marked with arrow d in figure 8b coincide exactly with those seen in the thermographic image represented in figure 8f (arrow d).

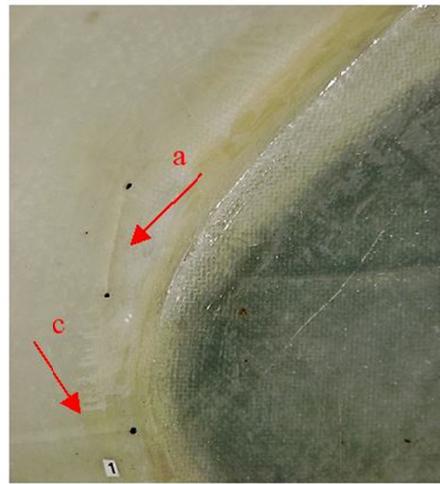
Figure 8d shows the visual aspect of a fiber break (arrow a) in the inner fabric of the piece. The corresponding radiographic indication is the one indicated by the arrow a in figure 8b, being presented in figure 8c a detail of the same one. However, the vertical line that appears in the photograph in figure 8e (arrow b), should be very superficial and affect only the outer layer of resin, since its radiographic indication, marked by arrows b in figures 8a and 8b, is barely perceptible. The thermographic inspection of the area did not clearly reveal any of the two discontinuities.

Likewise, in figure 8d, part of a union joint practiced in the nucleus (arrow c) can also be seen, which gives rise to diffuse radiographic indications marked by arrow c in figures 8a and 8b. The indications due to the joint are clearly visible in the thermographic image in figure 8f (arrow c).

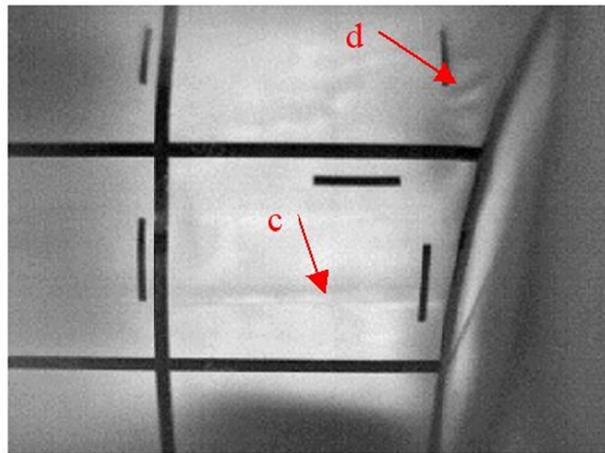
Figure 8f. Thermography corresponding to the same area as the radiography in figure 8b

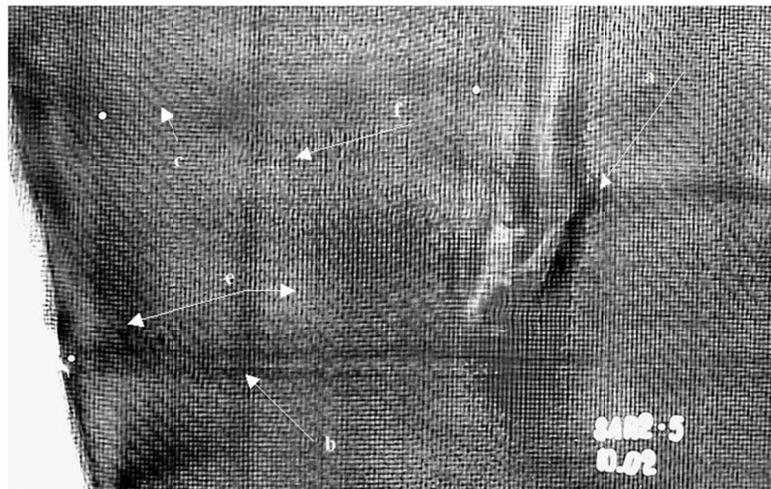
Figure 9a represents the radiographic image of an area where folds and broken tissue are detected (arrow a), in addition to a slightly curved vertical indication. These discontinuities must be on the outer side of the radome, where they cannot be observed by visual inspection, since the piece is painted on that side. Figure 9d, which corresponds to the thermography of this area, shows very remarkable concordance between the two methods, although the X-ray provides more information in this case (Halmshaw, 1966).

Figure 9a. X-ray showing tissue ruptures and other discontinuities

The irregularities in the distribution of resin shown in figure 9a by arrows e and the deformations in the structure of the tissue (figure 9a, arrow f) are clearly observed in radiography, but not in thermography.

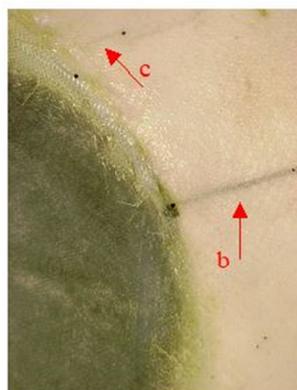
Figure 9b. Photo showing a seal (arrow b) and a break (arrow c) of the core

The arrows b in the entire group of figures 9 point to a joint in the foam core. Figure 9b shows what it looks like with the naked eye when the surface from which it is viewed is not painted, while figures 9a and 9d, 9e compare the indications provided by the radiographic and thermographic methods, respectively.

Core breaks, such as the one shown in Figure 9c, are not detectable radiographically. Thus, the break marked with the arrow c in figure 9b does not give an indication in the radiographic picture of figure 9a (arrow c). On the other hand, these discontinuities provide a very clear indication when inspected by thermography, as can be seen in the place indicated by the arrow d in figure 9e, where a branched break appears, which is not the same as that seen in figure 9c. The radiographic undetectability of the foam core breaks is due to the low density of the foam core compared to the material that composes the "skins". The case of the joints in the core is not comparable to that of the breaks, since other materials, such as fillers and adhesives, may exist in the joint, which facilitates radiographic detection (Lendze et al., 2006; Kang et al., 2006).

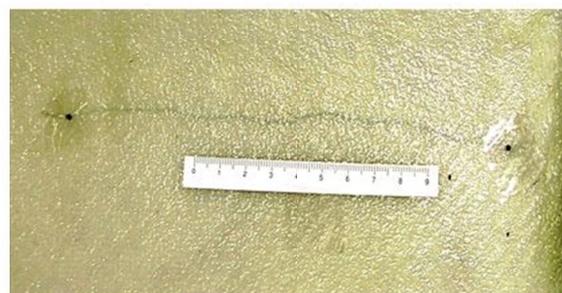
Figure 9c. Visual aspect of a core break

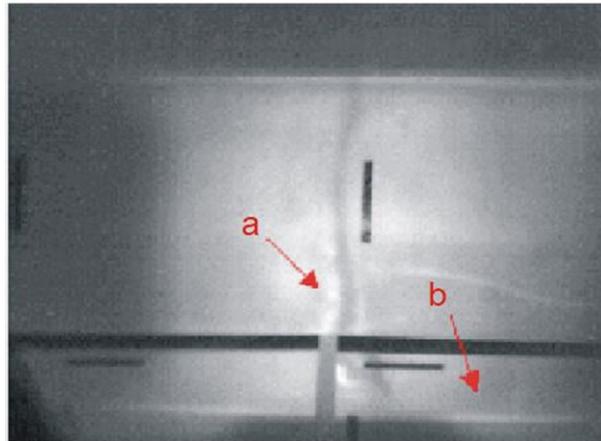
Figure 9d. Thermography of the area shown in figure 9a

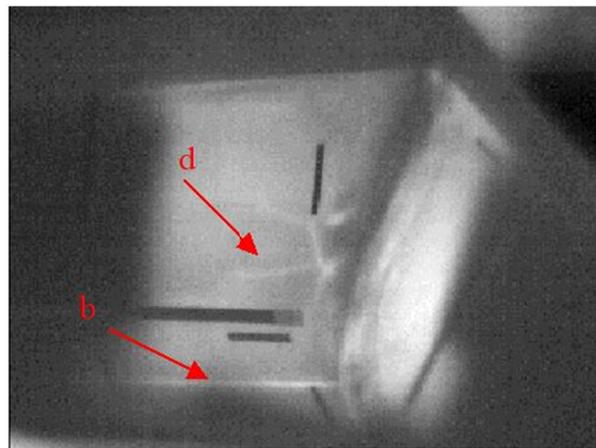
Figure 9e. Thermography showing a branched core rupture

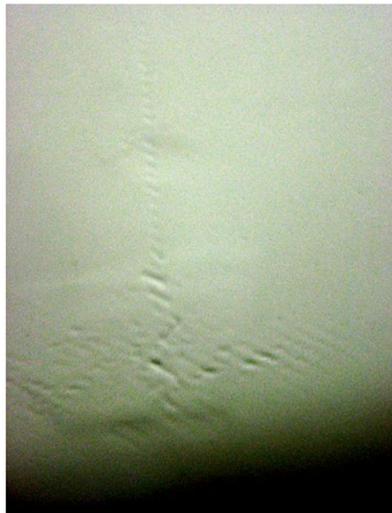
Figure 10a. Photograph of an area of the outer face of a radome

The photograph in figure 10a corresponds to an area of the external face of a radome in which you can see quite deep dents and tracks, inclined at 45 degrees. The X-ray in figure 10b clearly shows the footprints due to the loss of thickness that they represent. The thermography (figure 10c), besides providing indications (not as clear as the X-ray) of the prints, shows us an indication of dark color that is associated with the dented area; this indication is probably due to the fact that the fabric contains additional resin in that area.

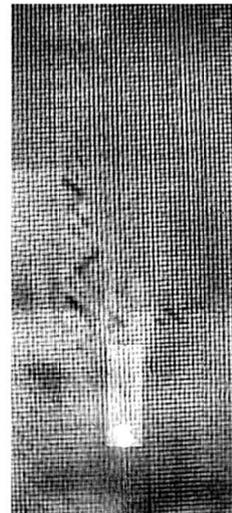
Figure 10b. X-ray of the area shown in figure 10a

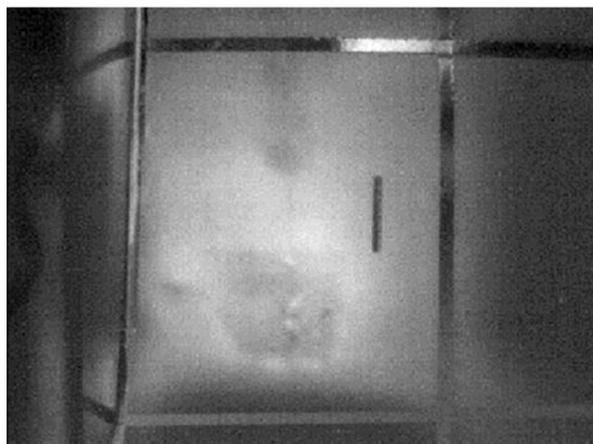
Figure 10c. Thermographic image corresponding to the area shown in figure 10a

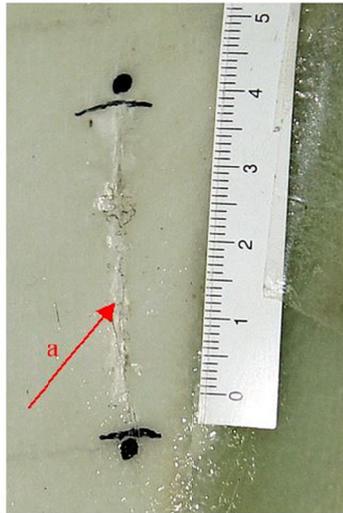
The group of figures 11 illustrates a set of almost coincidental breaks in the fabric of both "skins" and in the core giving rise to a "through crack". In the photograph of figure 11a you can see a line (arrow a) in which the two layers of fabric are broken on the inner side, its radiographic indication is marked with the arrow a in figure 11c. As it can be seen in figure 11b, the outer side of the piece also shows a very severe tear of the fabric. The appearance of this in radiography is indicated by the arrow b in figure 11c. From the examination of the last figure, it can be deduced that the two ruptures are very close but their projection does not coincide and, given that in that area the nucleus is also broken, the set of the three discontinuities can be called "through crack".

Figure 11a. Photograph showing a tear in the fabric on the inside

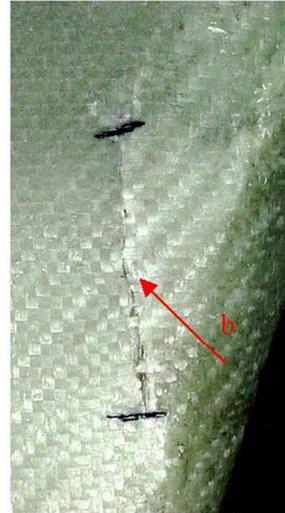
Figure 11b. Image of the exterior face showing a very severe break

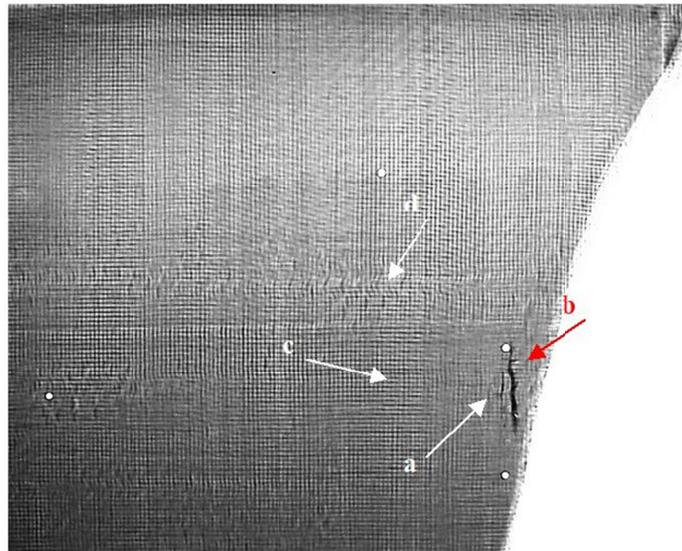
When the fabric has a shortage of resin, its structure (weft and warp) is perfectly defined in the radiographic images, as shown in the area indicated by the arrow c in figure 11c. Likewise, the X-ray is also able to reveal if there are deformations of the tissue or deviations in its direction (arrow d in figure 11c).

Figure 11c. X-ray showing the breaks in figures 11a and 11b, together with other discontinuities

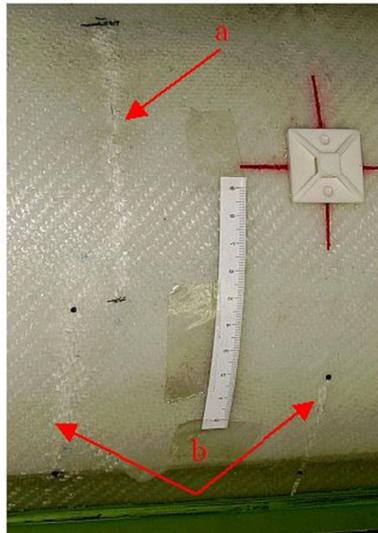
In the photograph shown in figure 12, three discontinuities can be seen, indicated by arrows a and b. Of these, the one marked with arrow a is a break in the fabric that gives a clear indication in X-ray, but the two lines marked with arrows b are not detected by any method, except visual, as long as the surface is not painted. In fact, what it seems, and is corroborated by radiographic examinations of the area, is that these visual indications are not due to breaks, but rather are caused by the existence of areas with a shortage of resin. The area with resin deficit extends around the linear visual indication in a much larger area than the same, and may already exist, or originate during the life in service, delaminations in the "skins" or detachments in the union "skin"-core. Likewise, it is possible that in the place where the linear indication is found, a breakage of the fibers of the fabric is originated when the piece is submitted to efforts.

Figure 12. Visible image of an area in the outer curved part of a radome
