Ensuring Human Safety in the Disaster Prone Coastal Town of Limbe, Cameroon

Sunday Shende Kometa¹

¹ Department of Geography, Faculty of Social and Management Sciences, University of Buea, Cameroon

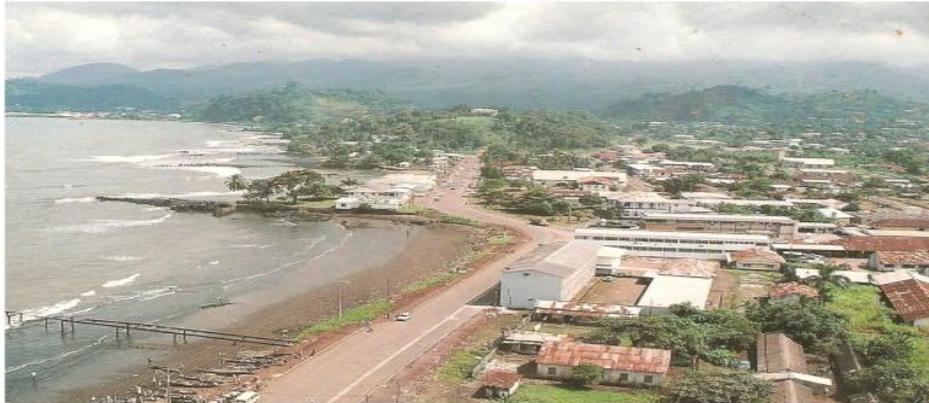
Figure 1. Partial View of view Limbe showing arms of the sea extending into Land

The figure is a partial view of the Limbe Municipality in terms of the extent of sea inland relative to the built-up area

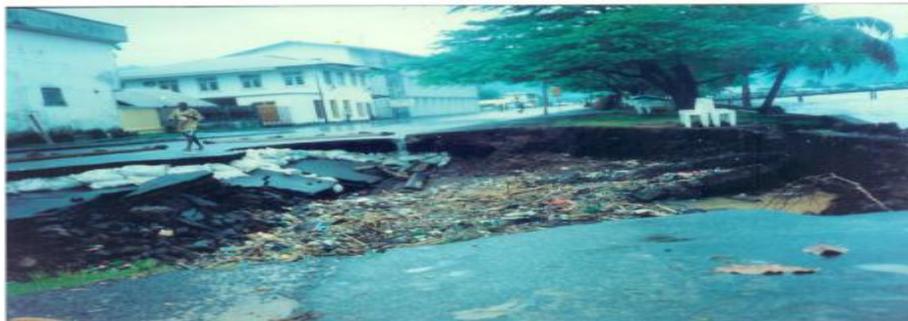
Figure 2. The main road at 'Down Beach' eroded by oceanic waves in June 2001

The figure shows the overwhelming energy of the sea waves given the partial collapse of the road in the area noted.

During heavy rains in June 2001, the level of the sea rose and huge masses of water were forced to crash on the coast. The foundation of the building housing the Red Cross as well as part of the main road linking this area to the rest of the town especially around the BEAC (Bank of Central African Region) junction were eroded (Figure 2). The intensity was so strong that both the building and the road collapsed. The engineering company which constructed the road did not take the local geology into consideration. Since this area is made up of mostly volcanic scoria which is easily weathered, chemical weathering took place and rendered the rocks susceptible to erosion. No supporting embankment existed and those there today only came after the 2001 disaster (Figure 3).

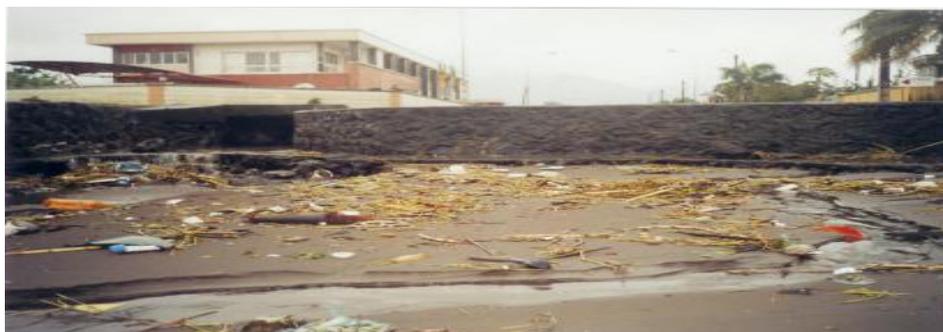
Figure 3. The same road at 'Down Beach' rehabilitated in 2004

The figure shows some rehabilitation effort in progress three years after the collapse portion of the road indicated in Figure 2.

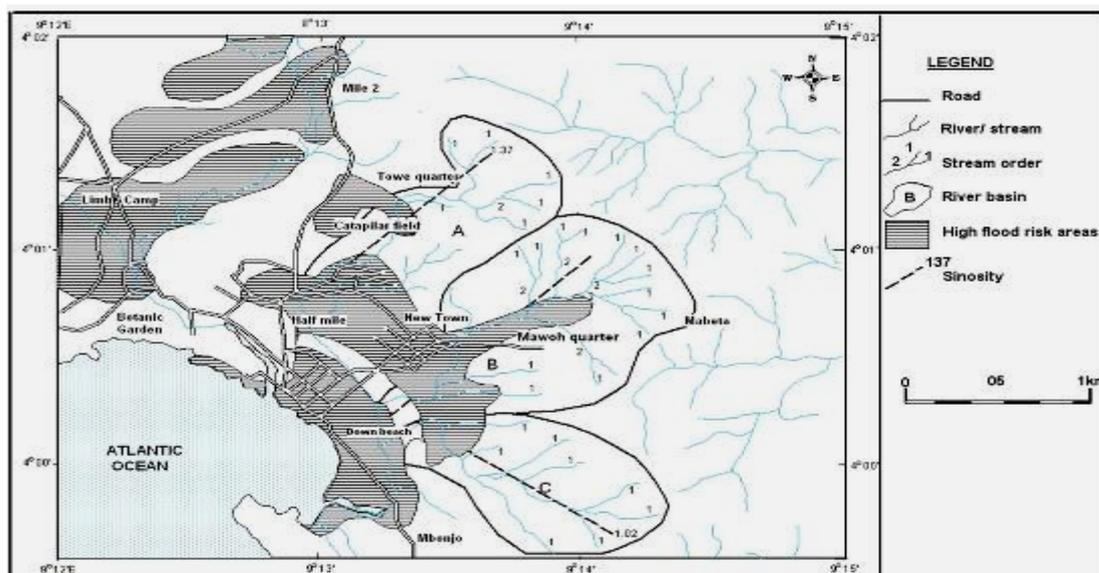
Figure 4. Flood-prone area in and around Limbe

The figure is a presentation of the humanized flood-prone areas in relation to their proximity to the natural drainage channels and the sea.

The topographic layout of Limbe shows a basin-like structure with a number of topographic elevations (Figure 4). This basin or coastal plain stretches for about 3 to 4 km from the sea and some of the built-up areas are only slightly above sea level making the soils constantly saturated. This problematic area of Limbe shows a low lying area dotted by a number of scoriaceous cones and this plain is ensconced by hills except in the south eastern portion where it opens into the Atlantic Ocean. Urban flooding in Limbe is therefore not recent but it has been more disastrous in the past decades because of the rapid growth the town has been witnessing. This with the site, relief and geology, the rainfall and drainage characteristic of Limbe make it an environment rife for persistent and disastrous flood hazards (Lambi et al., 2002). Topographically, most of the settled area is only a few meters above sea level which is thus served by rainstorms from the surrounding hills (Figure 5) that channel water in a 'funnel-like manner' into the city. This flooding is therefore made worse by the extremely low relief and the inadequate or poorly maintained drainage systems.

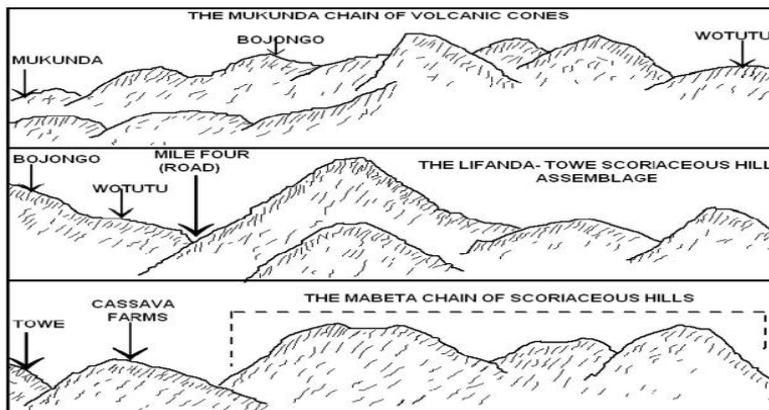
Figure 5. The surrounding scoriaeous chains of volcanic cones which make up funnel shaped topography that ensconces Limbe. Source: Adapted from Figure 1

The figure gives a picture of the topographic nature reflected in the chains of scoriaeous cones which partially surround the flood-prone lowlands in the study area.

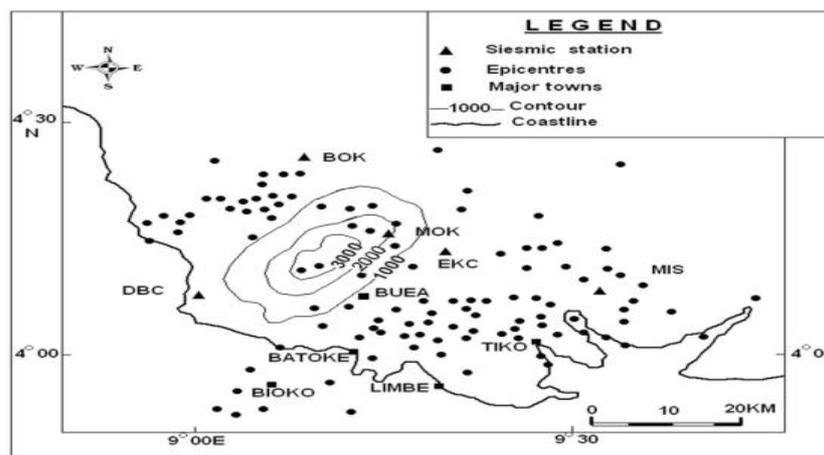
Figure 6. The distribution of earthquake epicenters around the Mount Cameroon Region

The figure shows the distribution of earthquake epicenter in the Mount Cameroon Region. It is important to note the occurrence of major residential centers relative to the earthquake epicenters. Source: Ateba and Ntepe, 1997.
