Architect's and Geologist's View on the Causes of Building Failures in Nigeria

Keywords: architect, building failure, geologist, Nigeria, site investigation

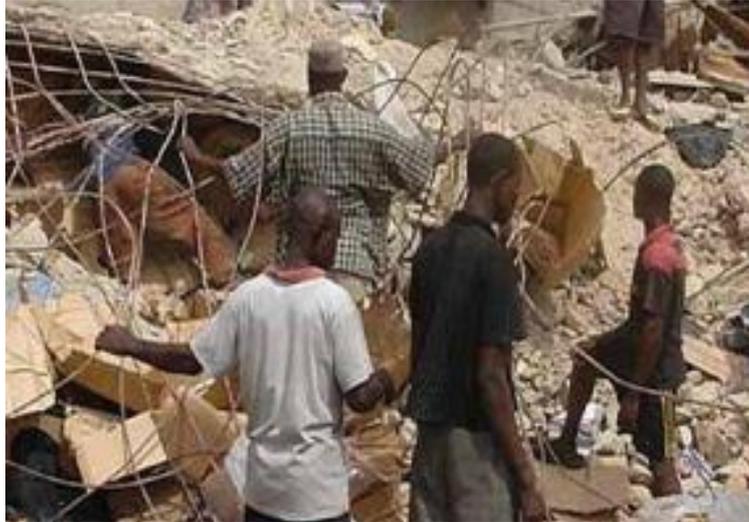
The use of sub-standard (inferior) material in building construction account for about 10% contributing factor to cases of collapse building in Nigeria (Oyewande, 1992). Poor mixing of concrete aggregate, poor quality steel reinforcement and use of sub-standard blocks from some block industries contribute their own factor to building collapse in Nigeria. Some of these constructional materials did not meet specified standard nor any quality control checks conducted on them before they are used for the construction. The frequent use of inferior and untested local building material leads to structural failures in buildings as shown below.

Figure 1. A collapse building due to use of sub-standard material (Source: Author, 2012)

- (e) Standard Organization of Nigeria (SON) and other relevant agencies should ensure that all constructional materials like blocks, cement, reinforcement steel are tested and standards not compromised.

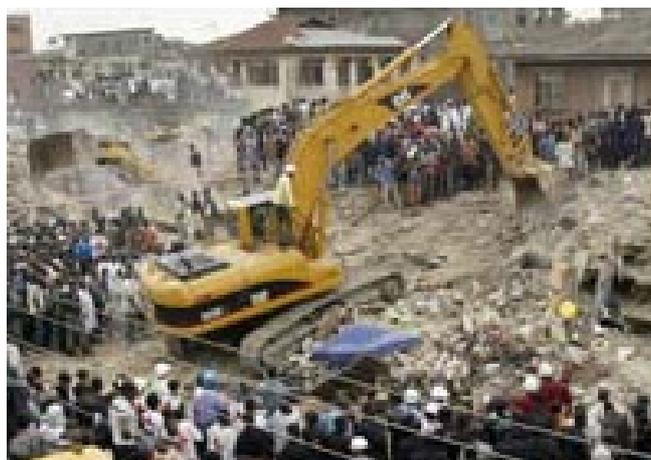
All engineering works start with the foundation. The purpose of a foundation is to transfer the load of structure to the ground without causing the ground to respond to uneven or excessive movement. Such load must be transferred in such a way that there will be no shear failure in the underlying soils. Many buildings have collapsed due to faulty foundation (Figure 2). Most of the foundations in Nigeria are designed without considering the soil type on which they rest upon. Therefore, it is vital that adequate soil investigation should be carried out before designing of foundation in-order to have a suitable design to suit the local geology of the area.

Figure 2. Collapsed building arising from foundation failure (Source: Author, 2012)

- (a) A pre-construction geotechnical survey or soil survey should be carried out before the commencement of any design and or construction especially in low lying terrain susceptible to high ground water table fluctuation and compressible soil.

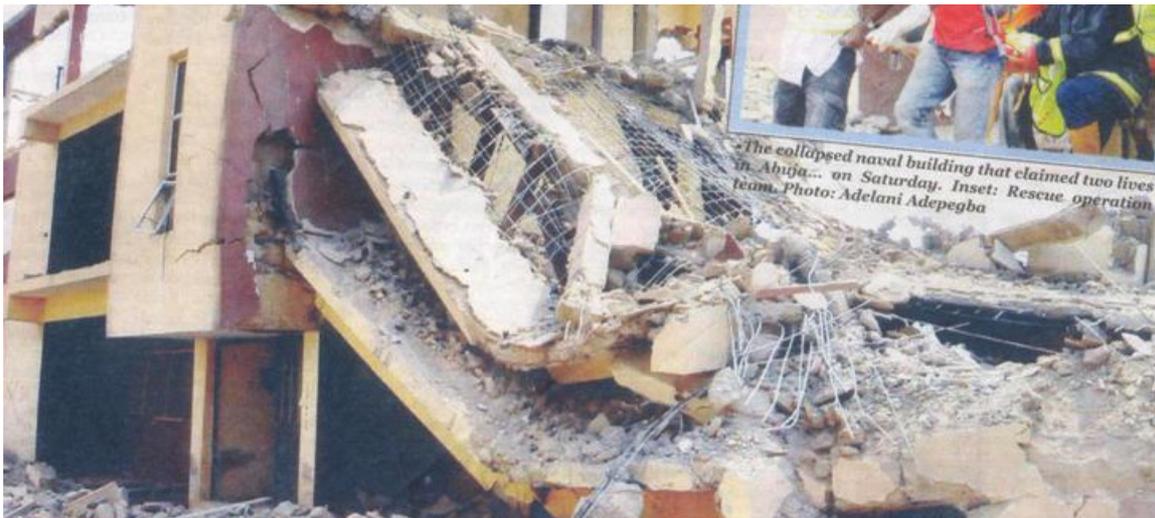
A number of professionals (stakeholders) exist in the building industry, but in most cases their services are not sought for due to one reason or the other, such professionals include: Architects, Quantity Surveyors, Land Surveyors, Builders/Contractors, Engineers (Structural, Civil, Mechanical, Electrical, and Geotechnical). It has been observed that due to high cost of consultancy fees needed to engage the services of these professionals, most Nigerians prefer to cut cost by engaging the services of non professionals (quacks) who lack the needed experience in construction sector. This is reflected in poor workmanship and low standard of construction, which results in structural failure and collapse of part or the entire building. Take for instance, the recent loss of human lives in the collapse of two storey building located at road 45, 1st Avenue Gwarinpa, Abuja on the 28th of January, 2012; according to 'Sunday Sun Newspaper' of January 29, 2012 on page 11; the collapse was as a result of involving non-professionals in the demolition of the said building for further renovation which led to collapse of the structure (Figure 3).

Figure 3: Building collapse as result of engagement of quacks/non-professionals (Source: Sunday Sun Newspaper of January 29, 2012)

- (b) Engagement of Professionals from design stage to completion stage should be made mandatory in the construction of future building.
- (c) Various regulatory bodies such as Council of Registered Engineers (COREN), Council of Nigerian Mining Engineers and Geoscientist (COMEG), Architects Registration Council of Nigeria ARCON and Council of Registered Builders of Nigeria (CORBON), should ensure that only registered and qualified professionals are involved in the construction of future buildings in order to minimize failures.
