# Retrofit Corrosion Control for Al-Zubare Harbor Marine Structures

Today's offshore and ocean going structures are fitted with systems which work to inhibit the rate at which the structure corrodes in the aggressive marine or soil environment. In Al-Zubare Harbor corrosion is also a significant problem, which is due in part to the marine environment and ignorance in corrosion control methodologies. Some costly examples which have recently occurred in Al-Zubare Harbor are excessive corrosion. These problems could have been avoided with selection of appropriate materials, better design, or utilization of corrosion control methodologies like cathodic protection. These retrofit cathodic protection (CP) systems are carefully designed to offer the structure a uniform protection over its surface with the most economical use of anodes. These operate by setting up an electrostatic field in the water surrounding the structure which causes a desired voltage and current density distribution over its surface area.

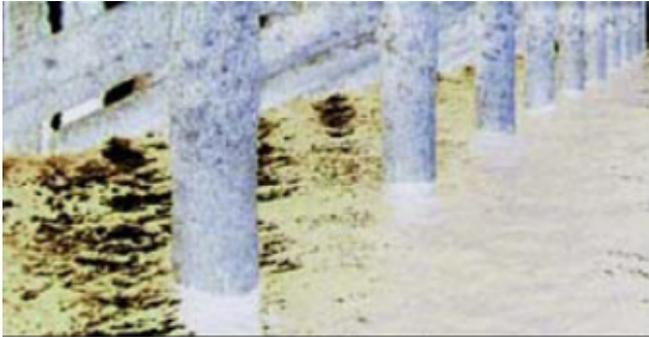
Figure 1. View under of the harbor structure

The general principles of the methods are to make the concrete less permeable and protect the steel as shown in Fig1 and Fig 2. Examples of methods are:

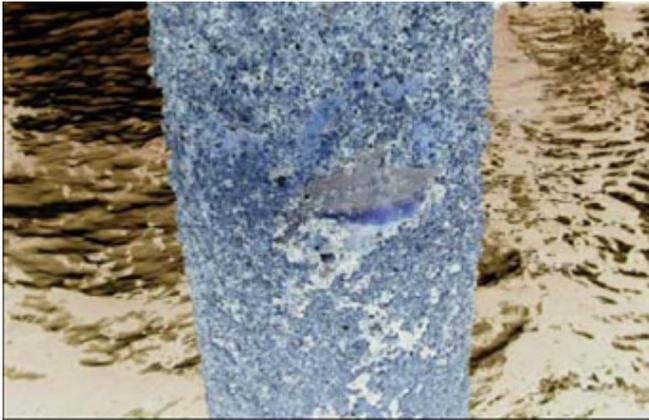
The observation of rust staining was noted on some structures as shown in Fig 3. This can be due to "tramp" steel corroding, especially if it is in contact with the anode. Although unsightly, this is not a problem, although it can lead to small shallow surface spalls. Problems will arise if the steel creates a short circuit between anode and

rebar (cathode). If this happens then the system will not function properly. Low resistance anodes like arc or flame sprayed zinc will show this problem readily. Other anodes with lower conductivity will hide the problem, which can be more serious.

Another cause of rust is the oxidation of iron containing aggregates. These are unsightly harmless. Accelerated anode consumption around patches was noted on some installations.

Figure 3. Rust stains on beam
