Investigation of Changes in Beach Morphology due to Coastal Armoring

Abstract

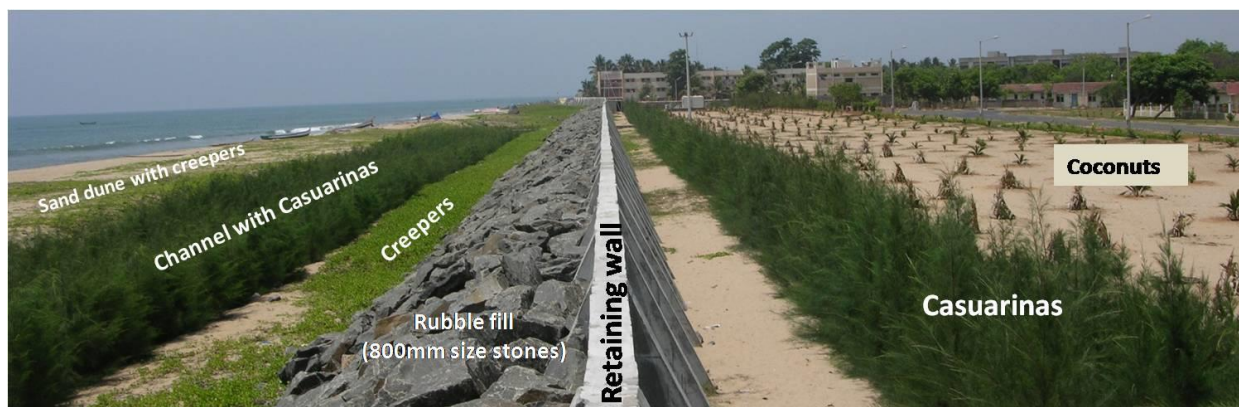
In 2006, at $\approx 42\text{m}$ away from the high water line, TPW was constructed with dimensions $3200\text{m} \times 4.5\text{m} \times 0.3\text{m}$. Further, the TPW was reinforced with rubble stones with a slope of 1 in 1.5 for a distance of 4m from the edge of the TPW towards sea and a sand dune with a bottom width of about 20m with its centerline located at a distance of 14m from the HWL (Fig.2). The wall has vegetation on either side comprising casuarinas, coconut trees, creepers, coastal grass etc. Raj et al. (Raj et al., 2006).

Figure 2. Typical elements of coastal armoring

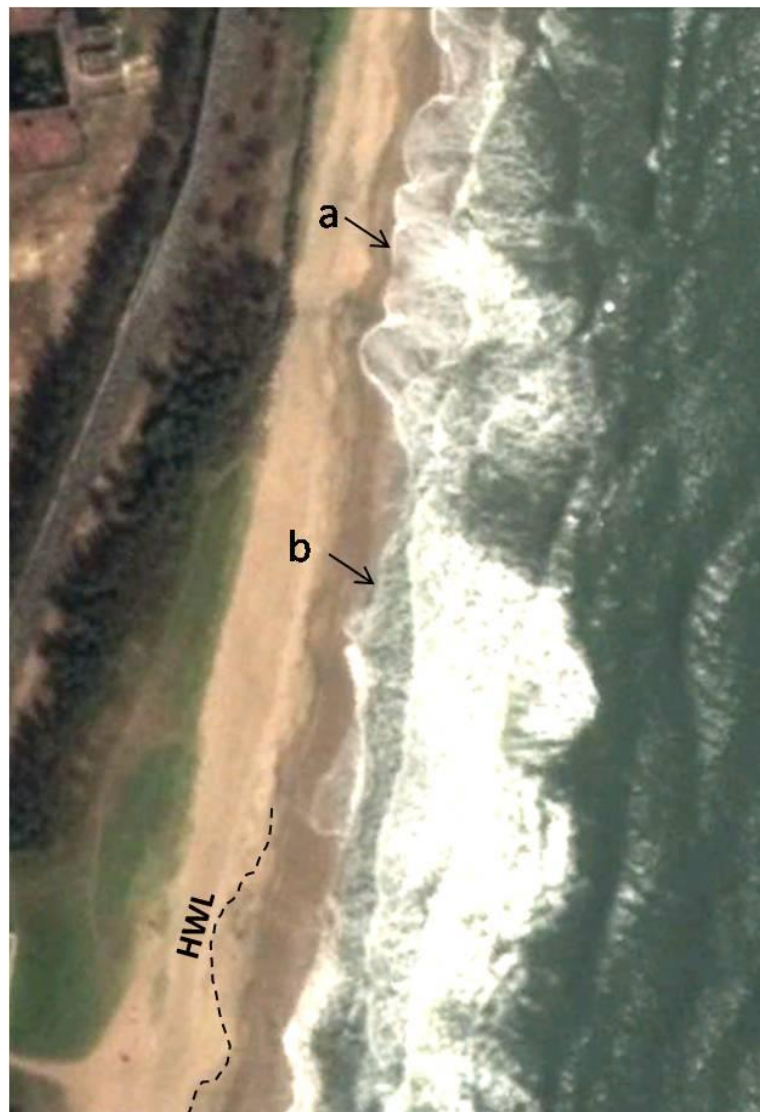
Generally, the physical interface of land and water is taken as shoreline and studied for changes in the beach Dolan et al. (Dolan et al., 1980). However, in practice, identifying shoreline is very difficult since the shoreline position changes continually through time because of cross-shore and alongshore sediment movement, dynamic nature of waves, tides, storm surge. The beach slope, tidal range, and prevailing wave/weather condition also affect shoreline position Morton (Morton, 1991). Some studies on shoreline change consider discrete transects or points and monitor how these change through time. However, there are large uncertainties involved in such sampling method, such as identifying the representative transects, the morphological feature such as beach cusps, etc. which influence the alongshore average shoreline position Boak and Turner (Boak & Turner, 2005). To study the changes in the shoreline, satellite data is very important. However, satellite data are snap shots of land features taken at a specific time whereas the shoreline is a dynamic nature and is difficult to identify shoreline from the imagery (For eg., points a or b in Fig.3). Considering the dynamic nature of the idealized shoreline boundary, for practical purposes, scientists have typically adopted the use of shoreline indicators as a proxy to represent the *true* shoreline position. There are ≈ 45 type of shoreline indicators adopted to extract the shoreline. In the present study, the most common indicator called High Water Line (HWL) is digitized as continuous line feature using GIS software by visually identifying the dry-wet boundary Dolan et al. (Dolan et al., 1980), Fisher and Overton (Fisher & Overton, 1994), Hapke and Richmond (Hapke & Richmond, 2000). The multi dated satellite data are geo-rectified and all images were projected into Universal Transverse Mercator geographic co-ordinates to identify the exact physical locations in the study area. Separate shape files are created for TPW with HWL demarked using on-screen digitization method by employing GIS software. The study area has been segmented into 21 parts and the distance between TPW and HWL, ($D_{tpw-hwl}$) are measured using the GIS software.

Figure 3. High Water Line used in the study

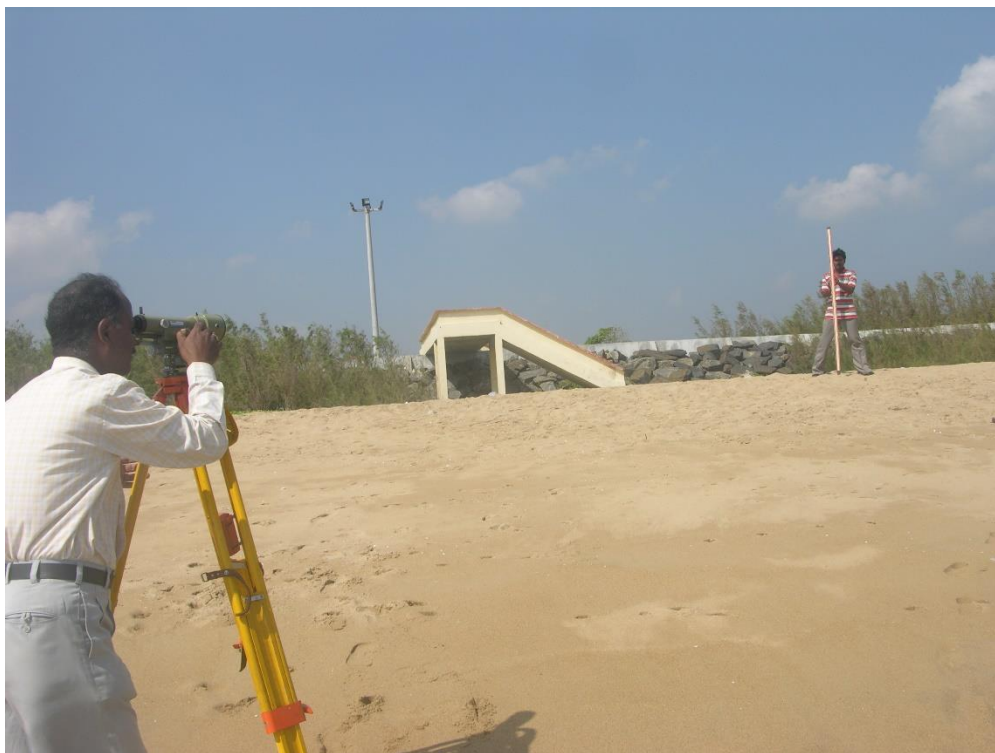
A base reference station is established by employing real-time kinematic GPS. With this base station, seven reference benchmarks are established in front of the wall area. Monthly field survey was carried out during 2009 to measure the sedimentation pattern at reference benchmarks with the help of N3 precision level survey instrument, a measuring tape and a standard measuring staff (Fig.4). The beach profiling was carried out along shore-normal direction from the reference benchmark to HWL, ($D_{rwl-hwl}$). These profiles were then compared to ascertain the change in the beach width with respect to seasons.

Figure 4. Beach profile using N3 precision level instrument

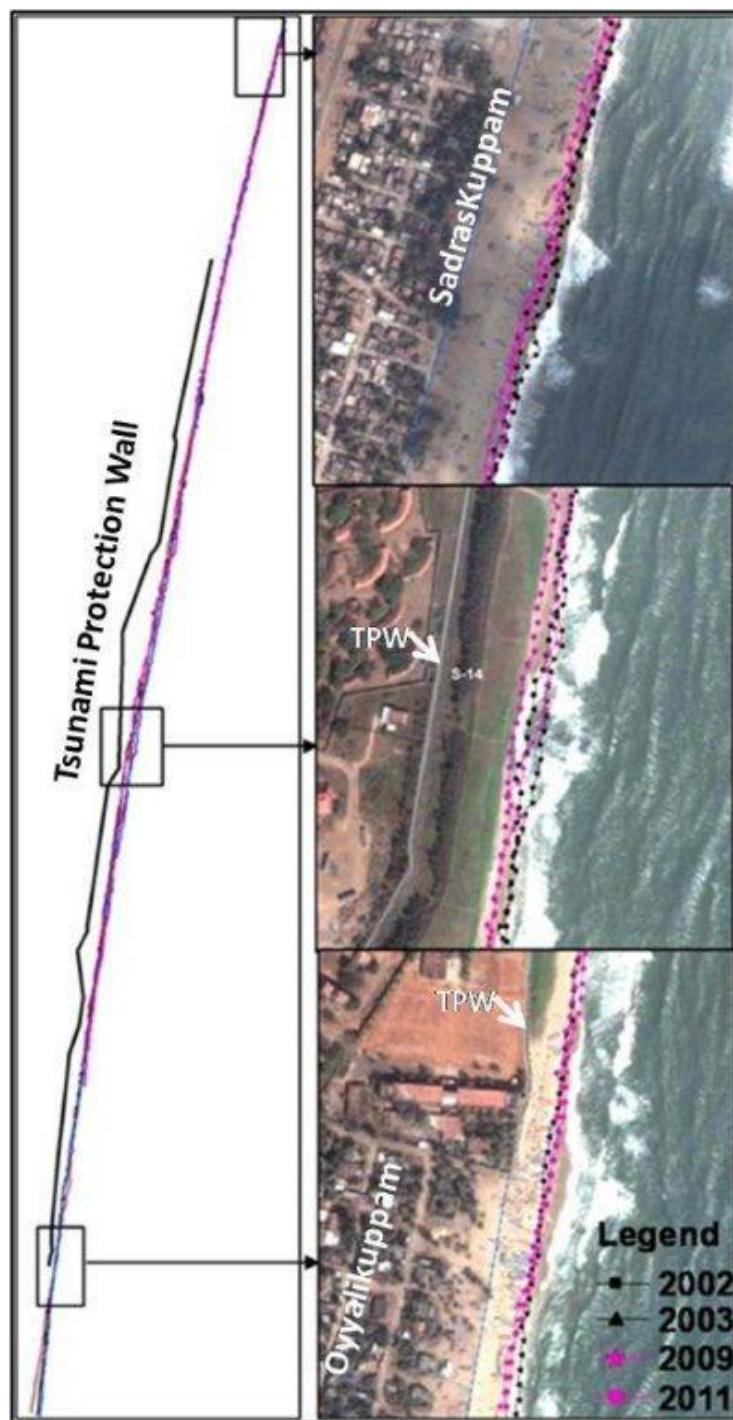
In the present study, the period of tsunami (2004) and the period of construction of TPW (2005-2008) are not considered so as to avoid their influence in the results. The change in the position of HWL, $D_{twl-hwl}$ is compiled for four years including the pre-construction (2002, 2003) and post-construction (2009, 2011) periods (Fig.5).

There is no uniform trend in the position of HWL in the segments i.e. in some segments it shows landward movement whereas in other segments a seaward movement is observed for the same year. This type of variation is observed for all years. The position of HWL in 2003 and 2004 was averaged and taken up as the position of HWL during the pre-construction period. Similarly, the HWL in 2009 and 2011 was averaged and taken up as the position of HWL during the post-construction period. By comparing these two HWLs, it was found that the average difference between the position of HWL in pre- and post- construction period is 4.6m (Fig.6, Table 2). The negative sign of the difference shows erosion trend. The average erosion rate of Kalpakkam coast was calculated as 0.46my^{-1} . This value closely matches with the earlier prediction i.e. 0.55my^{-1} NIOT (NIOT, 2009). In the study area, it is observed that three segments located very close to backwater/river mouth show significant difference in the position of HWL. The high rate of erosion along these locations is due to the interception of northward moving littoral currents by the river flows. These types of erosion behavior are common along the East Coast of India where the net littoral drift is towards north Rao et al. (Rao, Murthy, Bhat & Reddy, 2009). The pre- and post- construction period position of HWL, clearly indicates that the response of beach is uniform along armored and unarmored beach as the TPW was constructed ≈ 40 meters away from the HWL.

Figure 5. Variations in the position of High Water Line (at selected segments)

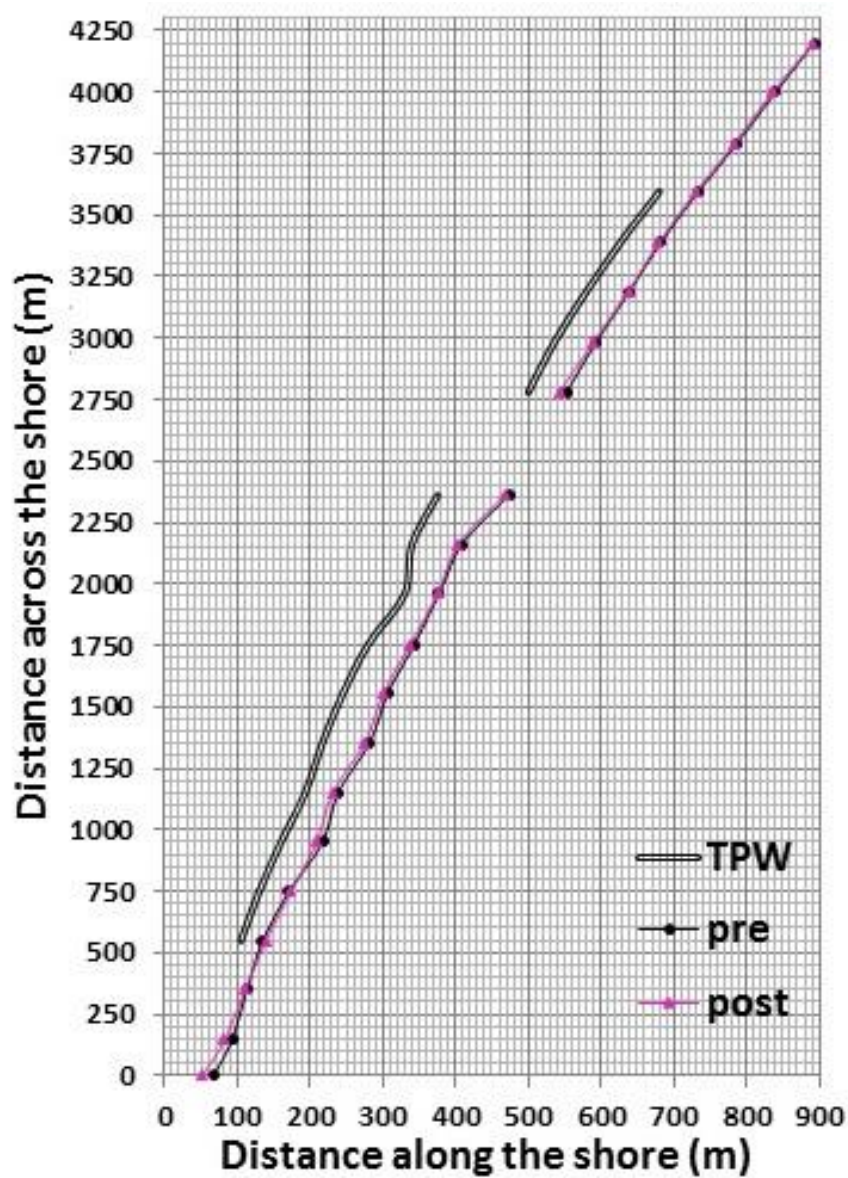
Figure 6. Comparison of HWL (pre- and post- construction of TPW)

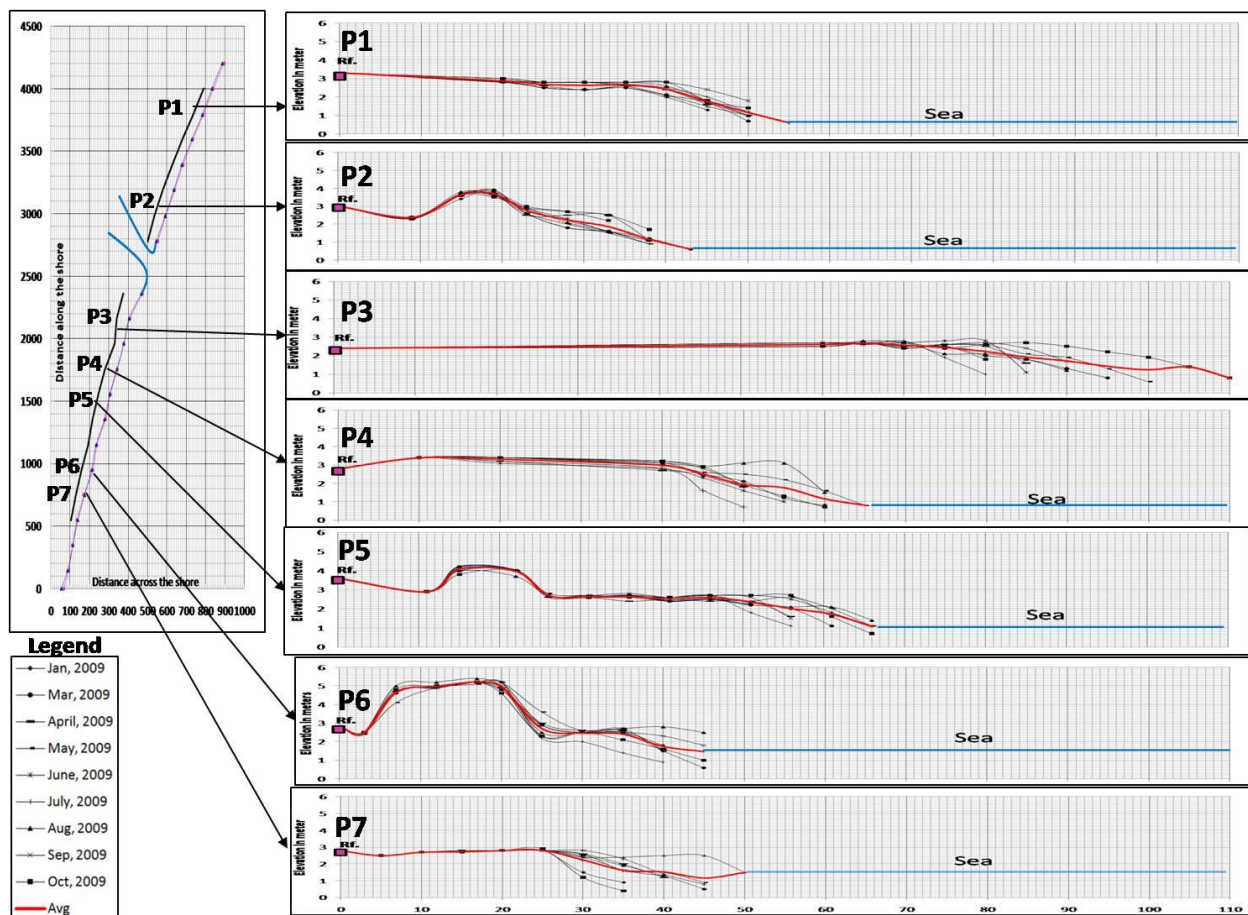
To monitor the variation in the sedimentation pattern, monthly field survey was carried out during 2009 by employing precision N3 survey instrument. Seven profiles (P1-P7) were drawn to know the changes in the cross shore beach morphology (Fig.7, Table 3). The one year profiling of beach indicate that average sedimentation changes is $\approx 0.5\text{m}$ in the berm of backshore region and $\approx 1.7\text{m}$ in the swash zone of the foreshore region all along the study area and is similar for armored beach and unarmored control beach (Table 3). From the seven profiles, it is evident that significant difference in sedimentation pattern is limited to swash zone of foreshore region. The decrease in berm was observed during pre-monsoon (Mar-May) to onset of south west monsoon (Jun-Sept) where the increase in berm was observed throughout the monsoon period which indicates the strong influence of wave action. The profiling of beach also indicated no induced change in the sedimentation pattern all along armored and unarmored area (Fig.7). The observed variation in the accretion/erosion of the sediment is insignificant.

Figure 7. Sedimentation pattr (accretion/erosion) observed in the study area
