Post - Tsunami Damages Assessment, Relief and Rehabilitation Measures in the Kanyakumari District, Tamil Nadu, South India

The present study is based on the post tsunami survey conducted in January 2005 along the south west coast of India. This paper illustrates the variation of tsunami intensity along the coasts of Kanyakumari district and the consequent morphological changes occurred in the coastal area during tsunami. 33 coastal habitations of Kanyakumari district faced the wrath of tsunami waves. We have attempted to study shoreline modifications using beach profile survey, tsunami sand deposits, inundation distance, run up elevation and tsunami height. The coastal environment changes through online survey on human losses, housing and shelter, fisheries, agriculture and damages of infrastructure were studied in the study area. The major destructions identified in this area were 3m-4m sea water rise leading to erosion activities and changes in the beach slope variation. Many gentle slope regions have been transformed into steeply sloped regions. This unknown killer wave causes casualties and mass destruction in the coastal environment due to unaware of tsunami. The shallow wate

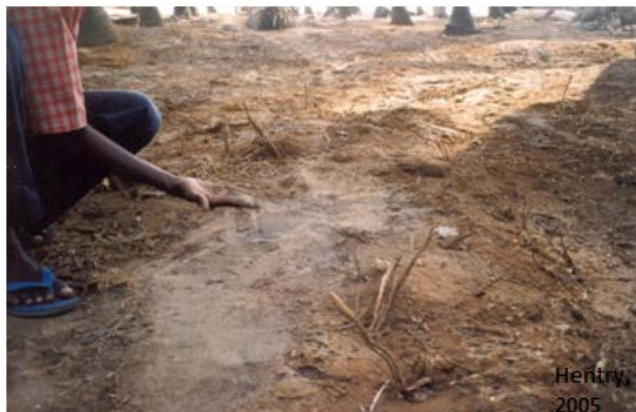
The catastrophic killer wave had carried sand and pebbles from the beach and ocean floor which deposited in the buildings, on top of roofs and also on the ground along the coast of this district. Tsunami pebble deposits had been widely glimpsed in all parts of the study area. The sandy deposits of the coastal tract had been eroded and transported from both foreshore and backshore. Tsunami pebble deposits have been noticed in Colachel, Kotilpadu, Muttom, Midalam, Azheekal, Manakudi, Keelamanakudy and Kanyakumari extending from 50 meters to 700 meters in the hinterland with the thickness of about 12 cm to 4cm thickness respectively (Plate 1). The huge catastrophic wave not only washed away but also had the ability of transporting larger materials including car, household items and even concrete buildings. Just on the mouth of the Manakudy estuary, the bridge connecting Manakudy and Keezhamanakudy has been dispositional toward either side of the banks each block is weighing about few tones and a catholic church totally demolished in Keezhamanakudy (Plates 2a and 2b).

Plate 1. Tsunami sand deposits in the hinterland of Midalam up to 500m from the coast

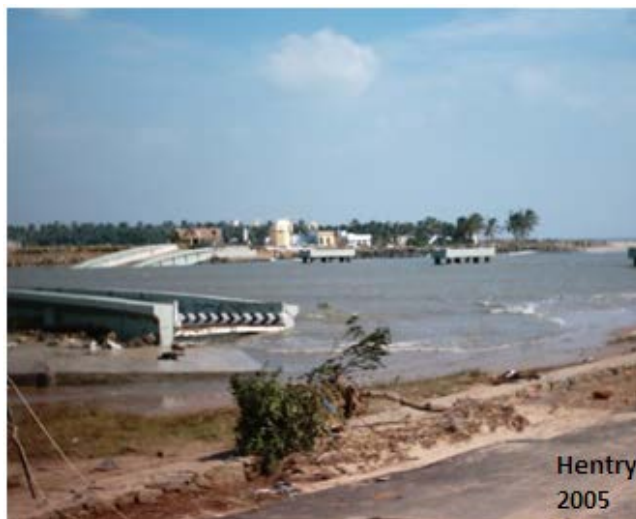
Plate 2a. The Dispositional Bridge connecting Manakudy and Keelamanakudy

The ferry service from Kanyakumari to the Vivekananda rock memorial and Thiruvalluvar statue got disrupted by tsunami. One boat was completely damaged and was washed away. Other two boats suffered extensive damages. The boat jetty got damaged severely. Sothavilai beach, which is a major tourist attraction of Kanyakumari was affected by tsunami. Various facilities like children's park, sanitary complex, bus shelters etc were damaged. More than 123 km of road was damaged by tsunami. 4 schools, 30 anganwadis, 12 sanitary complexes, 16 public buildings and 2 churches were fully damaged by tsunami. 2601 no of electric poles, 58 km length of electric conductors, 1316 no of public lights and 27294 no of house power connections were damaged. In Manakudi village, the concrete bridge across Pazhayar connecting Melmanakudi and Keezhamanakudi was washed away by tsunami. Four spans of the bridge (each weighing 775 metric tonnes and 140 m long) were

lifted from their position and carried away by tsunami waves. 23 small industries, 17 coir industries and 91 small traders were affected by the tsunami in the study area.

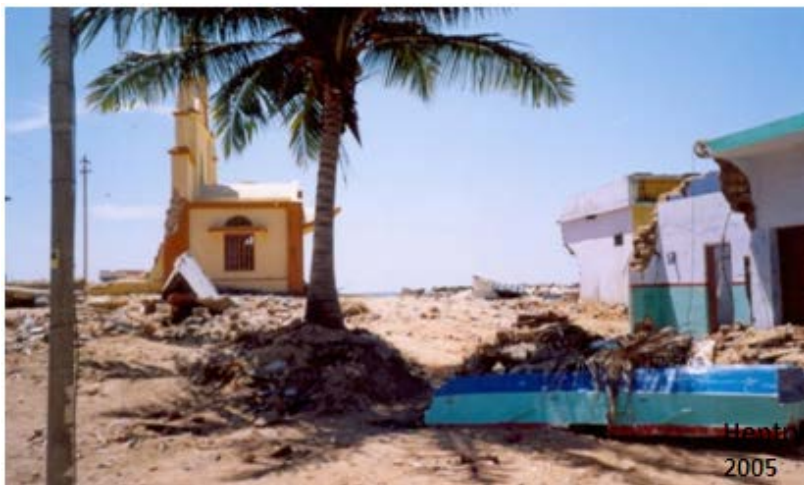
Plate 2b. The demolished Catholic Church in Keezhamanakudy village

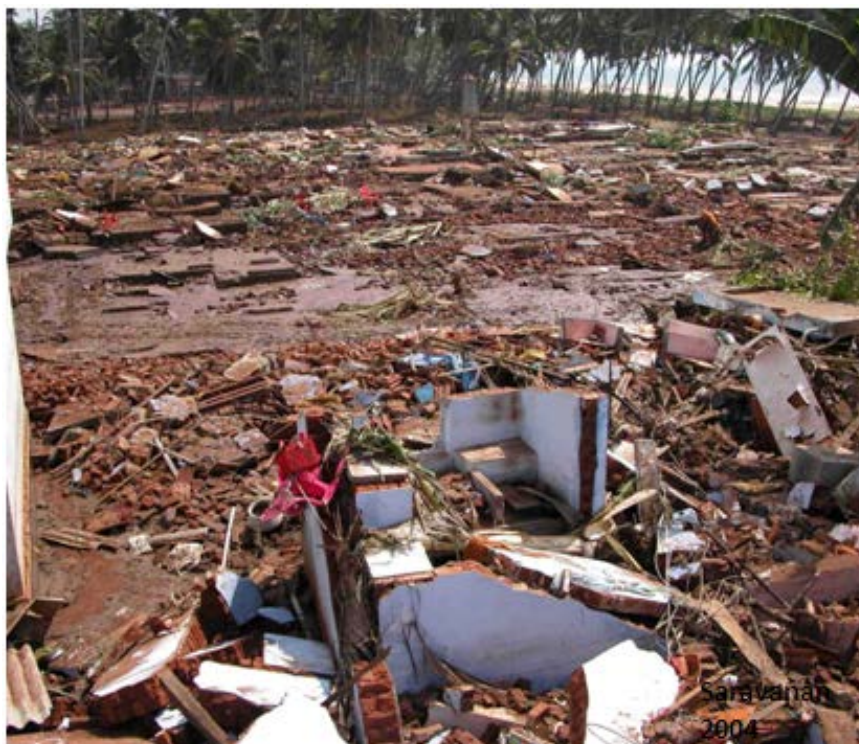
Run-up elevation is defined as the elevation above mean sea level of a tsunami at the limit of penetration. The run up elevation had varied from less than 2 meters to 10 meters. Run up elevation has more values between Kanyakumari to Chotavilai , Azeekal to Muttom and Kotilpad to Colachel regions. The variability of run up distance depends on the same factors as in the inundation distances. The run up elevation depends upon the inundation distances of the nearshore bathymetry of study area. This has been witnessed around Colachel and other regions to an altitude of about 6 m where the water level have been traced down in the buildings and other civil constructions. In the eastern areas, particularly at Keezhamanakudy and Azheekal run up elevation has been extended to an altitude of about 10 meters (Plate 4).

Plate 4. All houses were damaged in Singaravelar Colony

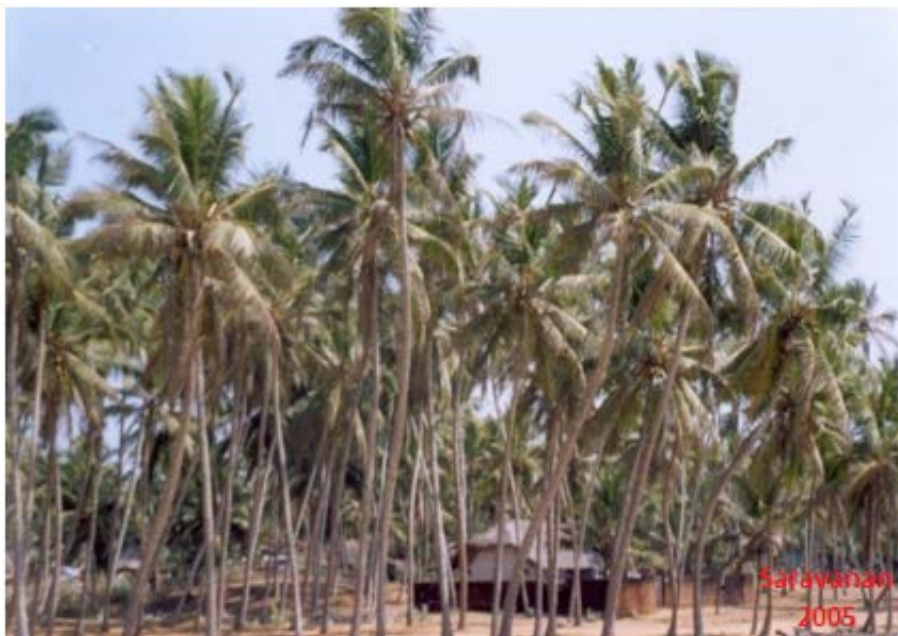
Kanyakumari District is situated in a tropical region with tributaries of rivers entered into the sea, nature bounty with greenish. Due to sea water intrusion, herbs in the regions were completely destroyed. The coconut trees were dried which can yield after a long gap. In nearby coastal villages, all plantation and agricultural wet land have been completely vanished. 282.57 Ha coconut area, 6.47 Ha paddy area, 6.57 Ha banana area, 1.4 Ha Palm tree area and 0.52 Ha other crops area affected by the tsunami in the Kanyakumari district. The damages to Agricultural crops have been given in Plate 5.

Plate 5. The damaged coconut trees in Thengapatnam

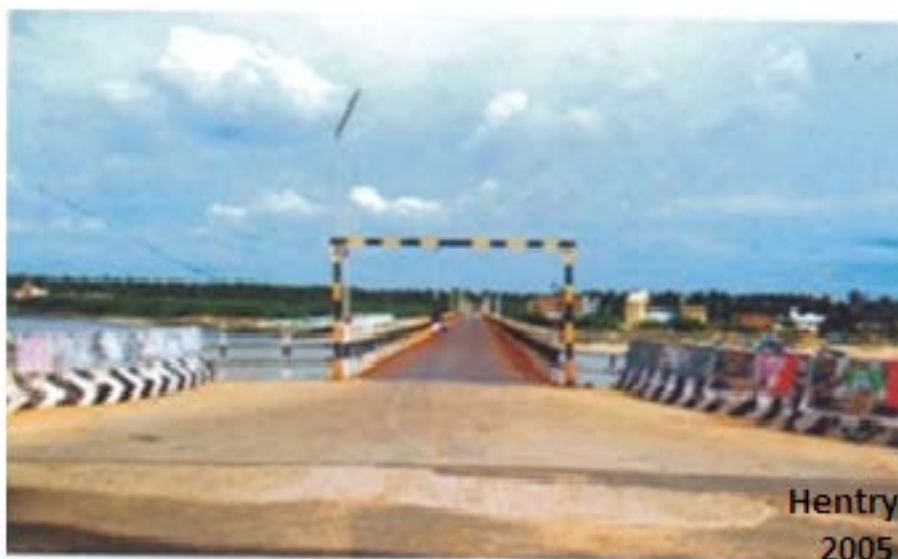
Plate 6. Temporary steel bridge connecting Manakudy and Keezhamanakudy villages

The Government sanctioned Rs 22.02 crore to restore, and improve by widening the roads damaged by tsunami. The government took steps for providing a temporary steel bridge at a cost of Rs 1.4 crore across Pazhayar river connecting Melamanakudi and Keezhamanakudi coastal villages which got washed away by tsunami (Plate 6). A permanent bridge has been constructed at a cost of Rs 9.00 crore. The ferry service from Kanyakumari to the Vivekananda Rock memorial was restored by repairing the boats and providing essential infrastructure at the jetty area within 40 days after the occurrence. Chinnamuttom fishing harbor repairs were taken up at a cost of Rs 72 lakhs. The Government sanctioned Rs 10.66 crore as subsidy and Rs 11 crores as loan for 386 boats. The district administration took up the restoration of Sothavilai beach at a cost of Rs 24.2 lakhs and opened to the public within 8 months after the tsunami. The Government came to the rescue of fishermen who lost their fishing equipments and provided assistance of more than Rs 22.87 crore to these affected fishermen. Also loans to the tune of Rs 12.2 crore was coordinated to fishermen as part as subsidy. Various NGOs and kind hearted philanthropists supplied sufficient no of Catamarans, Vallams and nets to resume fishing in the study area. The tsunami affected farmers were given assistance of Rs 11.53 lakhs by the Government. The Government sanctioned Rs 11.65 as assistance and compensation for small businesses and industries.(Two years of tsunami relief and Rehabilitation).

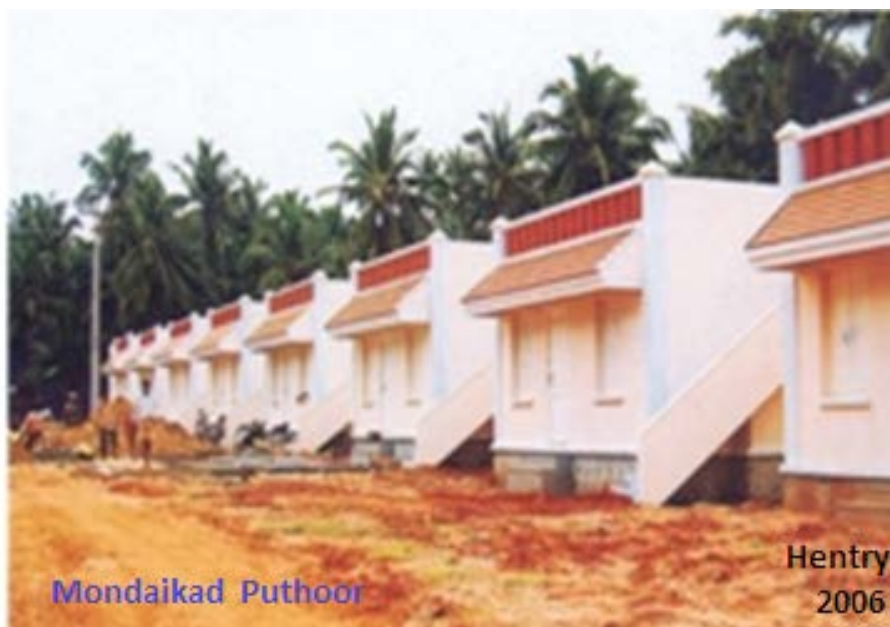
Plate 7. Newly constructed houses at Mondaikad Puthoor

One of the most important tasks in the rehabilitation program is construction of permanent houses for families whose houses got completely damaged by tsunami. Lands were acquired in 28 places. Totally an extent of 86.08 acres of land purchased at a cost of Rs 6.07 crore. 25 acres of Government land also made available in Colachel. 2578 houses have taken up for construction. The details of construction of permanent houses are given in Table 6. The newly constructed houses for the tsunami affected people are given in Plate 7. The district administration decided to develop the lands available in salt pan poramboke (Government Land) in Colachel. In order to improve the infrastructure in the coastal local bodies in the district has sanctioned road works under ADB assistance. These road works will improve the connectivity of various areas on the coast. 193 roads have been taken up for Rs 22.04 crore. Government also sanctioned Rs 27.44 crore for construction of RMS walls at 23 coastal habitations and Groins at four locations.
