# Stability of Rock Slopes along Raidah Escarpment Road, Asir Area, Kingdom of Saudi Arabia

Ahmed M. Youssef<sup>1,3</sup>, Norbert H. Maerz<sup>2</sup> & Abdulla A. Al-Otaibi<sup>3</sup>

**Keywords:** slope stability, raidah escarpment, rating systems, structural controlled sliding, KSA

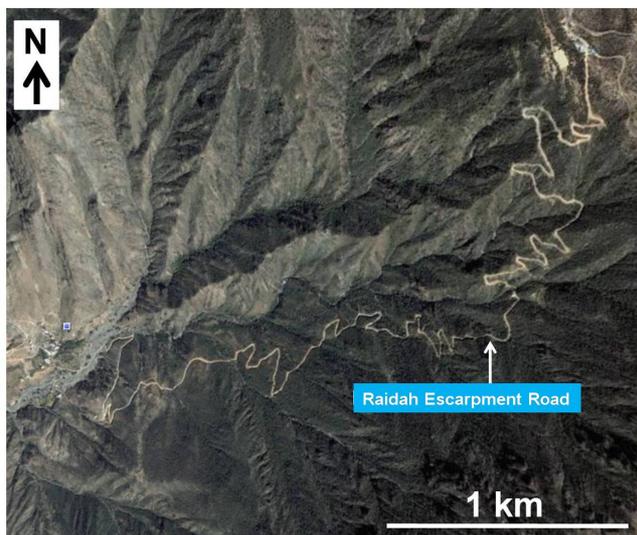
Figure 2. A general view of the Raidah Escarpment Road. Note, the highly irregular characteristics of the road on the high resolution QuikBird image (Google Earth Professional)

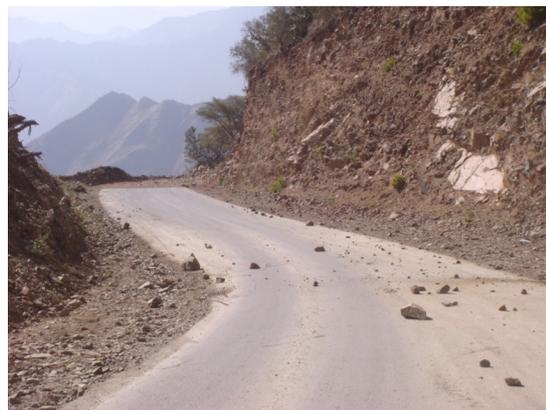
Figure 3. Characteristics of the Raidah escarpment road. (note, one lane with a 3 meter width for each direction)

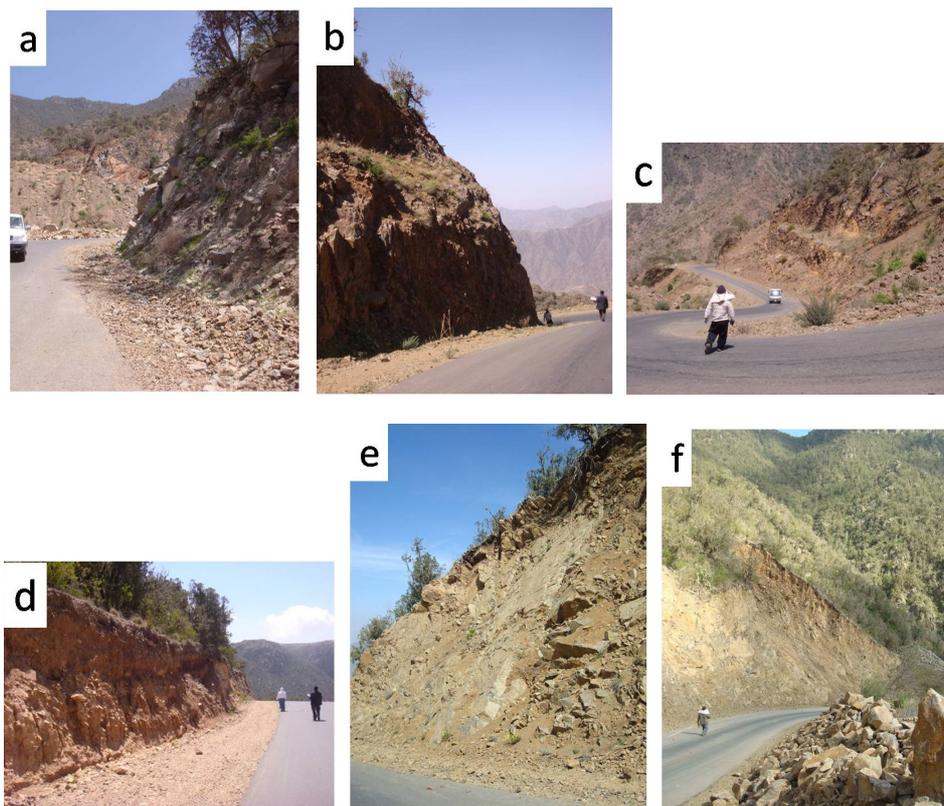
Figure 4. Different characteristics of the Raidah escarpment road. a) Photograph showing narrow ditch; b) Bad shoulder has a slope toward the road; c) Vertical curvature, d) Photograph showing wide and deep ditch; e and f) No ditch present

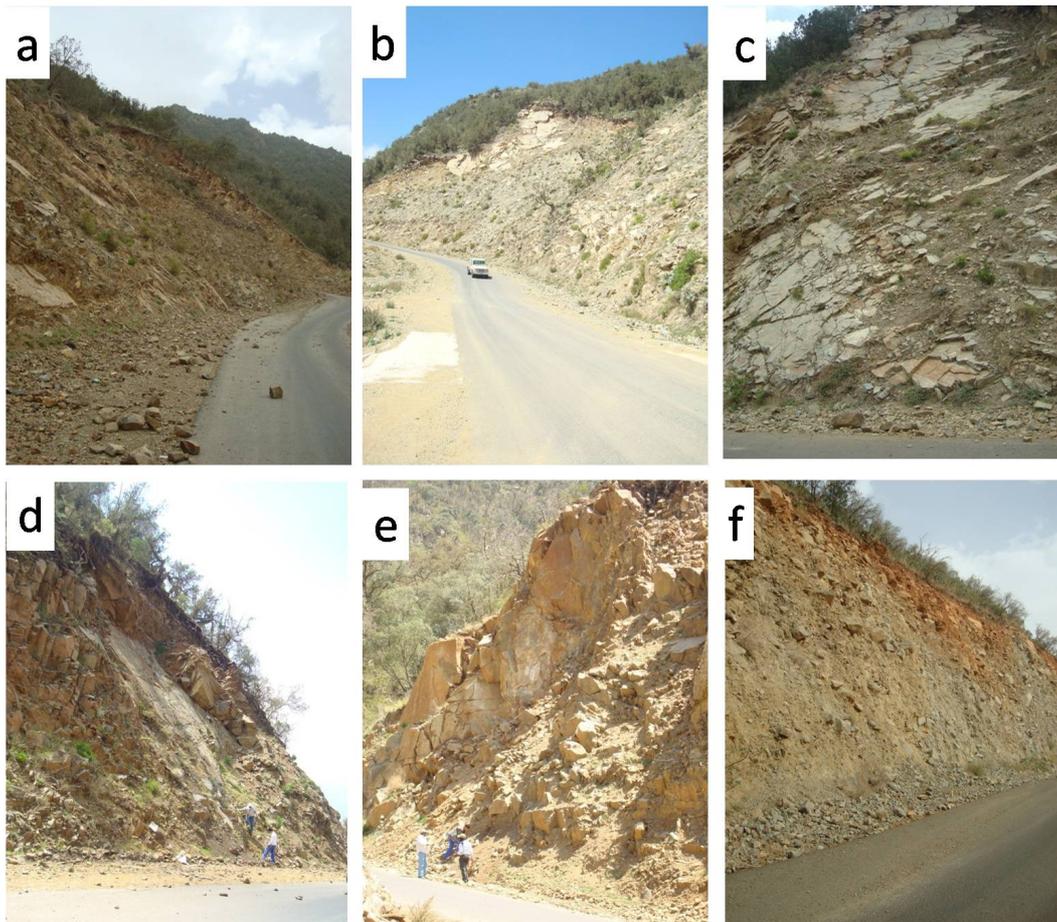
The Raidah road is an old road in the area which was an unpaved road at first, however since about 10 years an asphaltic road surface has been constructed. The road was widened and established some rock cuts, without any scientific or engineering studies. Accordingly, a large number of slope cuts (Figure 5) were left critically unstable and some areas are still showing failure phenomena from time to time resulting in rockfalls and sliding. No remedial measures were done along the road except in some areas where it is wide with deep ditches. Different types of materials are located along the cuts including crystalline rocks, sedimentary materials, block in matrix, and debris flow channels. Different types of failures also are encountered along the escarpment road, including raveling, sliding, and rockfalls (Figure 5).

Figure 5. Different types of cut instability along the Raidah escarpment road. a) Rolling and bouncing of the blocks over the slope face, b, c, and d) Sliding, e and f) Raveling type of failure

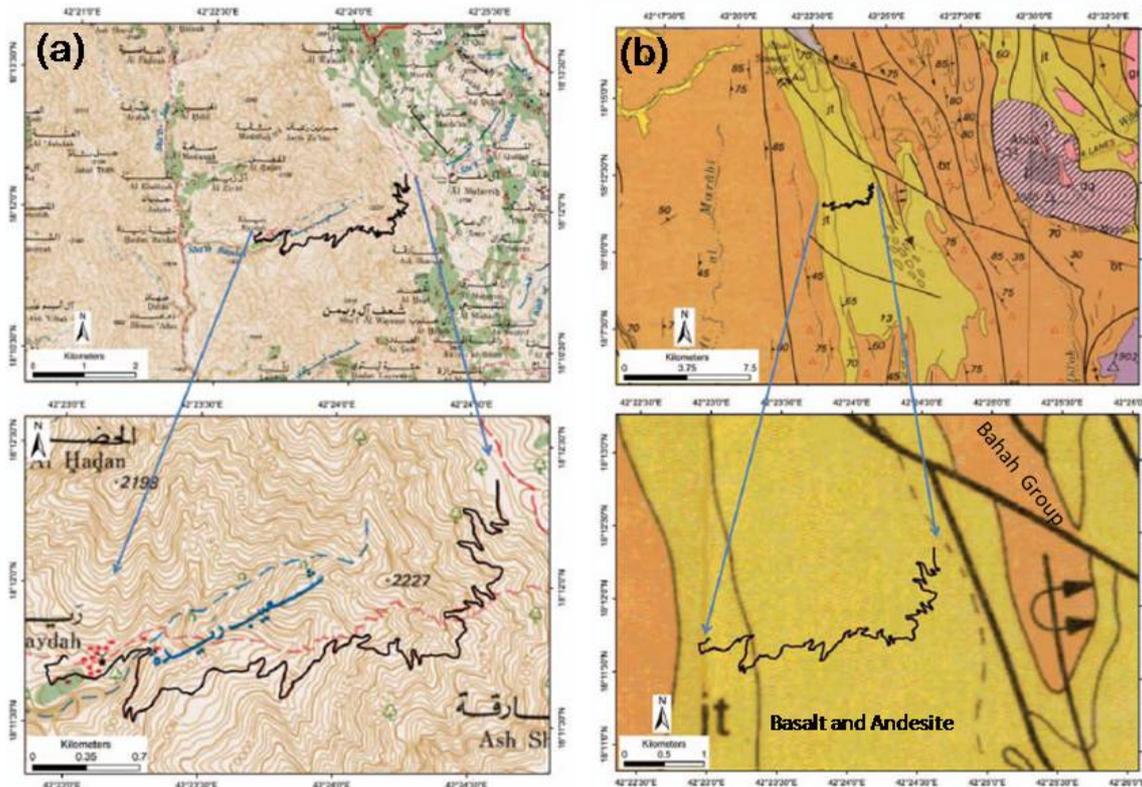
Figure 6. (a) Topographic map (Abha (West) Sheet 4218-32, scale 1:50000, 1975) of the area showing the Raidah escarpment road, (b) General Geology map of the area surround the Raidah escarpment road (Greenwood, 1985)

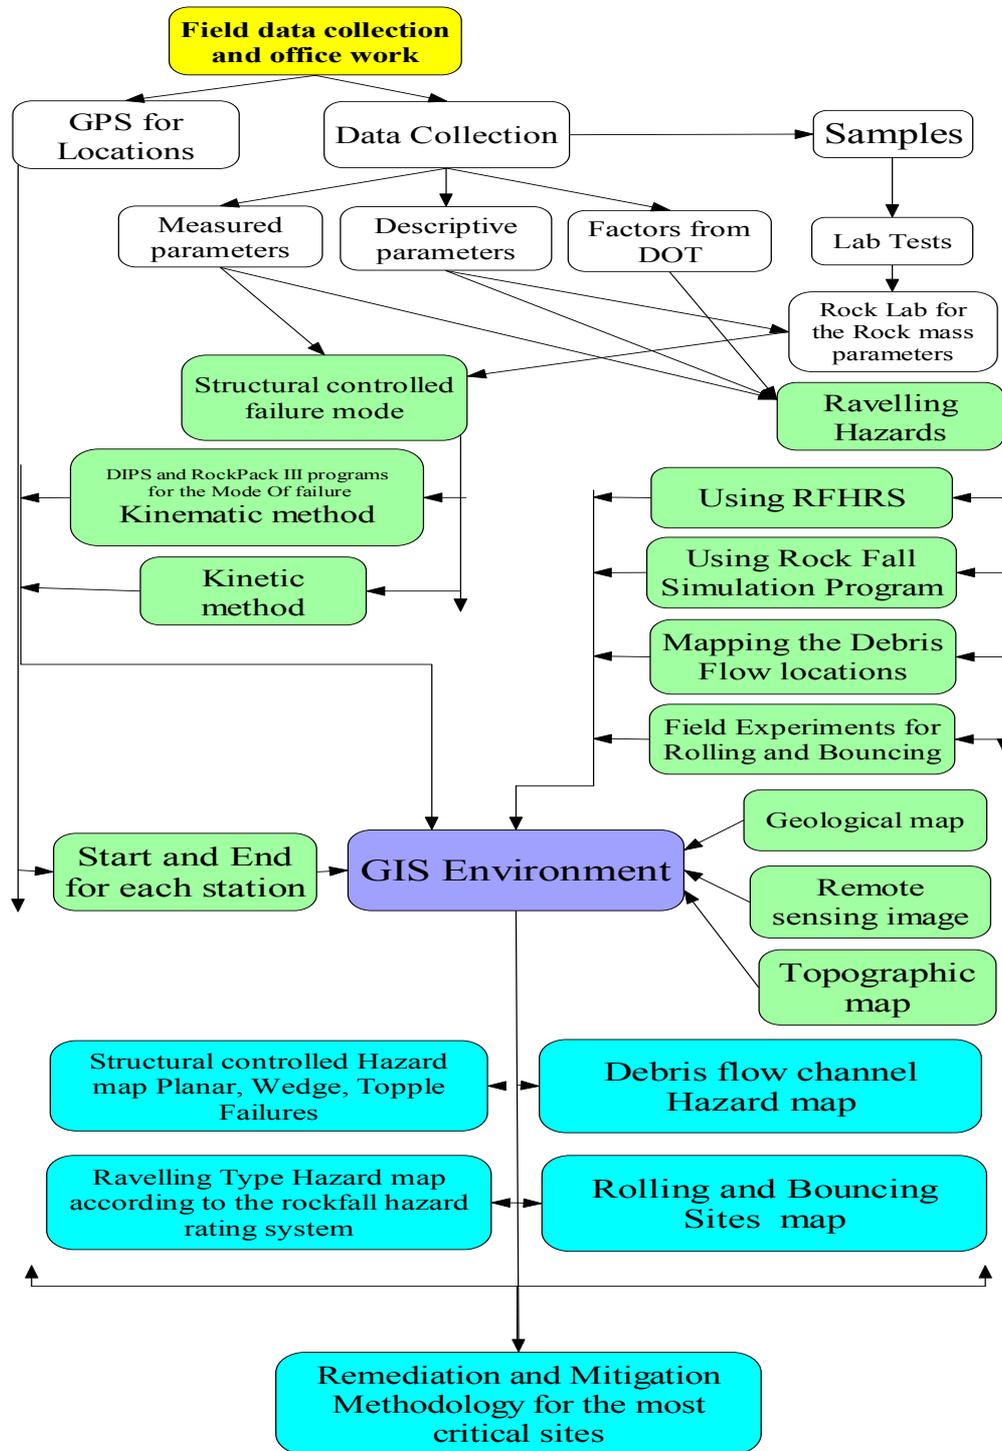
Figure 7. Flow chart showing the methodology used in this work

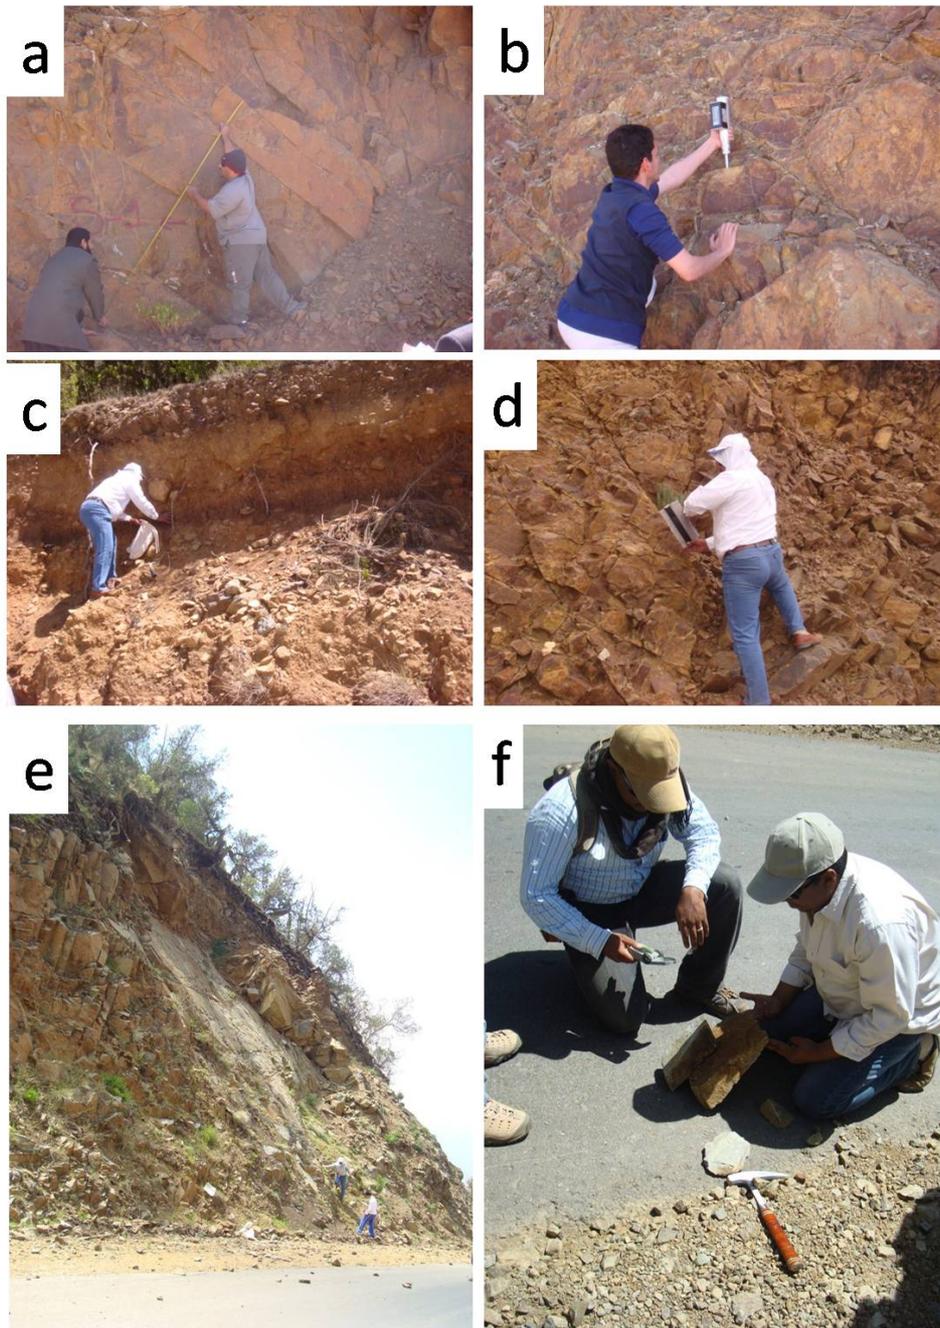
Figure 8. Saudi Geological Survey personnel measuring different factors and collecting data and samples during the field investigation. a) Making scan line along the cut, b) Using Schmidt hammer for rock strength, c and e) Collecting samples, d) Measuring surface roughness, and f) Determining the tilt angle of blocks

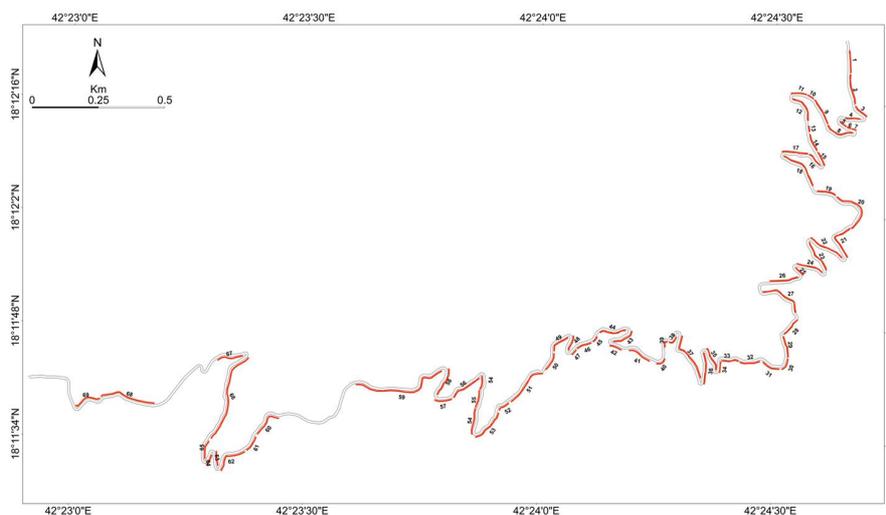
Figure 9. Rock cut stations along the Raidah escarpment road (Start and end points of each station collected from the field using GPS and drawn using GIS)

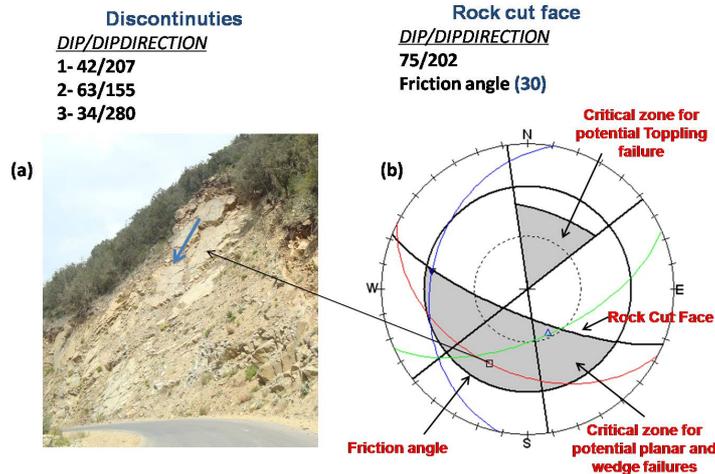
The friction angles calculated from soil shear box tests or from the RocData software for the rock mass or from rock shear box and the dip and dip direction of the rock cut were used to determine the potential types of failure. If discontinuity dip vectors plot within the shaded areas of the test plot, failure along the discontinuity is kinematically possible. Figure 10 presents an example of stereonet presentations of discontinuity data collected from the rock cut station number 11 along the Raidah escarpment road. In this example, the slope face dips at an angle of 75° toward azimuth 202° (A measured friction angle of 30° was used in this example (based on the shear strength of the clay filling materials of the joints). Three discontinuity sets are used in this analysis. One set dips about 42° in direction of 207°, the second one dips about 63° in the direction of 155° and the third one dips 34° in the direction of 280° (Figure 10). The dip vectors of these three sets occur within the crescent shaped shaded area, however the strike of the second and the third sets have an angle more than 20° from the strike of the cut face and so planar failure for this set is not possible. On the other hand, the strike of the first set is less than 20° from the strike of the strike of the cut and so that planar failure is potential. There are no dip vectors of the these sets occurring within the triangular shaded area indicating that toppling failure is not possible. The intersection of the great circles of the second and third sets with the great circle of the first set indicate that two wedge failures in the direction of 220° - and 265° are possible (Figure 10).

Figure 10. The analysis used in the study for each station along the Raidah escarpment road: (a) Field photograph at station 11 showing the planar joints dips toward the road and other two sets, (b) Markland Test plot showing the main sets, friction angle, and rock cut face plotted in RockPack III (note that there is no toppling failure however a planar and wedge failures are possible as the plot vector and the intersection between different planes are located in the critical zone)

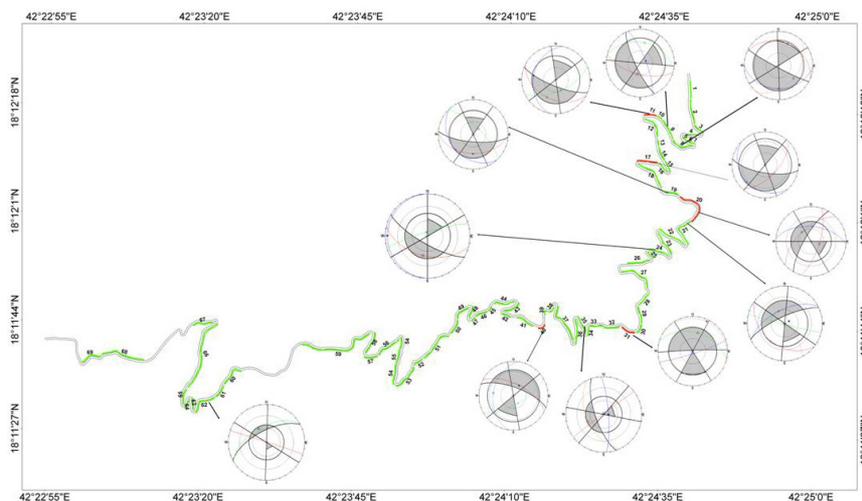
- 1) Planar failure was potentially found to be in stations 24 and 62;
- 2) Wedge-type failure was potentially found to be in station 8, and one station which is marginally potential for wedge failure where the dip vector plot is located very close to the critical zone for station 18;
- 3) Toppling type failure was potentially found to be in station 9, and four stations which are marginally potential for toppling where the dip vector plot is located very close to the critical zone for stations 20, 21, 27e, and 33;
- 4) Planar and Wedge failures were potentially found in stations 11, 17, 19, 20, 21, and 40; and,
- 5) Planar and Toppling failures were potentially found in stations 31 and 35.

Figure 11. Stations that may have potential structural controlled failures (Note the stereonets generated by the RockPack III software). Green colored stations are stable and red colored stations are potentially unstable, based on this analysis

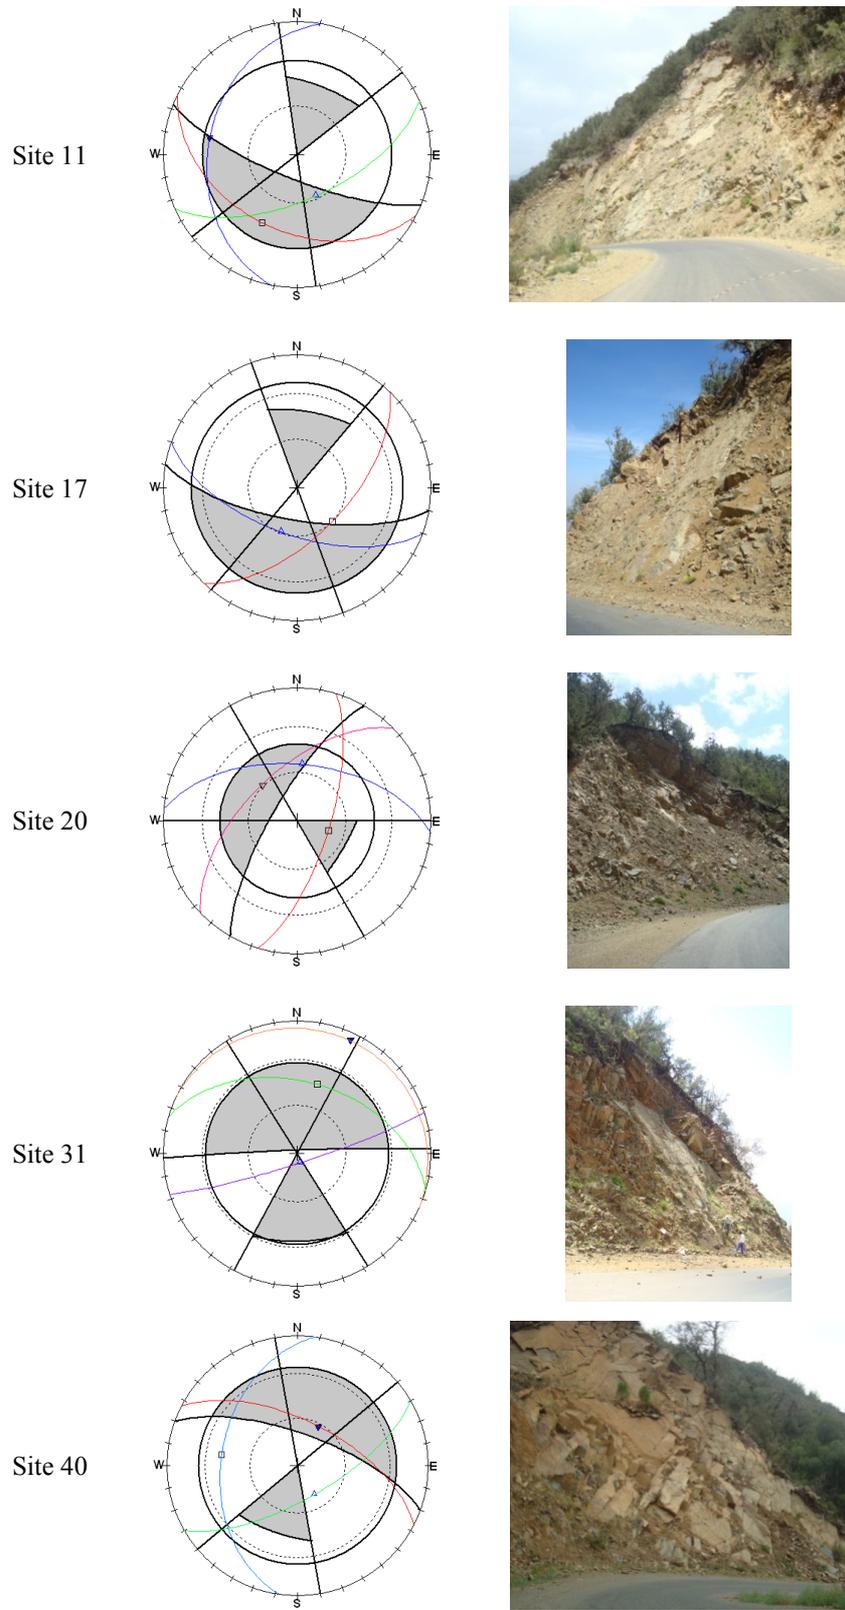
The study revealed that out of the 12 sites identified for planar, wedge, and toppling potential failures, it was found that 5 of these sites have high impact on the road including sites 11, 17, 20, 31, and 40 (Figures 12).

Figure 12. The kinematic method on the left and the site picture on the right

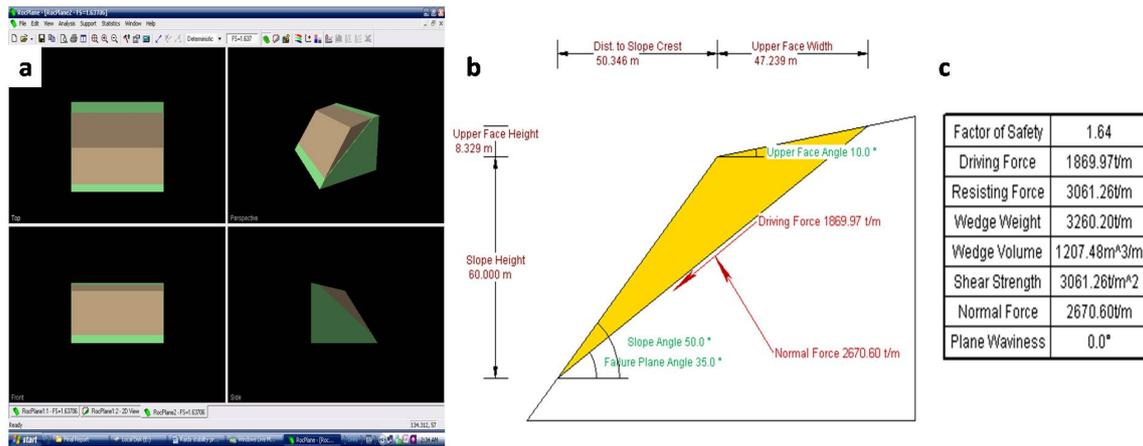
Figure 13. Application of the RocPlane program in kinetic analysis of planar failure. a) Plane view, b) Site geometry, and c) Factor of safety and forces

The data used in this analysis were collected from field for the site geometry (height), from the RockPack III results to determine the dip angle of the site face and the joint set that is responsible for planar failure (from the steronet analysis), and data from labratory such as friction angle, cohesion, and unit weight of the rock. Table 2 shows these data for the selected sites for limiting equilibrium planar failure analysis.

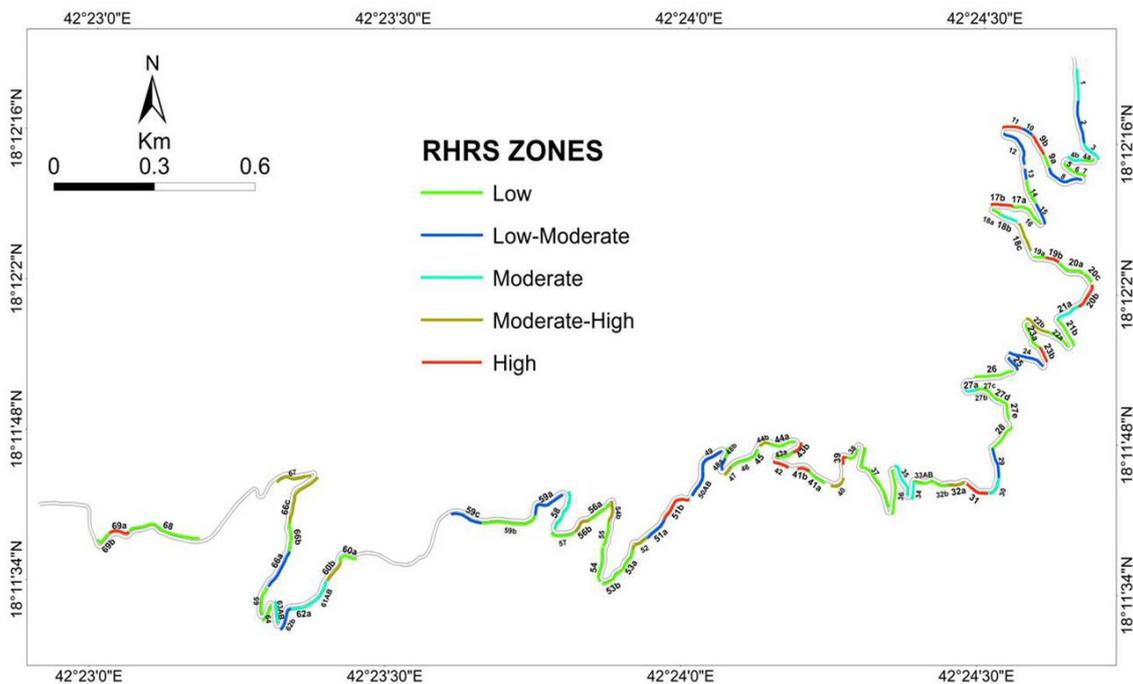
According to the data analysis and field investigation for the all stations, it was found that the rock fall hazard rating values could be classified as follow (Table 5). It was found that 49 sites have a rating value less than 300 (Low) which are safe; 18 sites have a rating value from 300 to 400 (Low to moderate); 11 sites have a rating value from 400 to 500 (Moderate) which are of moderate hazard; 11 sites have a rating value from 500 to 600 (Moderate to high); and 12 sites have a rating more than 600 (High) which represents highly hazardous rock cuts. Figure 14 shows all stations according to the degree of hazard of each station.

Figure 14. Station map for all stations according to RHRS values

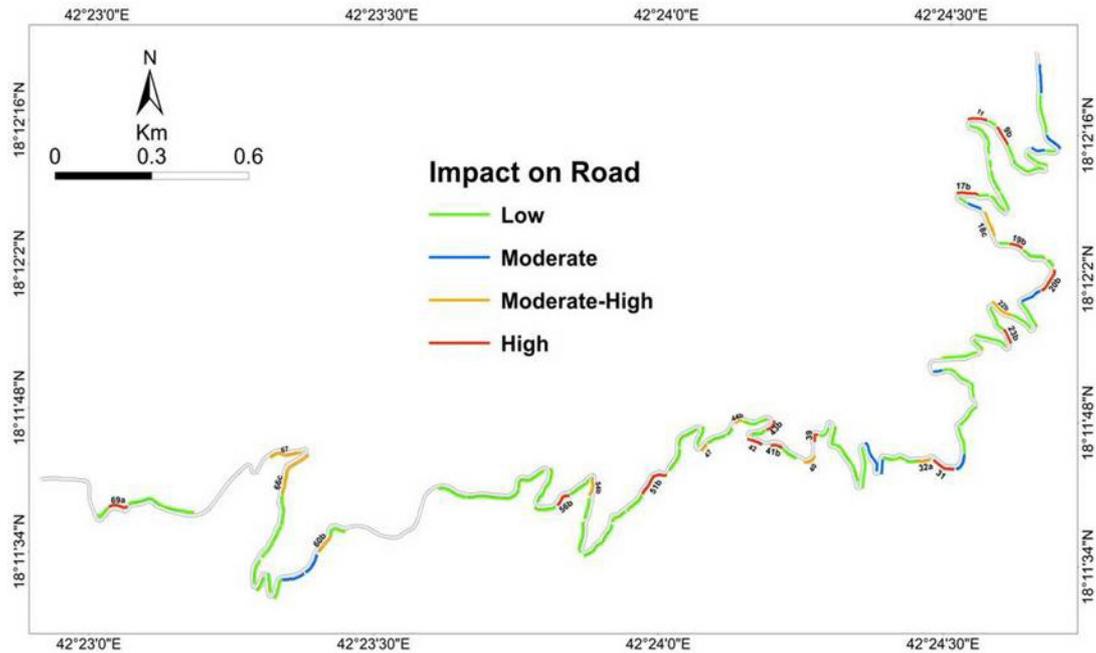
Based on the analysis of the consequence (of failure) of the rock cuts and slopes on the Raidah escarpment road with supported data from the field investigations and the previous failures observed along the road, it was found that these stations could be classified into four categories (Table 6): 1) Low consequence (no impact on the road) which include 69 stations; 2) Moderate consequence which also has moderate impact which includes 11 stations; 3) Moderate to High consequence which has 11 stations; and 4) High consequence and has a very big impact on the road which include 13 stations. Figure 15 shows all stations according to the degree of impact on the road.

Figure 15. The stations map showing the degree of the impact on the road

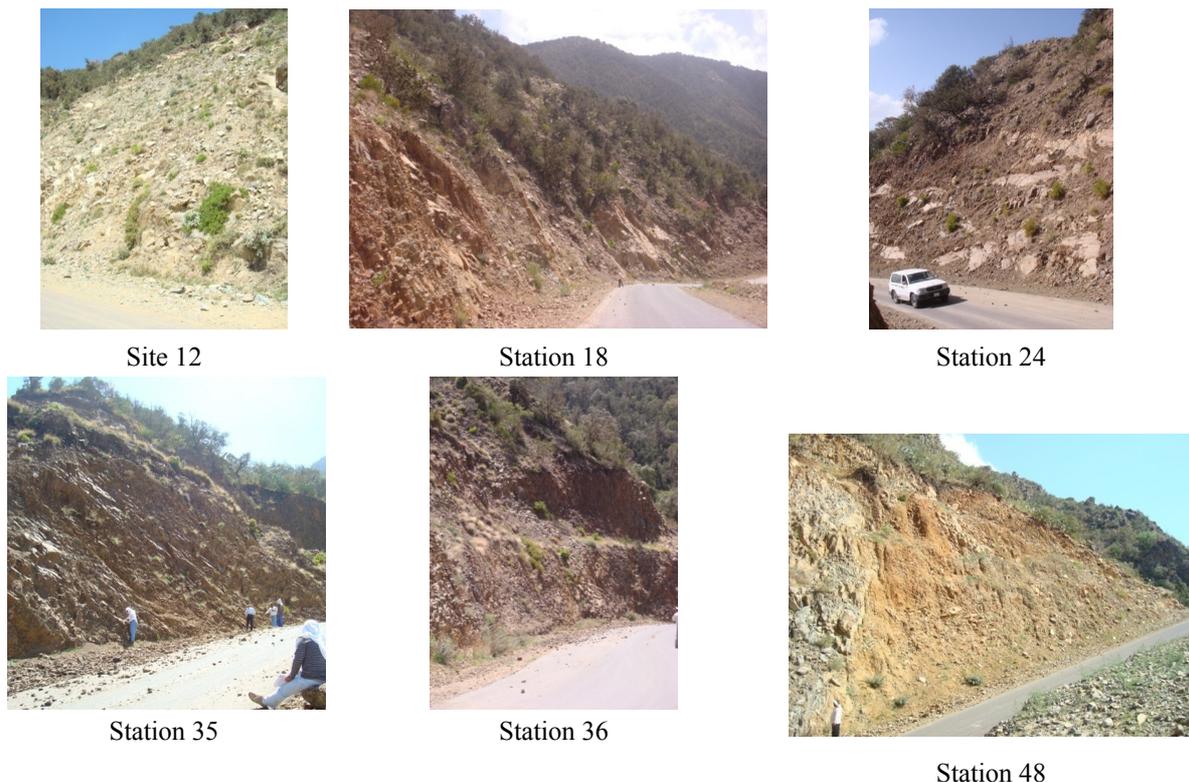
Figure 16. The stations that were investigated for simulation experiments

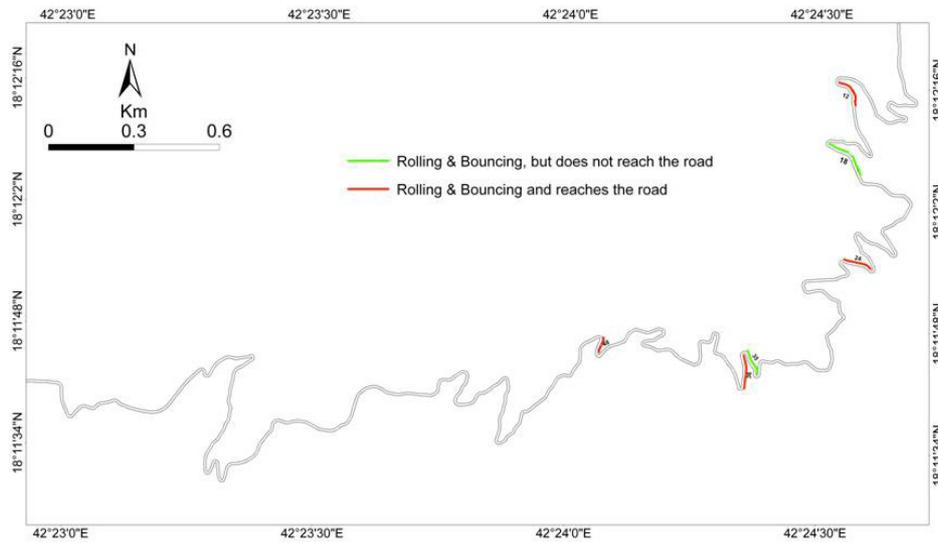
At each station, some blocks were measured and catalogued according to their dimensions (volumes) and shapes. These rock blocks were dropped from the top of the slopes. The tests were recorded by a digital video camera. This allows analysis of each block fall test in great detail. A series of points determined from the image analysis provides the definition of each block's trajectory for modeling. The slopes have a slope angle ranging from 35° to 85° and for the low angles large blocks reached the highway for the following stations 12, 24, 36, and 48. Figure 17 indicates that the most stations that will have a rolling and bouncing impact on the road.

Figure 17. The stations that have high impact on the road based on rolling and bouncing

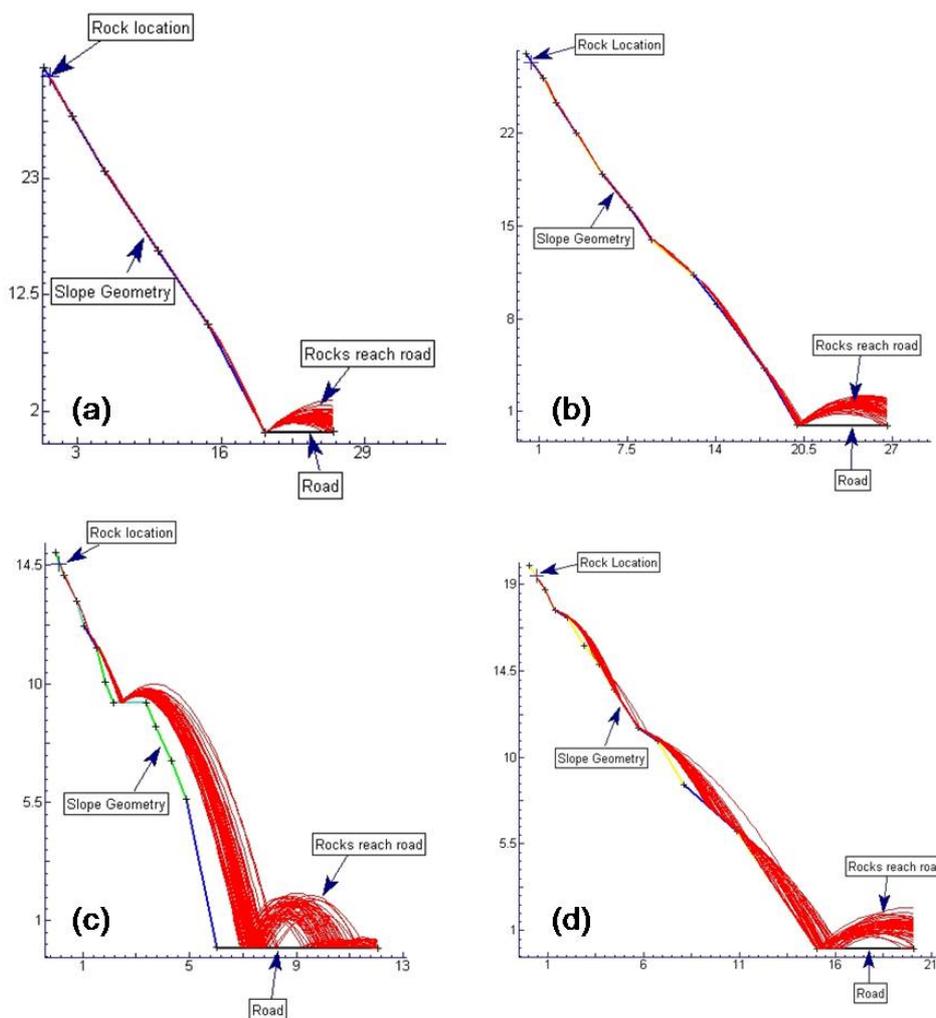
Figure 18. Rock fall trajectories resulting from the RocFall simulation program along (a) site 12, (b) site 24, (c) site 36, and (d) site 48

CRSP® (Colorado Rockfall Simulation Program (Jones et al., 2000)), was used for estimating runout. The simulation has been done for stations 12, 24, 36, and 48. The location of the unstable rocks were visually determined in the cuts, and their geometry was measured and used as inputs into the simulation. The topography of the cut/slope is shown in Figure 16. The CRSP results are shown in Figure 18. Rockfall simulation analysis shows that most of the falling rocks will bounce and roll far enough to reach the highway. This may cause a serious hazard for the vehicles especially with the presence of horizontal and vertical curves which does not allow enough time for the driver to react. An interesting example shown in Figure 18, demonstrates that the falling materials will hit the rock cut or the pavement area and bounce to the roadway. The data of the stations 12, 24, 36, and 48 indicates that most or all the falling rocks will reach the highway especially in the areas where there is no ditch present.

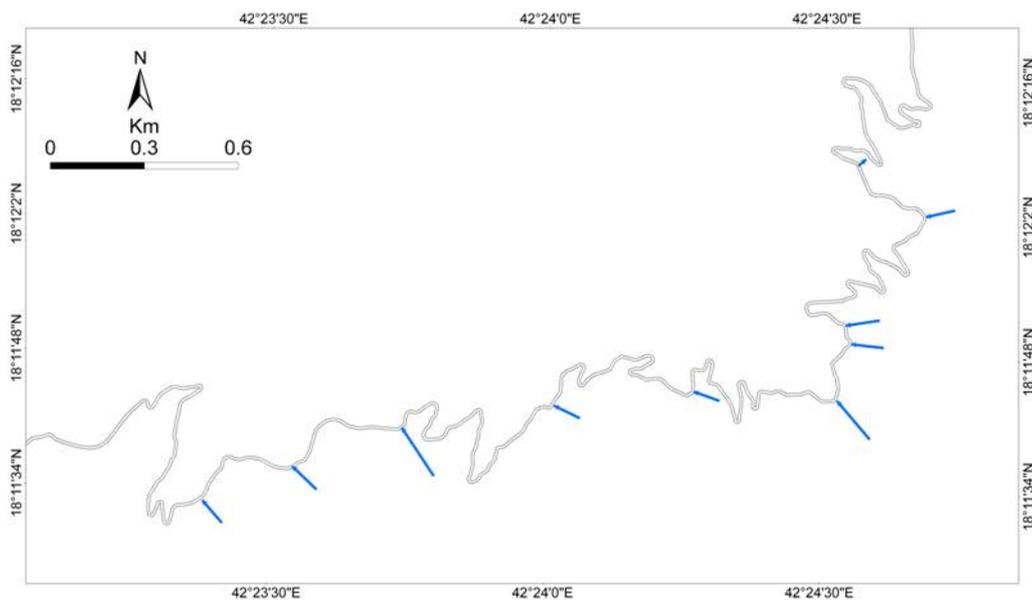
Debris flow is a phenomena in which a high density mixture of water, mud, and larger fragments flow down along a stream at high speed. Because of its high density and speed, it has huge destructive power. Thus damages by debris flows are very severe and sometimes tragic. It destroys houses, roads, bridges and sometimes claim's people lives. Field investigation was used to map all the locations of the debris flow channels as shown in (Figure 19).

Figure 19. Debris flow direction vectors intersecting the Ridaa escarpment road

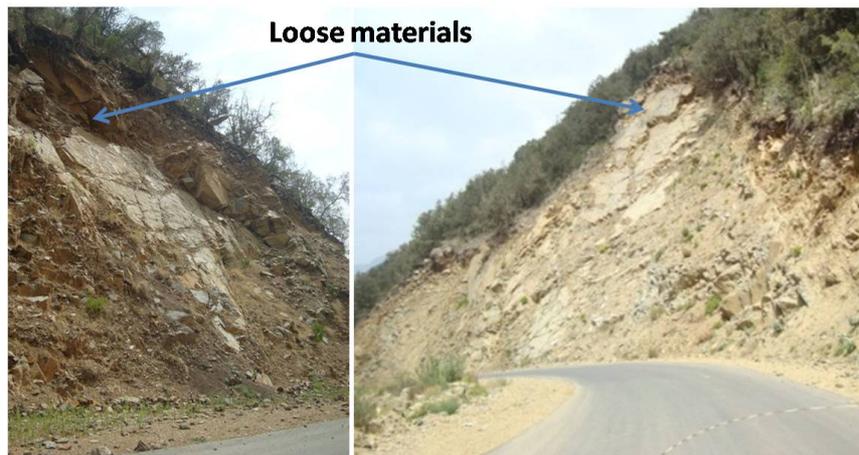
Figure 20. Shows loose materials need to be scaled from some sites

- 1) Scaling of loose rock: The first and most cost effective level of remediation is to scale cliffs and rock faces where loose blocks threaten areas below. Scaling is a way to remove loose, overhanging, and unstable

- materials from the rock face (Figure 20). Scaling is usually the most cost effective solution to reduce the risk of falling blocks, unless the blocks in question are very large. There are different methods for scaling, either manual or mechanized. Scaling is a short term solution, as blocks loosen up over the years.

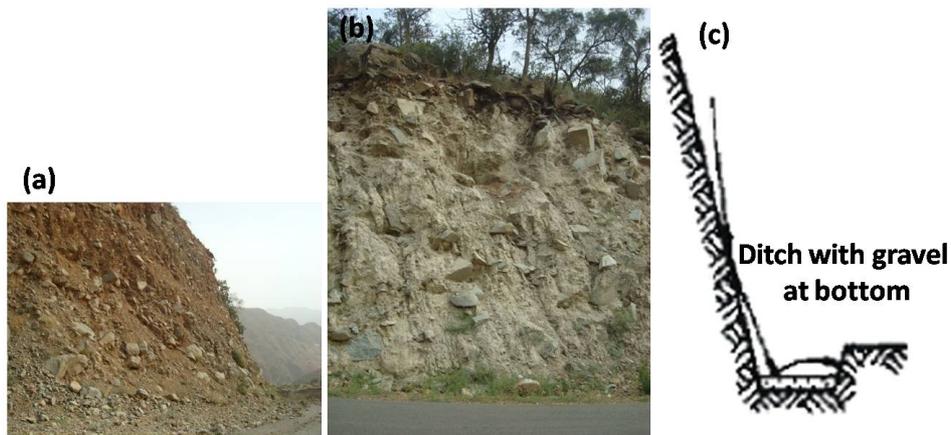
Figure 21. Sites (a and b) requires a ditch with a gravel at the bottom (c) to absorb the falling block energy
