Space and Infrastructure Functionality in Yaounde Markets

Humphrey Ngala Ndi¹ & Emmanuel Ebai Enow Oben¹

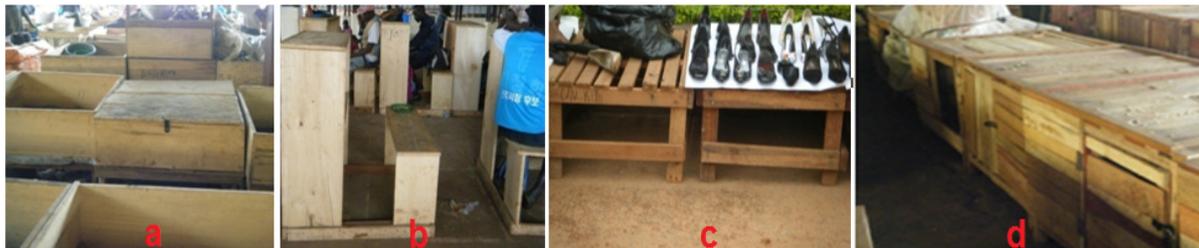
Figure 2. Stalls adapted to traders needs

The recent rehabilitation of the Mokolo market has witnessed the introduction of uniformly designed stalls that conform to the goods the traders sell. Figure 2(a) shows stalls used for the sale of groundnuts. They have an area of 1 m² and a height of 65 cm. This design prevents groundnuts from spilling to contiguous areas and guarantees maximum security by virtue of the fact that traders can seal the boxes with a padlock. Stalls constructed for perishables measure 1 m², the authorised size, and a height of 70 cm (Figure 2b). However, some stalls are less than 1m² to the displeasure of most traders. A desk-like design which measures 1.1 m² made for shoe menders and a stand which measures 70 cm² for those selling shoes are shown in Figure 2(c) and 2(d) respectively. It is worthy of note that these structures are unique to the Mokolo market. This has helped to create a uniform landscape and improved on the aesthetics and functional efficiency of this market.

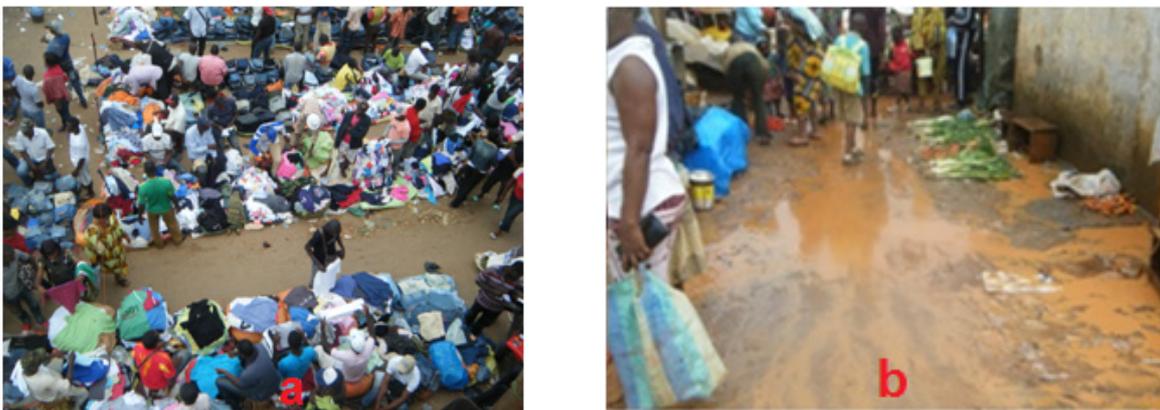
Figure 3. Open space trade in the Mokolo market vicinity

In an ideal situation, traders are supposed to sell in a well sheltered shop or a stall in order to avert adverse health risks resulting from environmental conditions. The situation in Yaounde is a mix of people trading in open spaces generally on, or adjacent to high streets on which many potential buyers converge in the typical bazaar fashion (3a); and those who sell in well-designed sheds and shops. Furthermore, other traders sell in any available crowded space irrespective of its hygienic conditions as Figure 3(b) depicts.

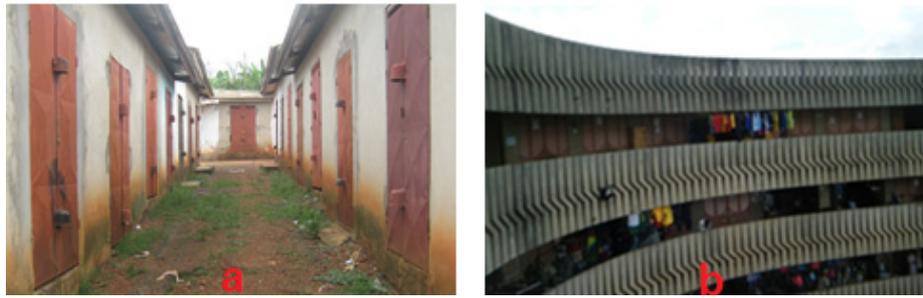
The low occupancy of the upper level stalls in the markets in Yaounde can be blamed on the absence of segmentation. The more storeys you climb, the weaker the level of stall occupancy. This is true in the Central market which has five storeys. The fourth and fifth storeys are underutilised as Figure 4(b) shows. It was noticed that 130 stalls in the Central market are vacant because trade is unprofitable in these areas. The low upper level occupancy is also characteristic of the Mokolo market, in which 59% of upper level stalls are not effectively occupied. The unprofitable nature of trade in storey-buildings is compounded by the fact that goods sold at the upper levels can easily be bought from the lower floors. This brings to fore the importance of segmentation in increasing the chances of all traders having exposure to potential customers.

Figure 4(a). Vacant shops in the Mvog Betsi market, (b) Low occupancy in the Central market. NB: Pictures were taken on a Saturday when the customer density is often highest. Notice the quasi absence of traders on the 5th floor of the Central market

The operational inefficiency of this market has been partly blamed on its retail design. According to traders, an inversion of investment style in which shops dominate the down throw of the market, while perishables occupy the upper throw, so as to expose clients to non-perishables upon ascension to the perishable sector would improve on the marketability of this site. Other factors that contribute to the non-marketability of the site are: poor accessibility and the influence of the nearby bigger and more attractive Mokolo market.

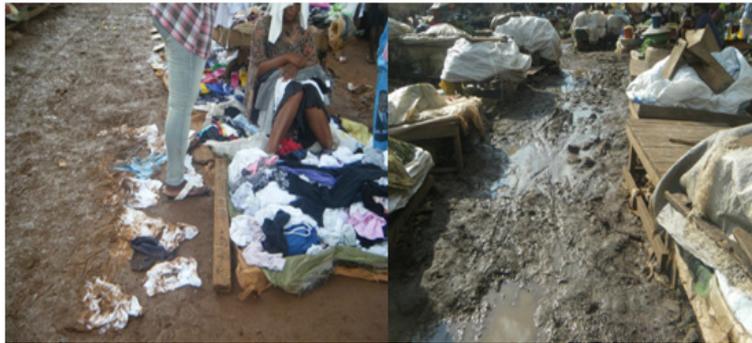
Figure 5(a). Muddy aisles in the Essos market

69% of markets are characterised by unpaved aisles which are very muddy during the rainy season as illustrated in Figure 5(a). This affects the suitability of trade coupled with the fact that about 95% of petty traders expose their articles on the ground, predisposing them to contamination. The fast rate of aisles degradation was observed in the newly built Mvog Betsi market. Rapid degradation is as a result of erosion since the market is located on a slope, compounded by the absence of roof gutters, the poor disposition of surface drains and the relatively light nature of tar used to pave the aisles.
