# Geospatial Application in Mapping Gully Development for Effective Remediation and Control

In south-eastern Nigeria, gully erosion has assumed an alarming proportion and this prompted the use of geospatial information technology to map a gully erosion site in Oron, Akwa Ibom State for effective remediation and control. Ground controls were provided in the vicinity of the gully head through the use of dual frequency Leica GPS 1200. The obtained data were downloaded and processed using Leica Geo Office 8.3 and the processed data exported to Arc GIS 10.1 and Auto CAD Civil 3D 2013 for terrain analysis-DEM. Also, the Leica Total Station TS 06 was employed to carry out topographic mapping. The delineated runoff contributing area aided in the computation of maximum discharge (using the Rational method). The computed runoff of 33.919m<sup>3</sup>/s accounts for the rapid rate gully headscarp retreat at the rate of 1.2m/day during the month of July, prior to intervention by the state government. The results obtained were employed in designing gully control structures.

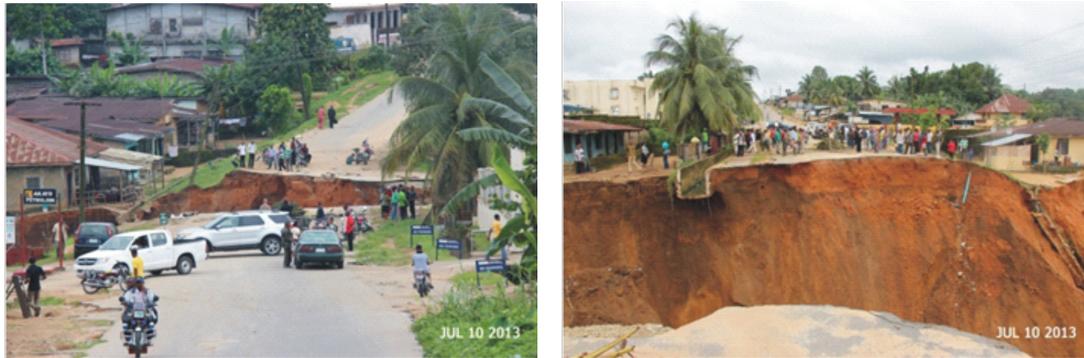
Figure 1. A section of the road destroyed by an impressive gully channel

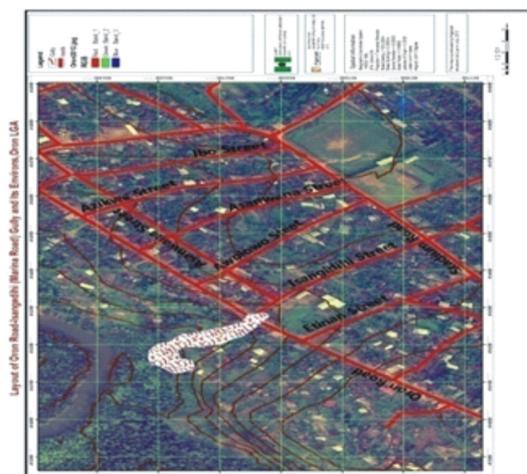
Orthophoto imagery of the gully site and its environs on a scale of 1:10,000 (Figure 3) was digitized and integrated with the field acquired data to determine housing density.

Figure 3. Orthophoto imagery of the study area

The base level of erosion relative to Etim Inyang River is 40m and most of the adjoining streets i.e Etienam, Awolowo, Isangedighi, and Amwanaba contribute with enormous volume of runoff to the gully channel (cf Figs 3 and 4.). For instance, our field observation on the discharge drain adjacent to Access Bank with dimension 1.2m by 1.2m gave a reading through the use of Flow meter, -of 1.2m/s two hours after rainfall and this particular drain overflowed during most of the rainstorms. Gullies in the area became pronounced since 2011 while the rapid advancement towards the buildings became obvious since the onset of the wet season in 2013. All the streets/roads studied were also poorly provided with drainage systems. Therefore significant proportion of the surface runoff flows along the untarred roads and the unpaved drains. In some areas, where concrete drains and culverts are constructed, runoff drains directly into the gully head, as shown in orthophoto imagery of the gully site (cf Figure 3). Fig 4 shows that the catchment area is almost circular, with a very short concentration time of 7minutes. Another interesting feature is that virtually all the adjoining streets contribute with surface runoff to the gully head at the same time, thereby reducing the time of concentration of surface runoff. Often during rainstorms the process of basal undercutting at the gully headscarp is enhanced and subsequently the gully side collapses and the debris at the gully floor is swept by ephemeral flow of water on gully floor. Similarly, the computed maximum discharge of  $33.919\text{m}^3/\text{s}$  explains the spasmodic nature of gully headscarp retreat at the rate of 1.2m/day during the month of July, prior to intervention by the state government. It then means that a rainfall event that lasts for an hour will generate a maximum discharge of  $33.919 \times 3600\text{m}^3/\text{s}$  into the deep gully system. It is true that without the intervention, the entire residential buildings including a bank and a petrol filling station would have caved in between July and September 2013, bearing in mind the severity of rainfall in these months. Presently, about ten buildings including a church are at the edge of another gully system radiating from Etim Inyang River on the same Oron road at Awolowo/Oron road junction.

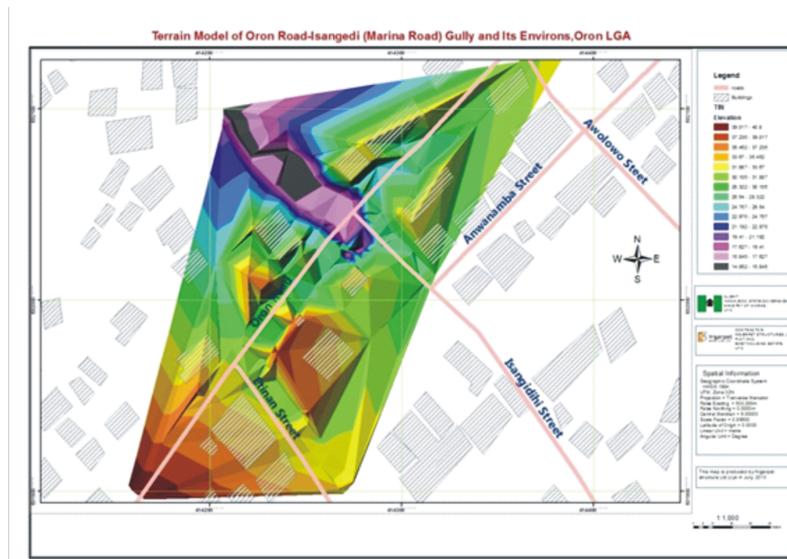
Figure 4. TIN of the sub catchment

A vector based representation TIN (Figure 4) was used instead of the more robust DEM to visualize the configuration of the surface since the catchment is relatively small. The square method was used to compute the gully catchment in  $\text{cm}^2$  and then multiplied by the scale factor and the gully-catchment expressed in  $\text{km}^2$ . Furthermore, the computed area was converted to hectares by multiplying it with 0.0001ha. The Rational Method was employed in estimating maximum discharge in the area. Rainfall intensity was calculated as 304.65mm/hr; length of longest axis was computed from sketch map; the difference in elevation was calculated too, while bare fallow was assumed in the study. The total area was converted to hectares.

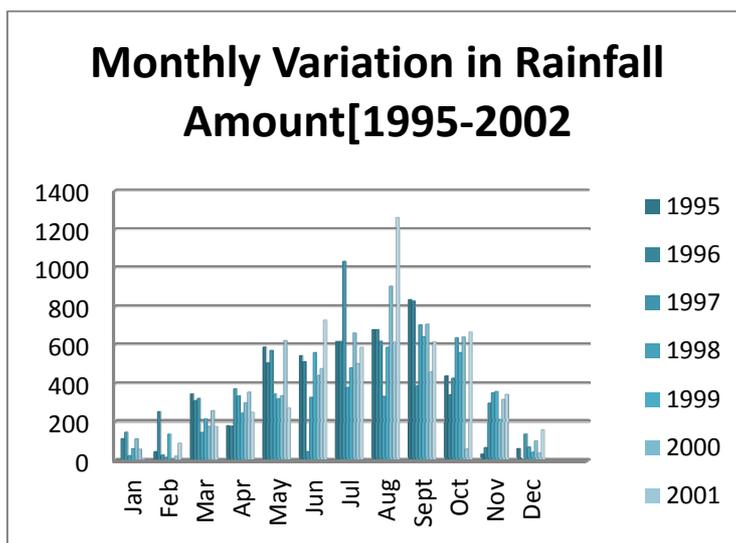
2008b). It is quite evident that the duration of rainy season ranges from eleven to eight months (Figure 5) based on the periods of records i.e. 1995 to 2002.

Figure 5. Monthly rainfall at Oron (1995-2002)

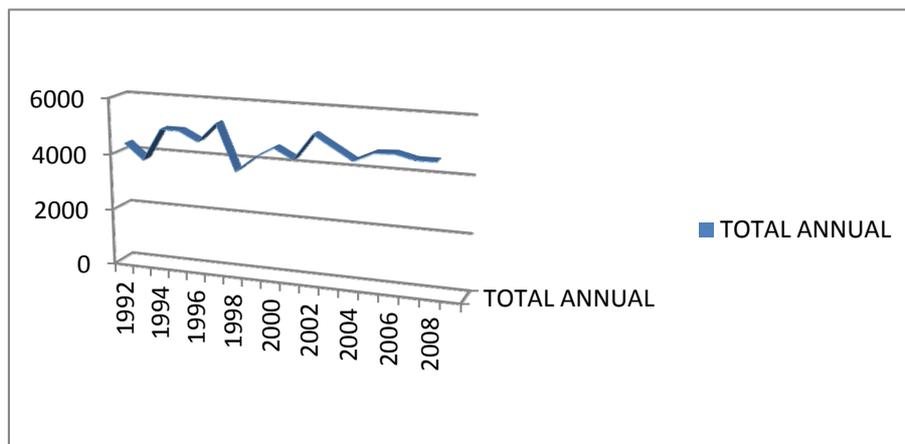
Figure 6. Inter-annual variability of total rainfall from 1992 to 2008

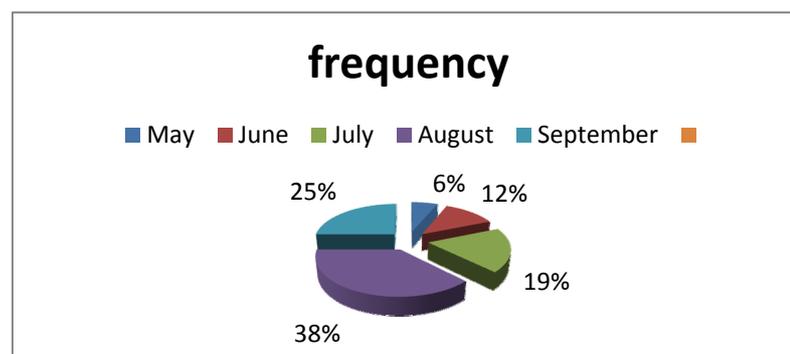
finally May (6.25%), Table 2 and (Figure 7). The implication is that the gully at Oron, which has already advanced across the road will continue to expand at an alarming rate before the end of the wet season in 2013, if nothing is done and would have devoured the building of Access Bank and a Petrol filling station, presently under constant threat.

Figure 7. Frequency of occurrence of maximum monthly rainfall

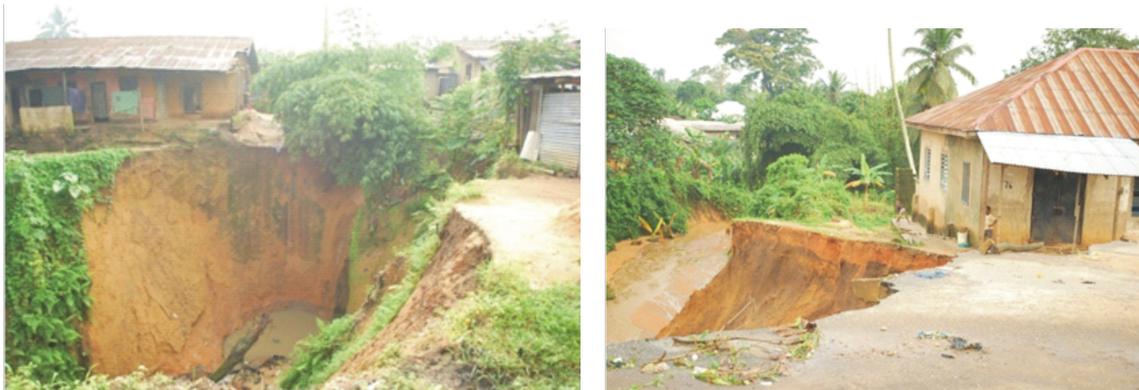
Figure 8. These buildings have been abandoned by the residents

At the time of the study, about 25 of houses cling precariously to the edge of the gully system. Observations showed that some buildings in the gully affected area have been abandoned, and many of those still occupied were at the verge of collapsing into the channels. Most severe damage to properties was observed in gully headscarp which is broadly-loped.

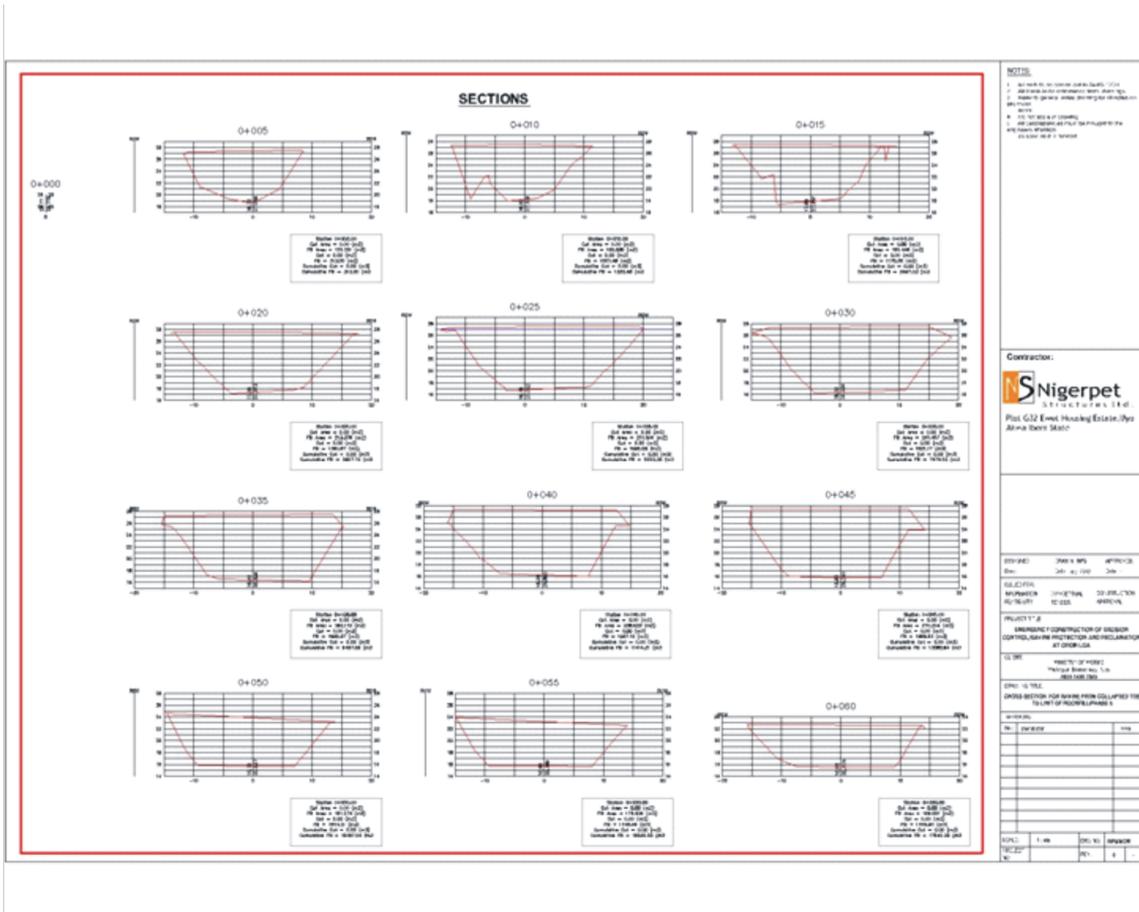
Figure 9. Cross sections of the gully channel

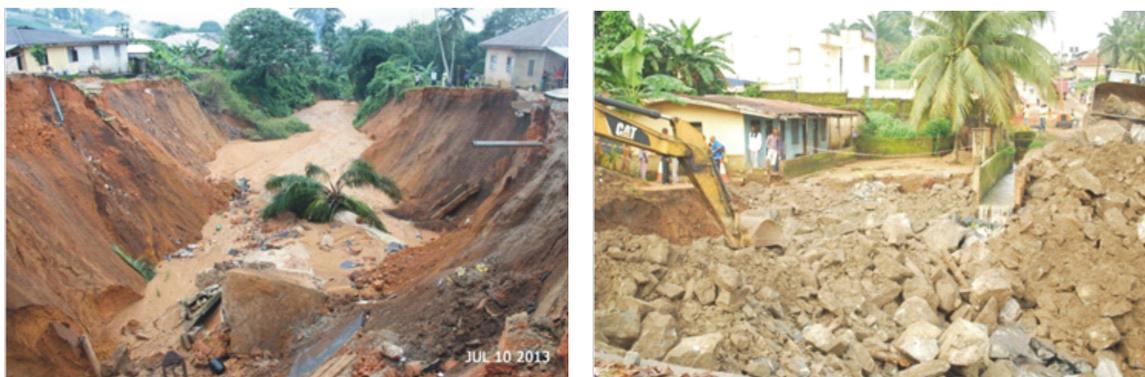
Figure 10. Rock filling to re-grade the wide gully channel

In conclusion, the gully complex at Oron is caused by heavy rainfall exceeding the capacity of the drainage systems which include the outfall drains, the culverts, the outfall structures, and the estimated catchment area; Increased paved area giving rise to increased run-off; other anthropogenic activities in the vicinity of the gully; the weak and unconsolidated coarse-textured coastal plains sand. This soil type is prone to erosion as it is unstable to raindrop impact and slides easily while wet. The application of geospatial technology and the computation of the maximum discharge facilitated the design of gully stabilization structures (appendix 2). These erosion control structures consist of an efficient outfall drainage systems which will improve underground and surface drainage, re-grading the gully through rock filling (Figure 10) and construction of stabilized runoff channel and slope stabilization.
