Determine Sinkholes and Overburden Thicknesses in Selected Covered Carbonate Karst Terrains (Kinta Valley), Perak, Malaysia by Combining Wenner E.R. Tomography, Geological and Satellite Images Techniques

Riyadh R. Yassin¹, Ros Fatimah Muhammad¹ & Samsudin Hj Taib¹

¹ Department of Geology, Faculty of Science, University of Malaya, 50603 Kuala Lumpur, Malaysia

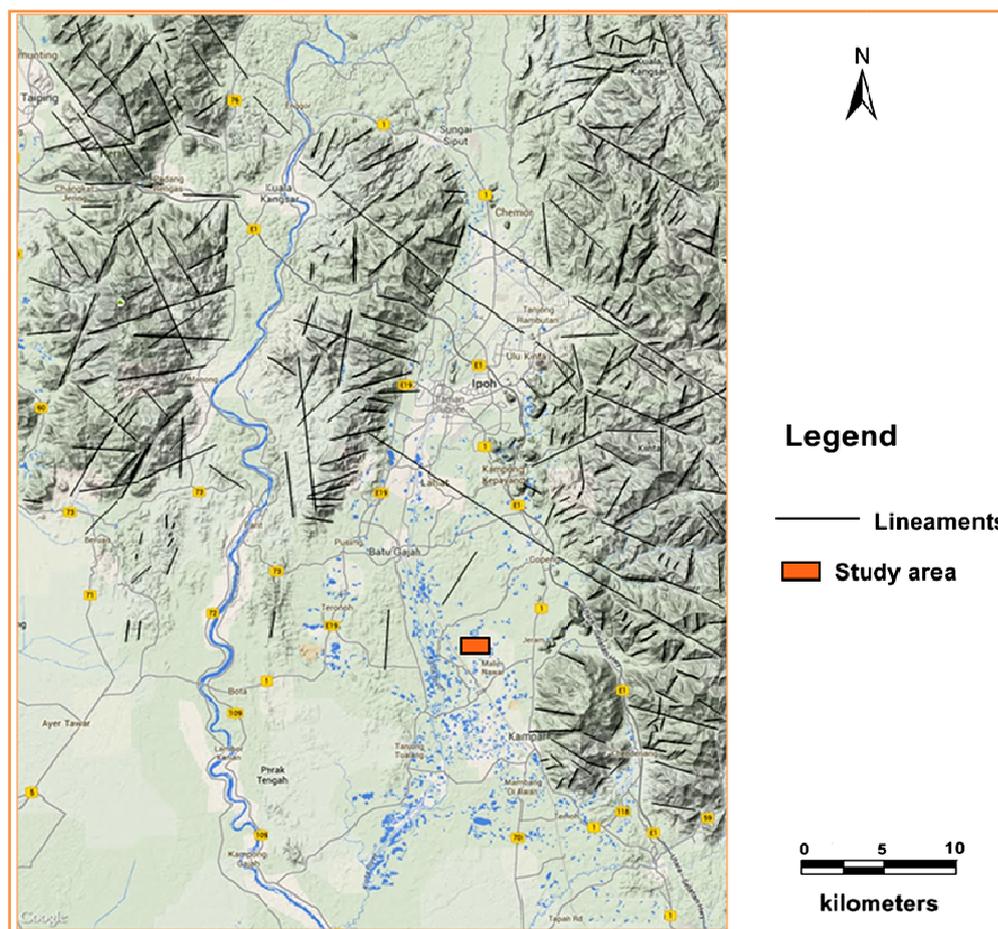
Figure 4. Google terrains map shown several lineaments were recorded with main orientations appears to be in the NNW-SSE

The limestone of Kinta valley was affected by intense fracturing. Several lineaments were recorded, and their main orientation appears to be in the NNW-SSE as shown in Google terrains map, figure 4. Several geologists have suggested that major karstification is controlled by the structures in the areas when it's occurred. The structural Geology in the limestone of Kinta valley area are dominated by faults and folds oriented NNW-SSE which gives a noticeable grains to the landscape especially to the orientation of isolated, steep-sided, residual hills (mogotes). Which are composed of either limestone, marble, marblized limestone or dolomite and surrounded by nearly flat alluvial plains in the central part of the valley.

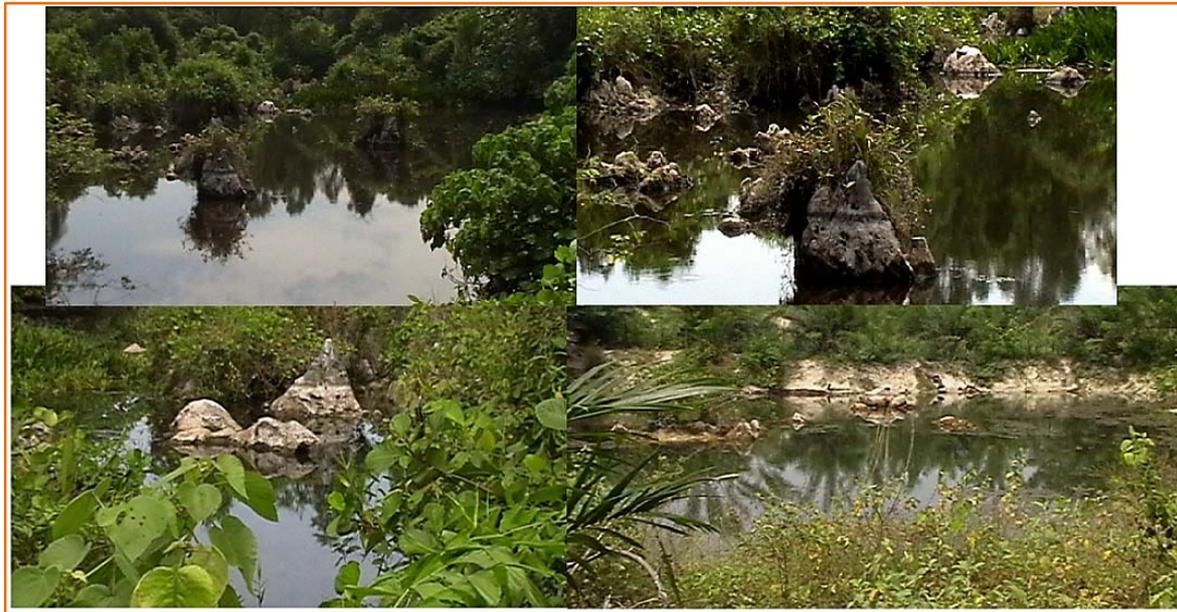
Figure 5. Pinnacles identified in ex-mines and sinkholes that distributed in the study area presenting that the depth of limestone with few meters from the ground surface

It is believed that the sub-surface karst is developed below a cover of alluvial sediments during the geologic past Yeap (1998); Dian (1996). The opinions that, the early stage of pinnacle development is due to the differential resistance of physical weathering of the rocks and the role of geological structures (bedding planes, joints, fault etc.) lead to the formation of pinnacles under the cold climates of Tibet to developed. The depth of limestone with few meters from the ground surface can be identified from the depth of pinnacles which determined in ex-mines and sinkholes that distributed in the study area, figure 5.

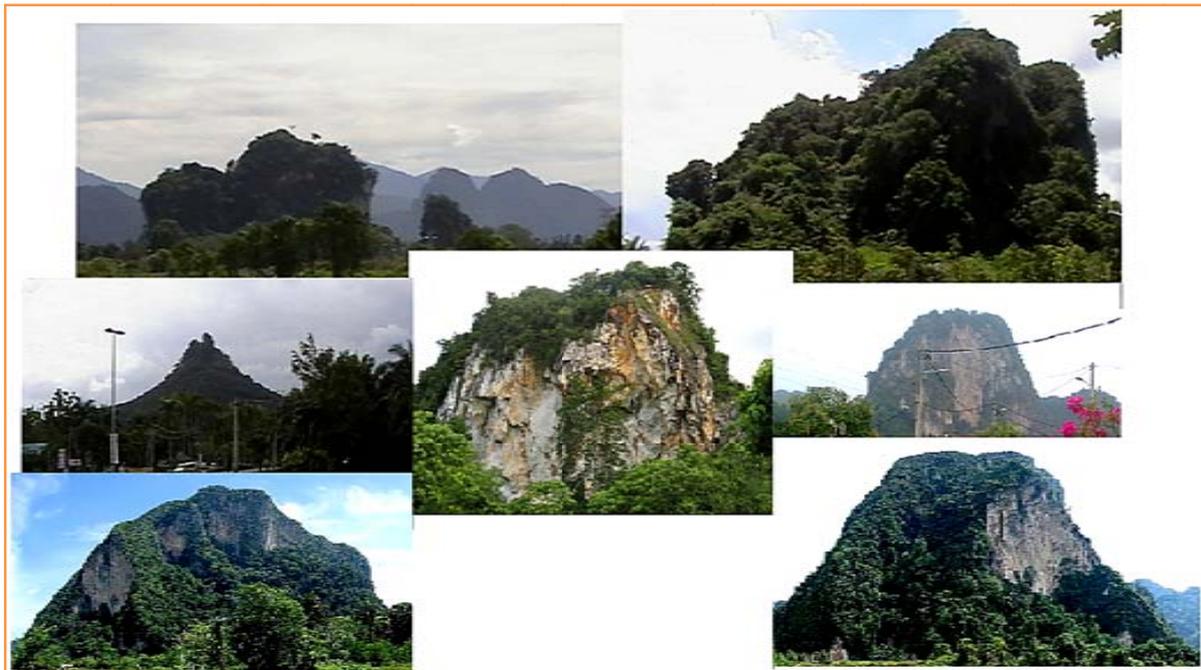
Figure 6. The cockpit towers and isolated towers, the complex and cone - shape tower, hills which are composed of either limestone, marble, marblized limestone or dolomite and surrounded by nearly flat alluvial plains in the central part of the valley

A further type is the Cone - shape capped by steep-sloped tops of carbonate rocks with gentle slopes from almost the top of the hill to the bottom. The cockpit towers and isolated towers, the complex and cone - shape tower with the steep-sided walls in the study area was presented in figure 6.

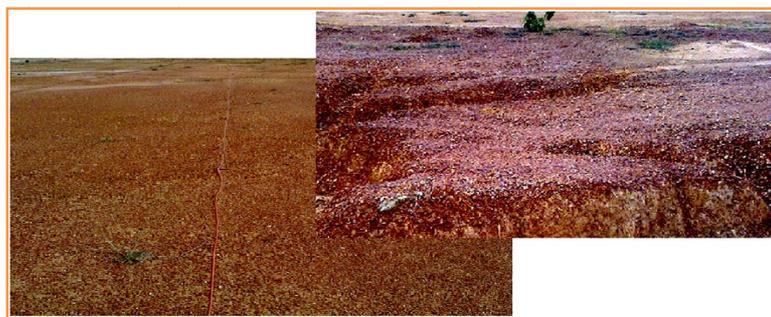
Figure 7. Soil clay containing different size of granite rocks and minerals found covering different sites in Kinta valley

The cover layer of Soil clay with thickness between (1.0m -1.25m) containing different size of granite rocks and minerals are mostly from (0.5cm-1.0cm). This appearance is due to runoff of heavy rains which has deeply eroded and washed both highest granite ranges around the Kinta valley and then carried away by the new rivers and canyons which was formed due to the erosion. Soil clay containing different size of granite rocks and minerals found covering different sites in Kinta valley presents in figure 7.

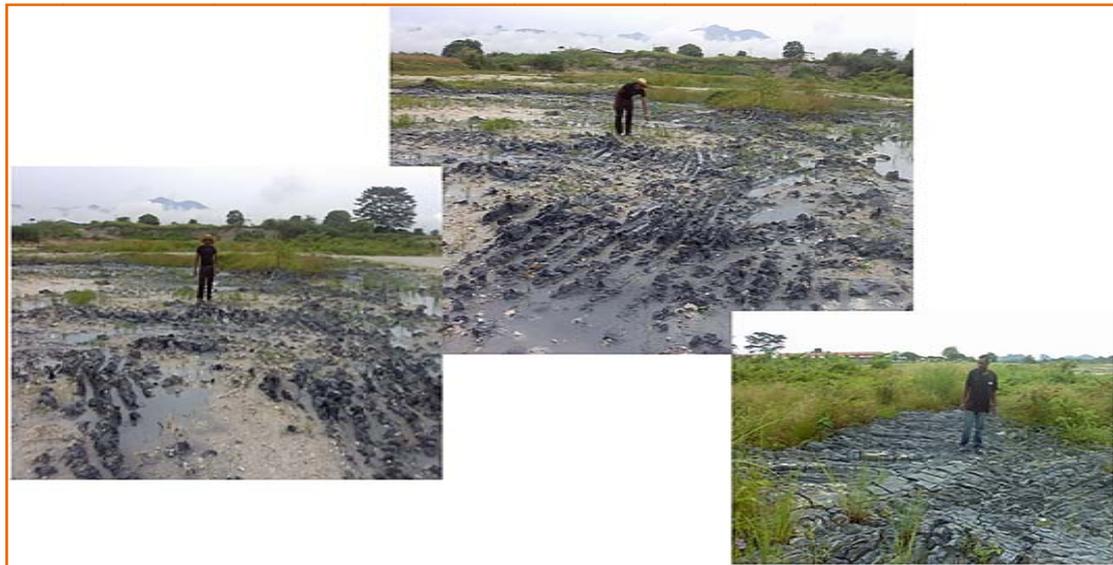
Figure 8. Land Photographs viewing several positions which were identified as swampy area from the deposits of organic gray clay

The climate conditions changed from wetter to drier and the strong rainfall decrease gradually and the atmosphere starts to clear. At the same time as the effect of rains become lesser and the sea surface temperatures start to return to normal. Growth starts again from the roots and seeds that remain on the ground or near the land surface and the lands were spotted with lakes and swamps. The occurrences of thin bed found beneath the cover soil of peat from the organic remains suggest that the development of swamps and marshes. Several positions were identified as swampy area from the deposits of organic gray clay presents in Figure 8.

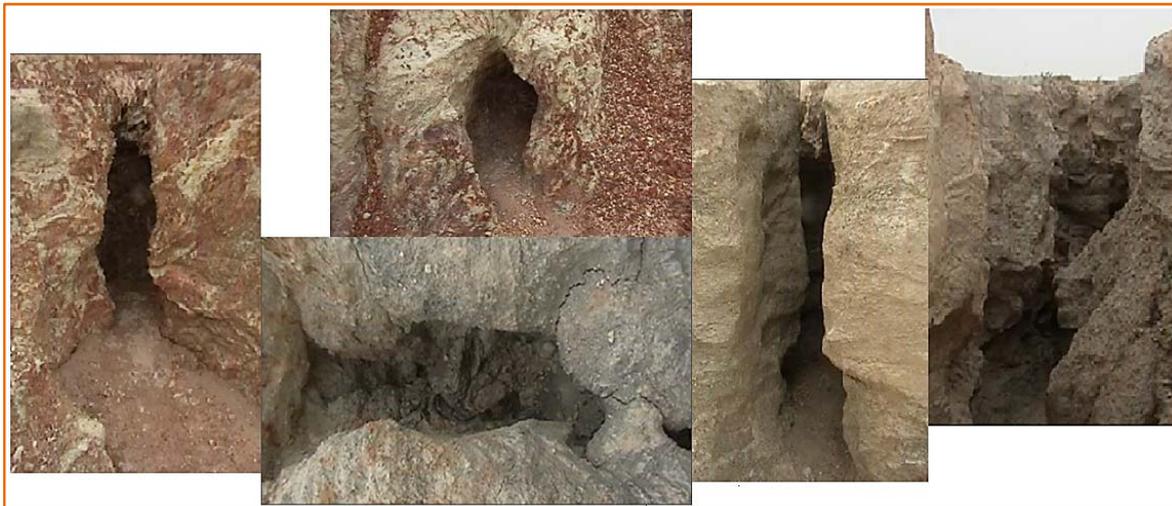
Figure 9. Land Photographs viewing some features in the upper most layer of the subsurface due to the effects of meteoric water in a several points the study area

Surface water can induce erosion along the frame of a sinkhole and cause its enlargement, reaching several meters long. Due to the interconnected nature of the karst features system, a group of small sinkholes observed in the study area is also capable of bonding to create an appearance of a larger sinkhole. This might enforce the thought that the small active sinkholes might be connected to one or more of the larger sinkholes (in diameter) by a series of groundwater conduits. There may be seep of water at the subsurface, with conduits for seep-water to a local lake, snaking along the base of slope to the east side. Tubular voids of visually undetermined depth infilled with clay or air karstic cavities were present, which could potentially threaten the integrity of these sites. Some features in the upper most layers of the subsurface due to the effects of meteoric water in a several points

in the study area present in figure 9.

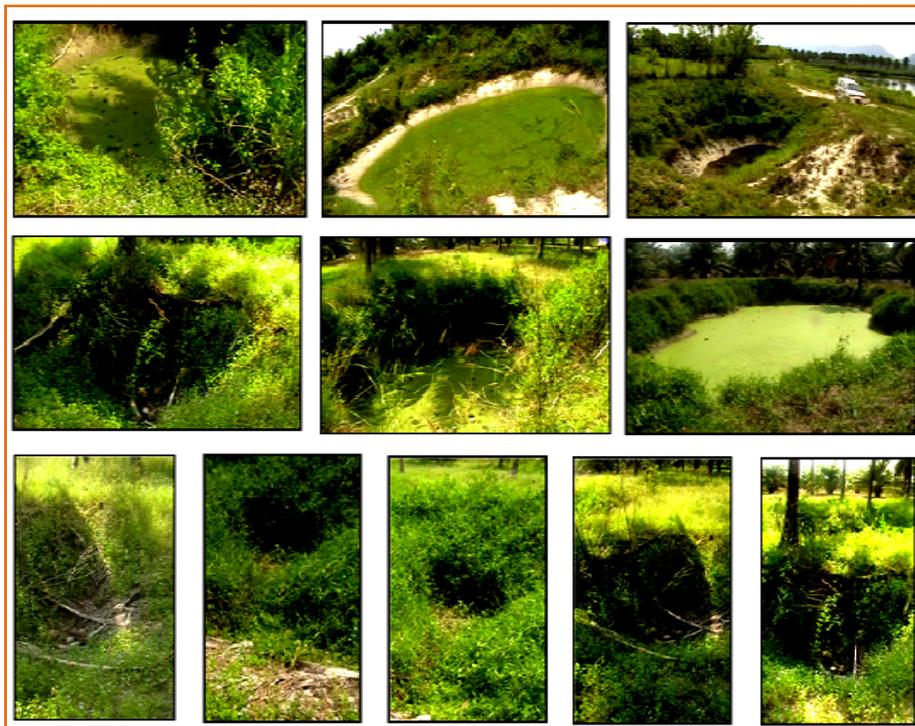
Figure 10. Several varieties of sinkholes were found and identified surrounding the site during the groundwork inspection

Several varieties of sinkholes were found and identified surrounding the site during groundwork inspection, some of it shown in figure 10. A total of 18 sinkholes were identified and given specific letters (A, B, C, D, E, F, G, H, I, J, K, L, M, N, O, P, Q and R). These sinkholes were not spotted in the satellite image of Perak at a scale 1/5000. Moreover, they were not observed in the satellite image of Google Earth for many reasons; first of all, the chosen satellite image may be older than the age of the sinkholes, meaning that these sinkholes were the result of recent developments. Secondly, sinkholes with smaller sizes were engulfed by plants, which in this case, compromised their visibility vis-à-vis satellite imagery. Additionally, the lake, which is a former tin mine, is clearly visible in the study area in this satellite image of google earth. A few of these sinkholes were selected to be analyzed by a high-resolution geophysical technique in order to achieve the case objectives. ERT in Wenner configuration was functional, which allows the imaging of the subsurface across and in proximity to many sinkholes as a primary stage to speculate on the origin of these sinkholes, recognize their shapes, and estimate their depths.

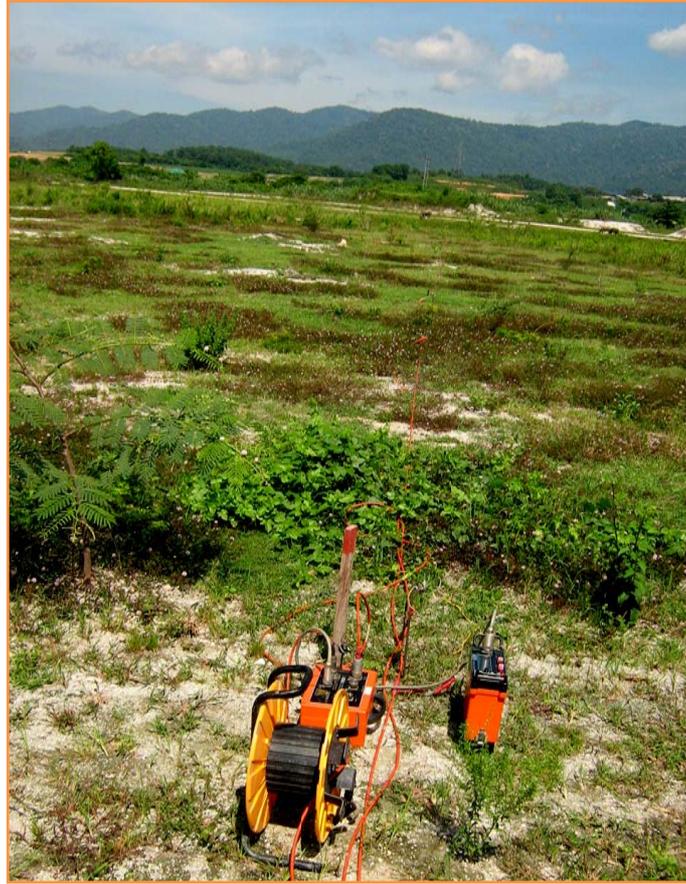
Figure 11. Demonstrate the instrument type SAS300 used in the survey and the typical setup for a 2-D survey, with a number of electrodes along a straight-line attached to a multi-core cable

These electrodes were connected to a multi-core cable Griffiths DH and Barker, R. D. (1993), configured in a Wenner array. The multi-core cable is attached to an electronic switching unit, and is used to automatically select the applicable four electrodes for each measurement. The typical setup for a 2-D survey with a number of electrodes along a straight-line attached to a multi-core cable and the instrument type SAS300, which was used in the survey and is demonstrated in Figure 11.

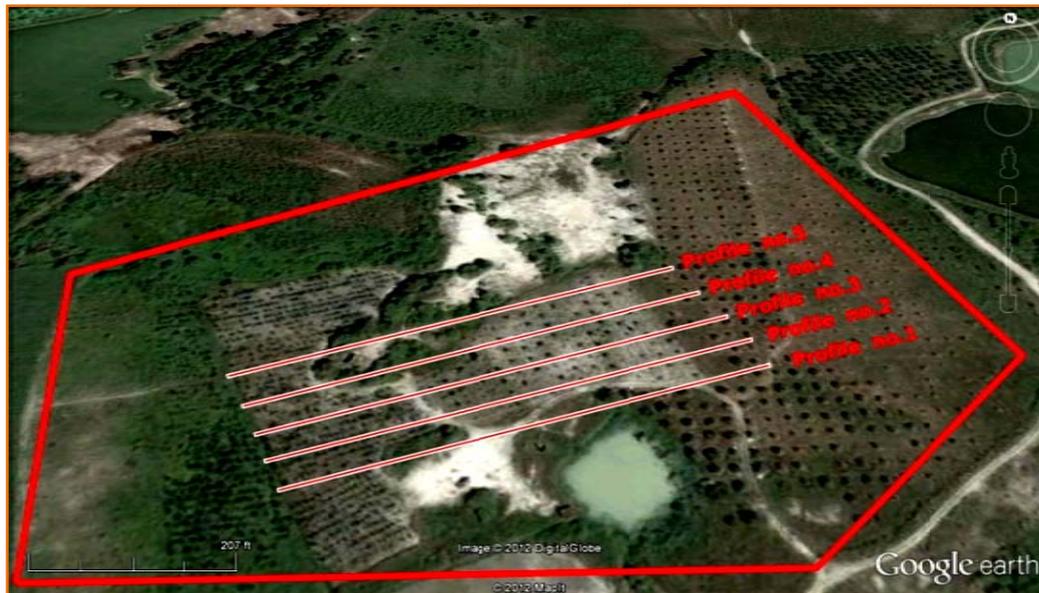
Figure 12. Satellite image of Google Earth viewing the location of resistivity profiles (1-5) in the studied site

Electrical resistivity data were collected along a relatively 2-D electrical resistivity profiles applied across and in proximity to many sinkholes located at this site. On average, 190 data points were collected for each 41-electrode in one profile, and on average, about 950 data points were collected for a total of five profiles at this site. The location of resistivity profiles (1-5) in the satellite image of Google Earth are in Figure 12.

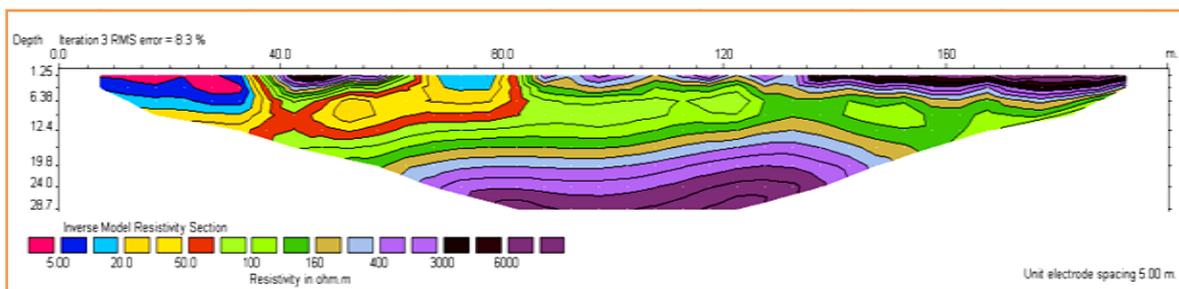
Figure (13 - A). Inverse model of electrical resistivity section for profile no.1

Figure 13(A-E). Inverse model of electrical resistivity section from profiles no. (1-5), viewing the interpreted location of shallow karst features (sinkholes and cavities) in the study area

Through the interpretation of E. R. Tomography section in profile no.1, figure (13-A), the upper most overlaying surface from the depth of 1.25m - 6m, and the proximity between the electrodes no.7&12, 18&22, 23&25, 26&27 and electrode no. 28&39 is characterized by high resistivities between 200 ohm-m to 3000 ohm-m and more, interpreted as stripped sand dry and friable, with remnants of limestone rock or other rock fragments, extracted by earth moving equipment from the pits of mine, due to previous mining and excavation operations, and is found covered along the profiles of the study area .

In this sand, collapses or subsidences were identified, one between electrode no.7&12 and the others between electrode no.32& electrode no.33, 36&37. These represent cover-collapse sinkholes which occurred in the soil or other loose material resembling sand. with small diameter of ~2m - ~5m, and with a depth approximately between ~3m and ~6m from the ground surface. When the geophysical data corresponds to the geological site inspection, it will match the interpretation. These small sinkholes the bottom half comprises of sand and other remnant of rock fragments. The top half was characterized mostly by resistivities of >3000 ohm-m, representing an air in-fill.

Also depression observed in ERT section extended in between electrode no.8&14 from the upper most surface to a depth of 5.50m packed with sand dry and friable and remnants of limestone rock or other rock fragments. Appears due to the wetter area in the subsurface which led the surface to plunging down due to the weight of material that fills this depression.

In this profile an anomaly with low- very low resistivities represents semi-lens or a wetter area of moisturized clay determine in ERT section. Besides it's observed in the field survey extended almost between electrodes

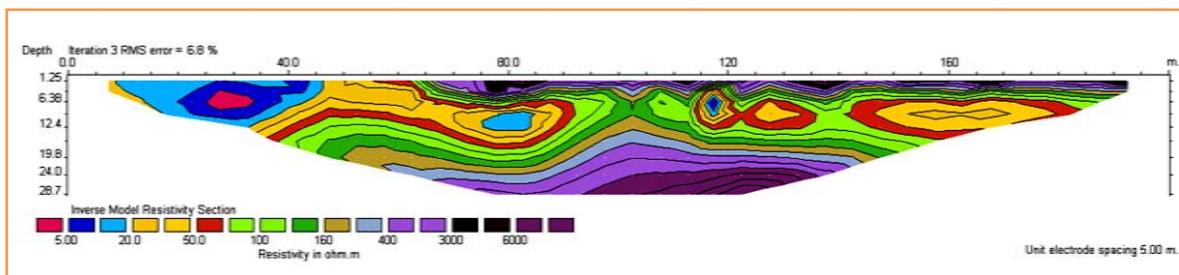
Figure (13 - B). Inverse model of electrical resistivity section for profile no.2

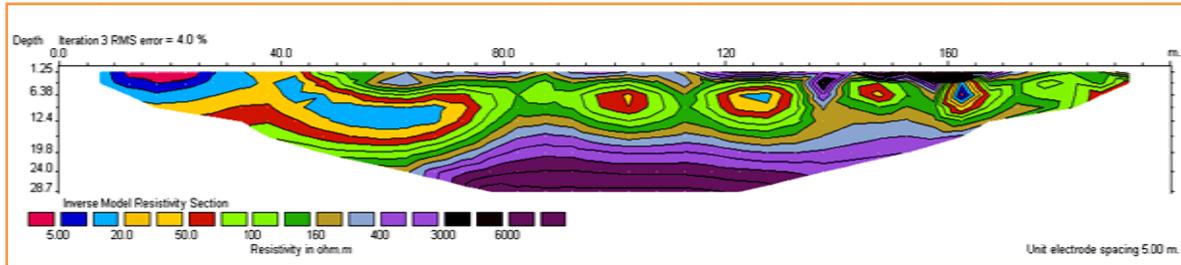
Figure (13 - C). Inverse model of electrical resistivity section for profile no.3

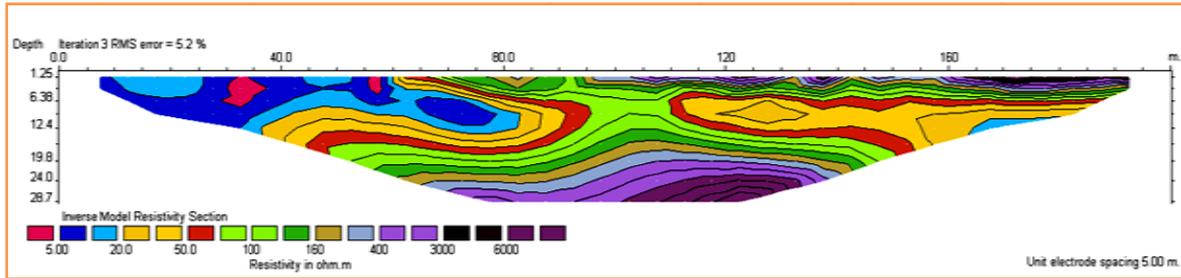
Figure (13 - D). Inverse model of electrical resistivity section for profile no.4

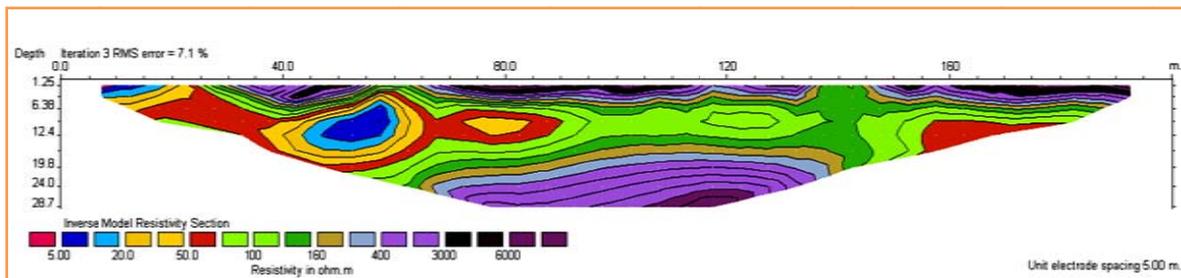
Figure (13 - E). Inverse model of electrical resistivity section for profile no.5

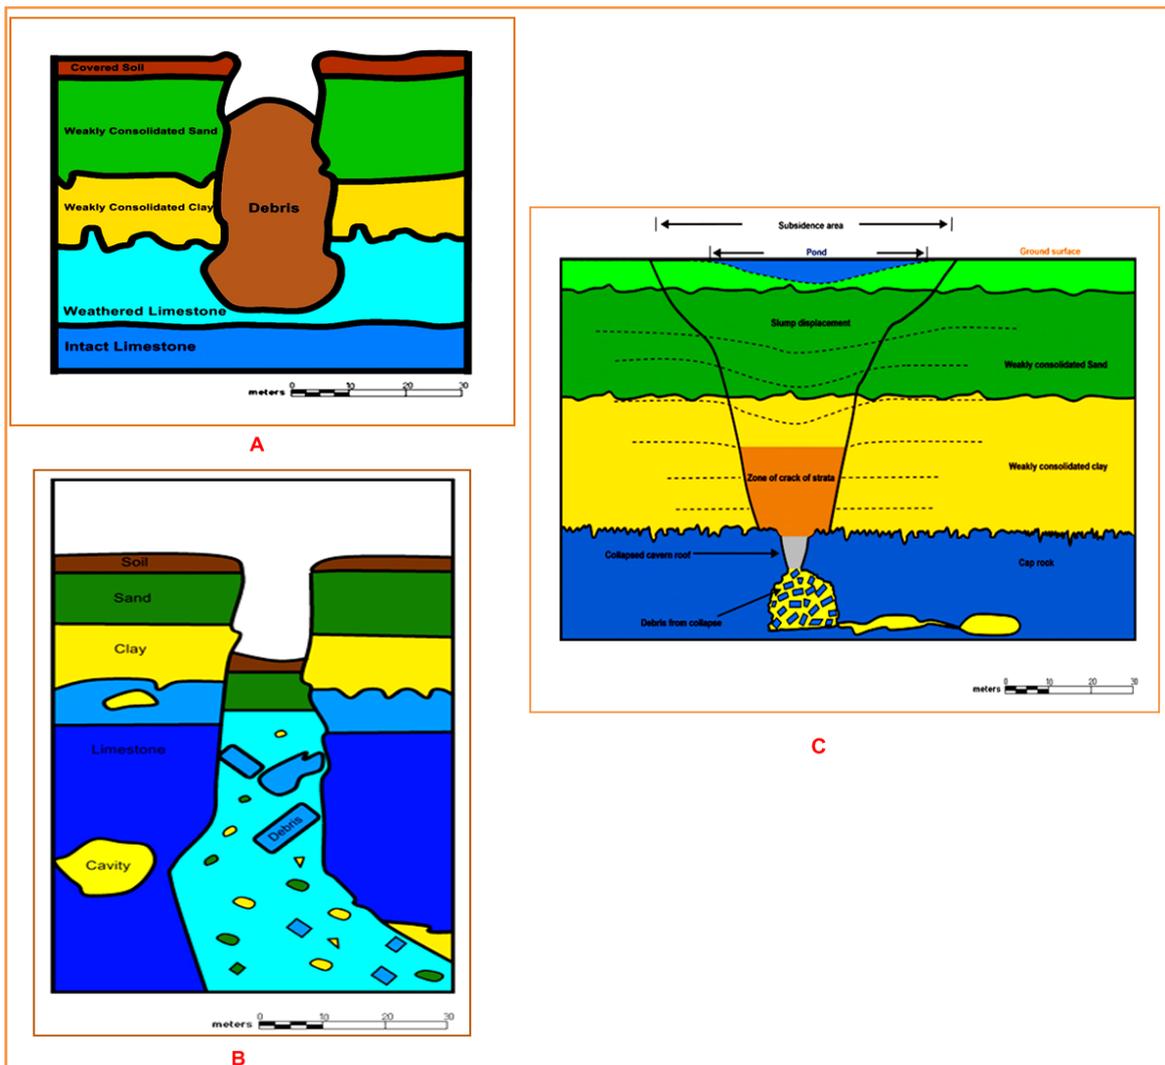
Figure 14(A-C). Diagrammatic cross-sections illustrating the type of sinkholes in the study area, A: The soil cover-collapse sinkhole was within overlain cover soil as a result of a thick section of weakly unconsolidated sand and clay. B: The cover layer subsidence sinkhole as a result of a bridge collapses and thick section of clay. C: the cavern roof collapse within the cap rock that is overlain by a thick section of unconsolidated or weakly compacted sands and mudstones

These layers are covered with soil. These layers are design with lacks of cohesiveness between the particles to form a significant "bridge" across the void where it occurs. The limestone rocks, which are sensitive to both physical and chemical and the natural dissolving processes, will eventually break down. When it collapses, a cavity or void usually forms. The dissolving granules of sand will drop down to fill this cavity or void. The small diameter and depth of these kinds of sinkholes are due to the fact that the open cavities were smaller, and cannot expand in order to reach the considerable size before they were in-filled with sand as illustrated in figure (14-A).

The second kind of sinkholes, depending upon the size of the cavity, is referred to as cover layers- subsidence sinkholes. Occasionally, if the sediments were more clay-based, the upper cover will lean towards becoming more inclined. This bridge will provide some dependence to the clay above. However, if this bridge collapses, the material acts as a conduit to any vacant cavity in the limestone bedrock. Some of the sinkholes appear due to an essential variance in the behavioral strength of the soil above the cavity, and the fact of whether this subsides slowly or collapses suddenly. The size of the sinkhole depends upon the size of the cavity, and whether or not it spreads efficiently and intersects the water table. The dissolution processes is possibly reduced in order to reduce the perpendicular difference between the phreatic water table and prospective meteoric surface, and consequently, reducing the percolation processes, as illustrated in figure (14-B).

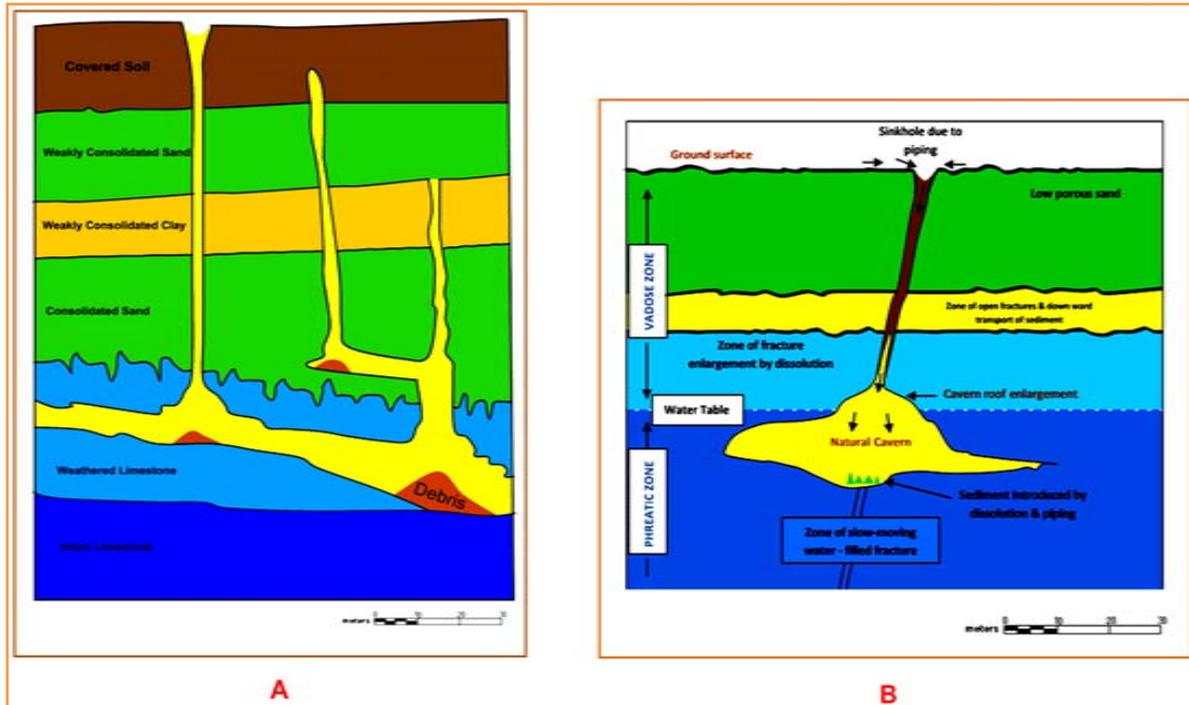
Figure 15(A-B). Diagrammatic cross-sections illustrating the type of piping in the study area, A: the piping process without the effect of water table. B: the piping process when the water table has been lesser to a lower position below the top of the cap rock of the limestone

The piping processes include infiltration and dissolution, and both can be active along the same fracture system. Although these processes are in hydraulic communication specified by a sufficient time, the two individual processes can be combined to produce a collapsed-pipe sinkhole. The emergence of a sufficient volume of material dissolution processes can take place in widening conduits or fractures in the cap rocks of limestone, which is overlain on the water table. However, if these processes result in fractures below the water table, it could allow meteoric water to penetrate downward along these fractures, and freely mix with phreatic water. The piping process when the water table has been lessened to a lower position below the top of the cap rock of the limestone is illustrated in the diagrammatic cross-section in figure (15-B).

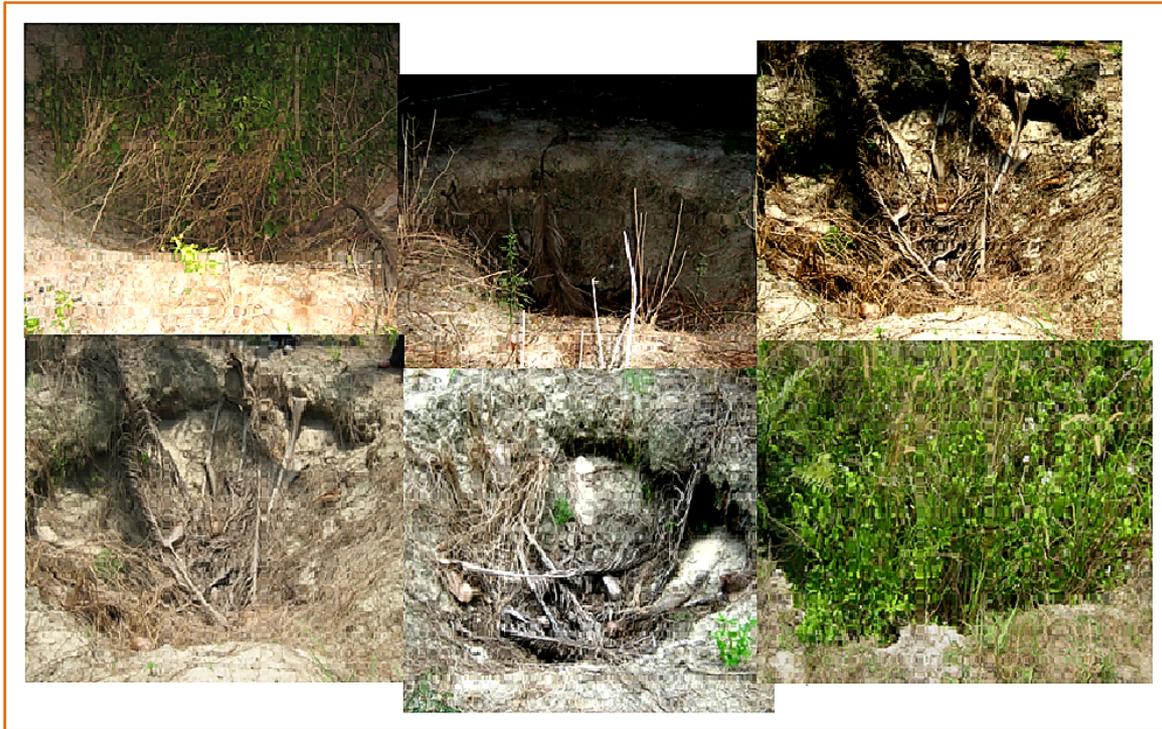
Figure 16. Several of small sinkholes describe as empty, sand in-fills and crammed with vegetations were identified during the site ground work inspection

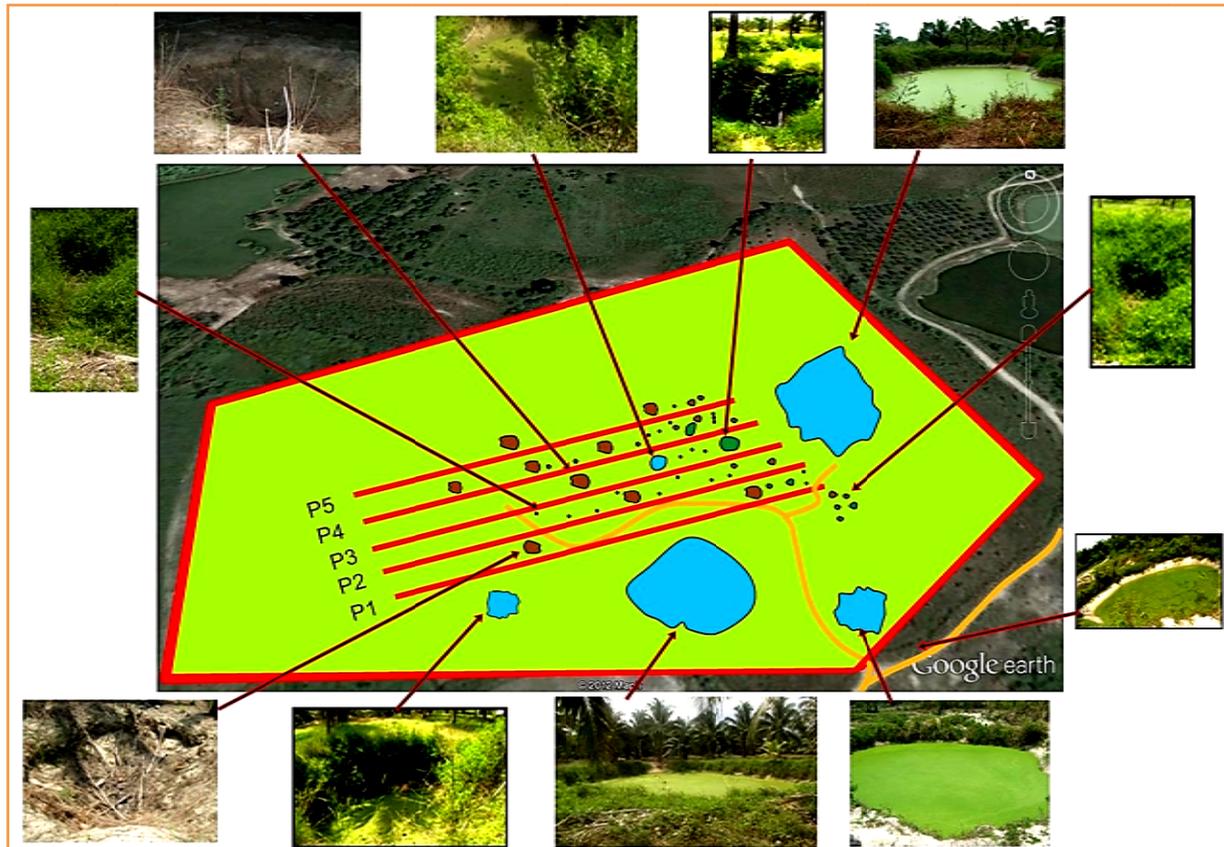
Figure 17. Several varieties of sinkholes identified and delineated in the site during the geological and geophysical survey

The failure to supervise areas and unfortunate management in storage of manure and fertilizers, and the application of liquid fertilizers via irrigation techniques may increase surface soil erosion. In addition, the inappropriate tillage techniques, such as before heavy rainfall may facilitate the emergence of sinking streams, cavities and sinkholes. This study discovered that this area was hazardous to farmers seeking living spaces, or animal's shades or horses stables over the area. This is due to the fact that a collapse or subsidence for the cover soil or material and underlying layers (due to load) might occur at any time in the near future. This study will enable an understanding that an area with specification approximating to this study area will create future threats. The variety of sinkholes identified and delineated in this site during the geological and geophysical survey is presented in Figure 17.
