# Risk Analysis in Civil Construction Services Using Mobile Elevating Work Platforms

## Abstract

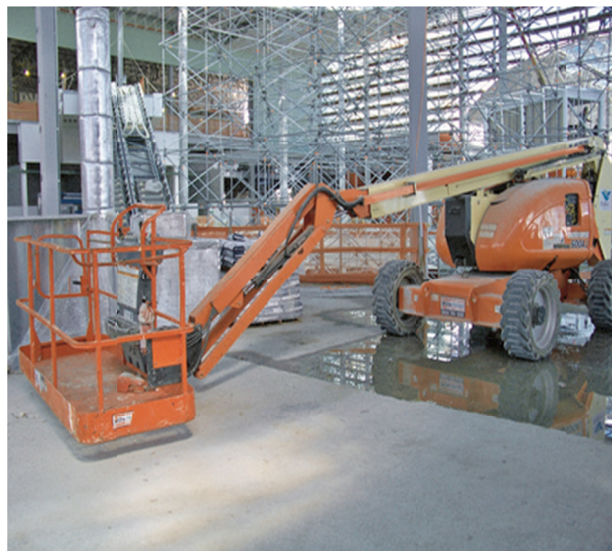
Figure 1. MEWP lance type

MEWP (Mobile Elevating Work Platform), replacing the term Aerial Work Platform (AWP) according to the new NR 18, is mobile equipment, with or without its means of propulsion, which has a work station, in the form of a basket or platform, and is supported at its base by a metal rod—called a boom MEWP (Figure 1)—or scissors (Figure 2), capable of lifting itself to reach an elevated point or workplace.

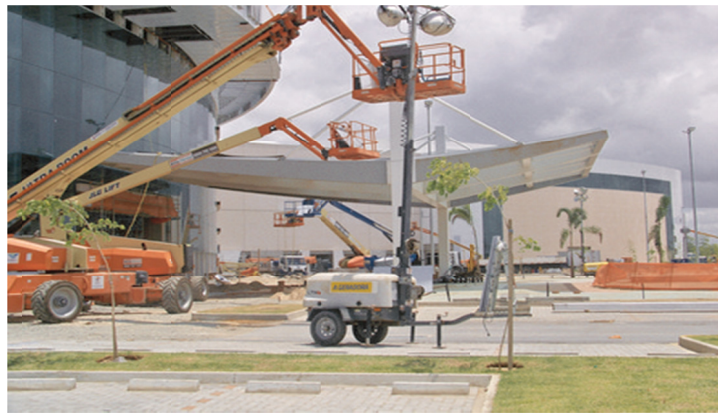
Figure 5. MEWPs stopped in working position without delimitation of work area

6. Isolate and signalize the MEWP handling area, allowing only the workers involved in the process access to the machinery circulation area.
7. Keep the MEWP folded in its base, when not in use, and turned off and protected from accidental operation to avoid accidents.
