Coupled Safety Assessment of Cable Stay Bridges

Alessio Pipinato¹

¹ University of Padova, Padova, Italy

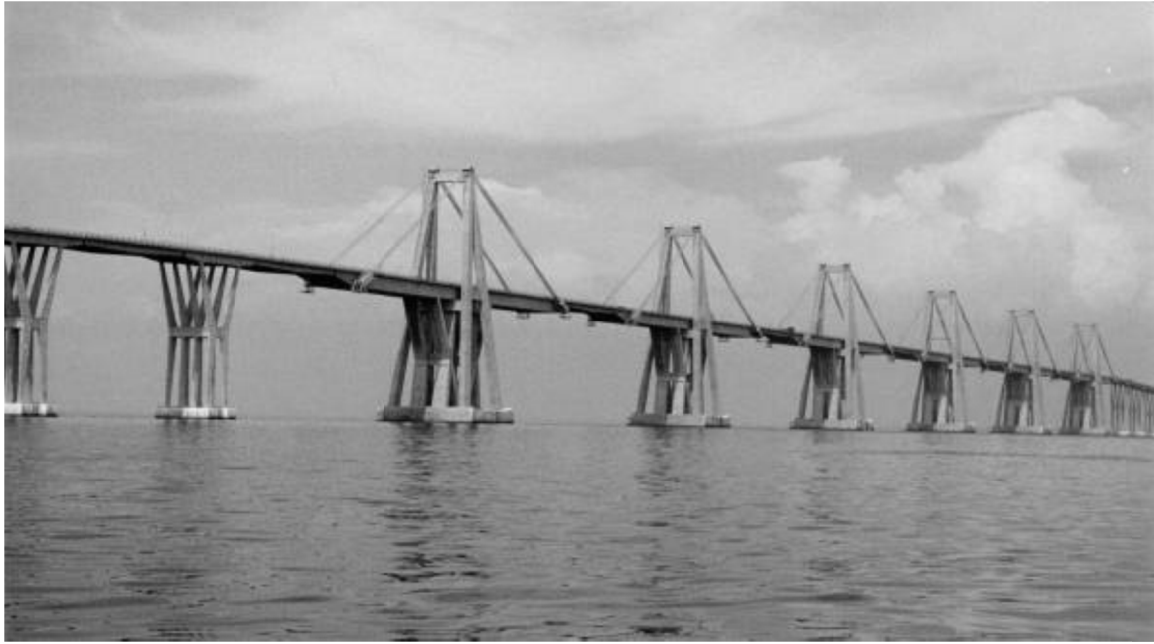
Figure 2. The Maracaibo bridge: central spans, cable stayed, main 235 m spans

This reinforced and prestressed concrete bridge structure ranks as one of the longest in the world (Podolny, 1973). The contractor was Maracaibo Bridge Joint Venture comprised of Precomprimido C. A., Caracas, Venezuela and Julius Berger A.G., Wiesbaden, Germany. The structural analysis and detailed plans were prepared by the Maracaibo Bridge Joint Venture in conjunction with the designer Prof. Riccardo Morandi. With the one exception, all the twelve designs submitted in the competition advocated a steel superstructure. The reasons for the selection of the Maracaibo Bridge Joint Venture design by the government commission were given as follows: reduction of maintenance costs as a result of the climate conditions existing at the site; the aesthetics of the design; the greater use of local materials and therefore less foreign exchange expended for imported materials; greater use of local engineering talent and labor. The five main navigation openings consist of prestressed concrete cantilevered cable-stayed structures with suspended spans having a total 771 ft (235 m) span (see Figure 2).

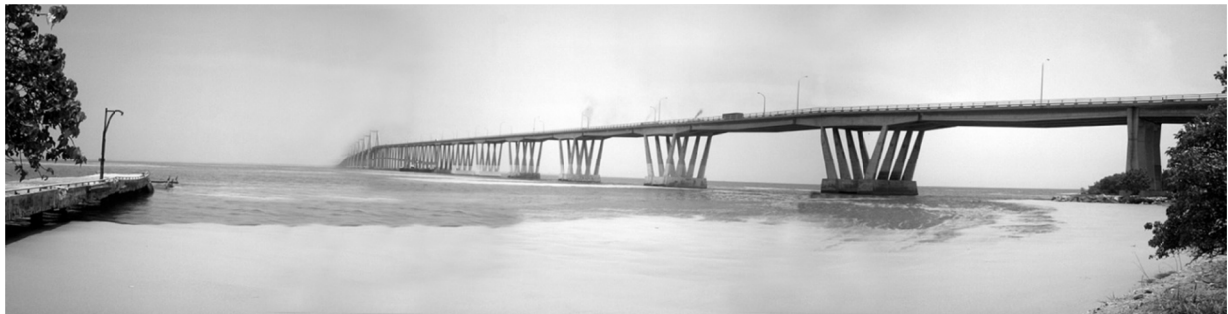
Figure 3. The Maracaibo bridge: approaching span

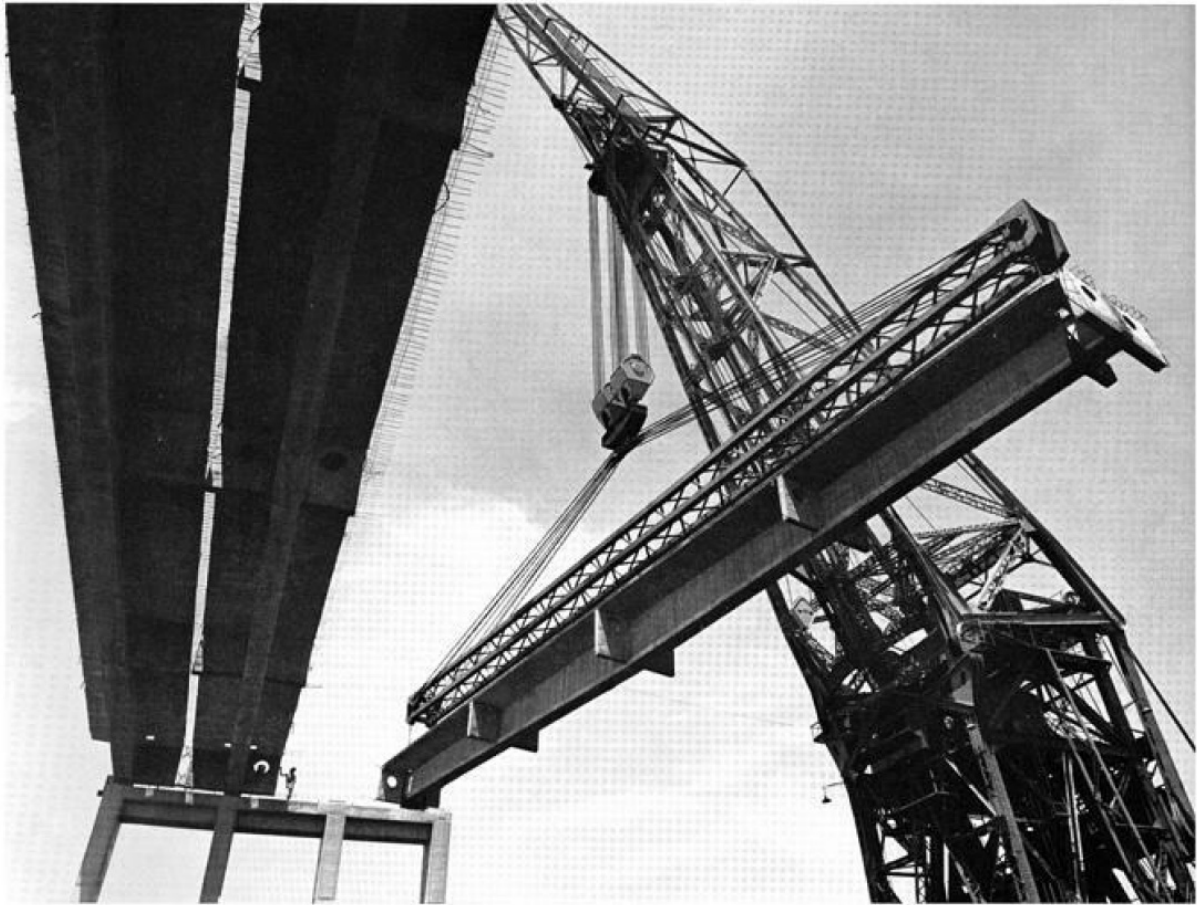
Figure 7. The 250 t floating crane lifting on piers the 190 t T-shape girder

After completion of the pier, service girders are raised into position to be used in the construction of the cantilever arm. Due to the additional moment, produced during this construction stage by the service girder and weight of the cantilever arm, additional concentric prestressing was required in the pier cap (see Figure 5). To avoid overstressing of the X frames during this operation, temporary horizontal ties were installed and tensioned by hydraulic jacks (see Figures 5 and 6). In the construction of the cantilever special steel trusses (service girder) were used for formwork. They were supported at one end by the completed pier cap and at the other end by auxiliary piers and foundations. The anchorages for the cable stays are located in a 73.8 ft (22.5 m) long prestressed inclined transverse girder. The reinforcing cages for these members were fabricated on shore in a position corresponding to the inclination of the cables. They weighed 60 tons and contained 70 prestressing tendons. The cable stays are housed in thick walled steel pipes which were welded to steel plates at their extremity. A special steel spreader beam was used to erect the fabricated cage in its proper orientation. The suspended spans were composed of four prestressed T sections (see Figure 7) for a grand-total of 528 precast prestressed girders.
