Utilization of Displaced Land of Former Red Stone Excavation for Milkfish Farming by Stick Net Cage System (A Case Study at Gentungan, Gowa Regency, South Sulawesi, Indonesia)

Abstract

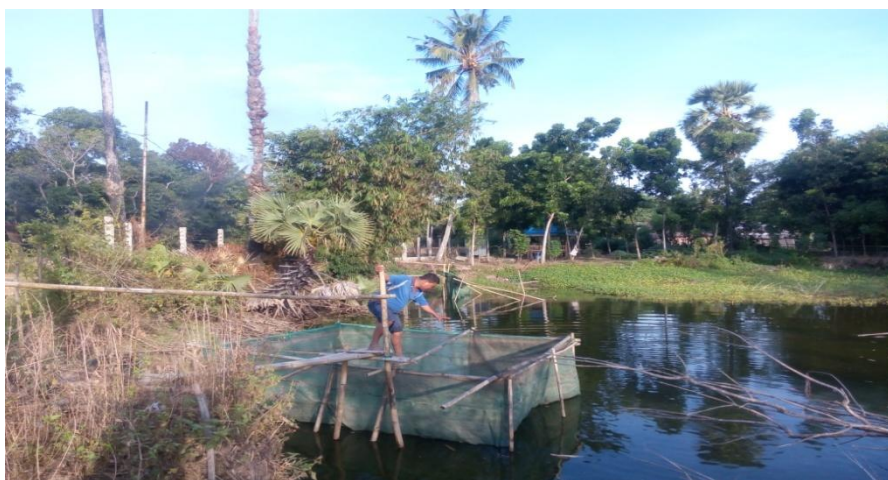
Figure 2. The Design of Stick Net Cage Method for Fish Farming in the Land of Former Red Stone Excavation

This study was conducted in an area of red stone excavation sized of 0.25 ha which was the square size. The cage types, which was used as the fish farming place on this formerly land, was the stick net cage which sized $4 \times 3 \times 1.5$ meters. The stick net cage was put on one of the pool corners, i.e., the adjacent corner of the floodgates which was aimed for the organisms farming always got fresh water directly comes from the channel. The layout setting of stick net cage was presented in Figure 2.
