## Forest Road Assessment in Ulu Muda Forest Reserve, Kedah, Malaysia

Mohd Hasmadi, I, and Kamaruzaman, J. (Corresponding author)

Department of Forest Production, Faculty of Forestry

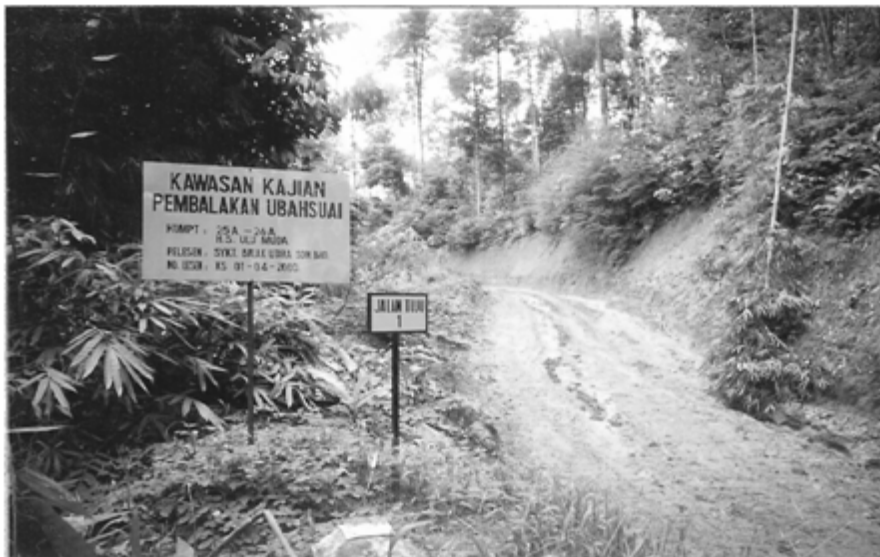
Figure 2. Feeder road in compartment 25, Ulu Muda Forest Reserve

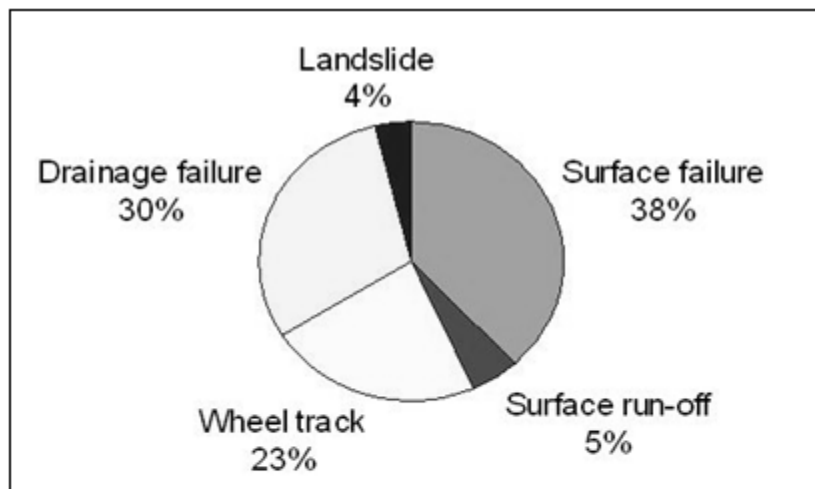
The road failures were classified into five types of failures, namely surface failure, surface run off, wheel track, drainage failure and landslide that as shown in Figure 3. The major failure occurred on the feeder road was surface

Figure 3. Percentage of road failure by categories of failure type.

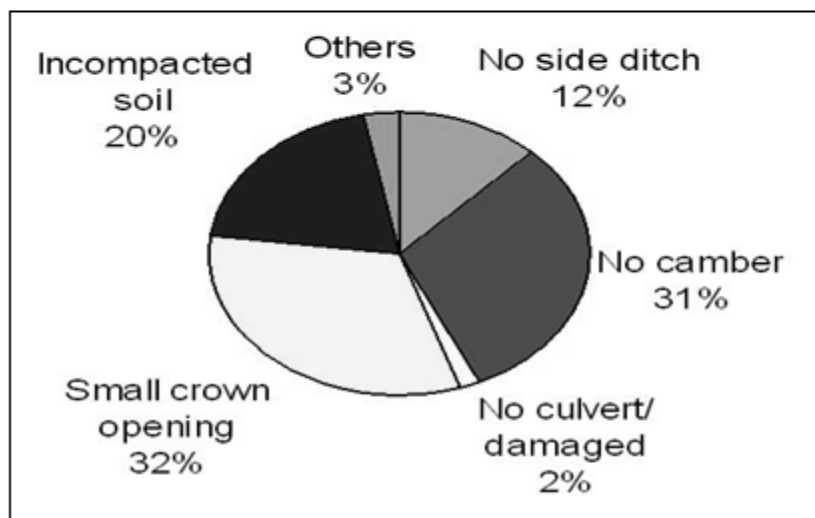
Road failures occur by several causes. The major causes of road failure were categorized to six factors which were shown in Figure 4. The failure caused by the small crown opening is 32% or 21 sections of the road failure. The minimum value of crown opening is 7.5m and the average is 14m. The minimum width of crown opening was blocked light intensity to reach ground that enable drying the road surface. A higher humidity is needed to allow evaporation process which air velocity is limited in contributing to the drying process on the road surface. Figure 5 showed the example of the failure caused by insufficient crown opening.

Figure 4. Percentage causes of road failure
