# Non-Destructive Testing in the Strategic Research on the Performance of Bridges

## Abstract

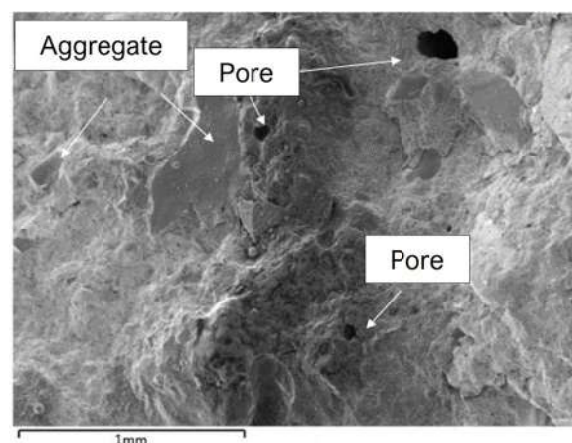
In the SEM images, it is possible to visualize the concrete matrix and some particles from the aggregates coming from the concrete of the three HBs. Through Figure 15, it is possible to observe a sample of the pillar of HB-A, in which several particles of quartz sand can be seen, which is confirmed by the EDS analysis (Figure 16), as well as some pores present in the concrete matrix.

Figure 15. HB-A, central pillar map, 50x

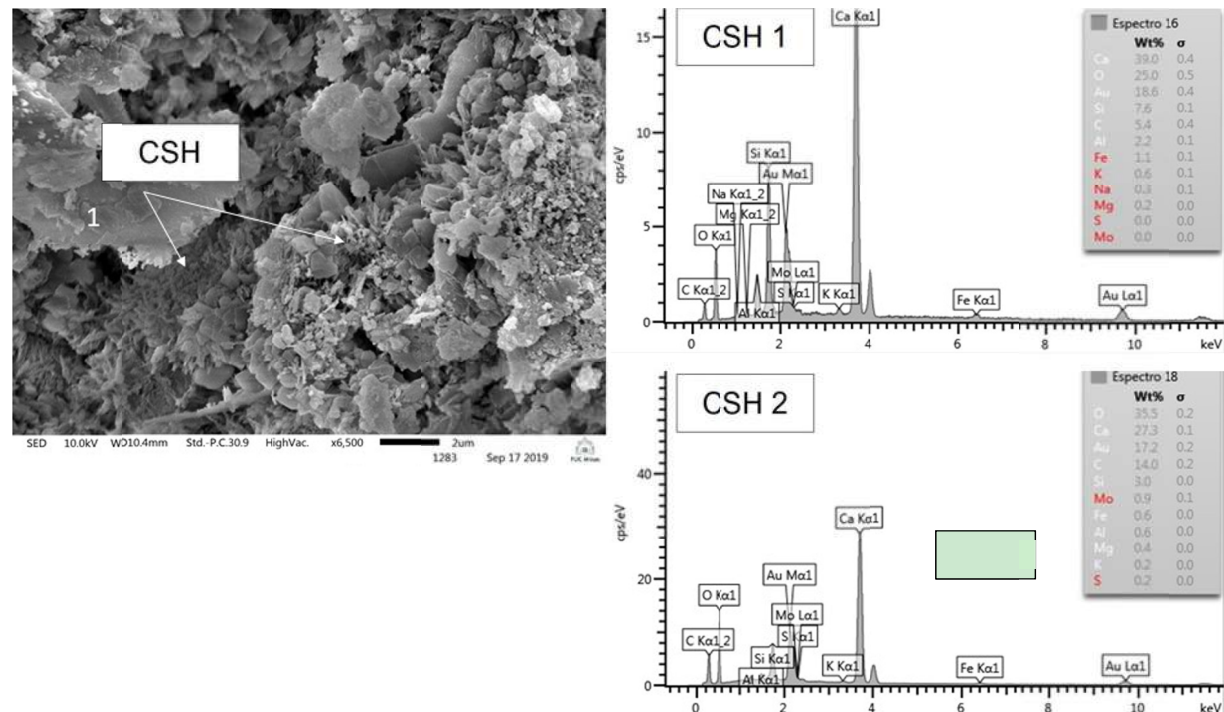
Figure 16. In the mortar work, at a magnification of 2000x, EDS - Calcium hydroxide and mortar and CSH

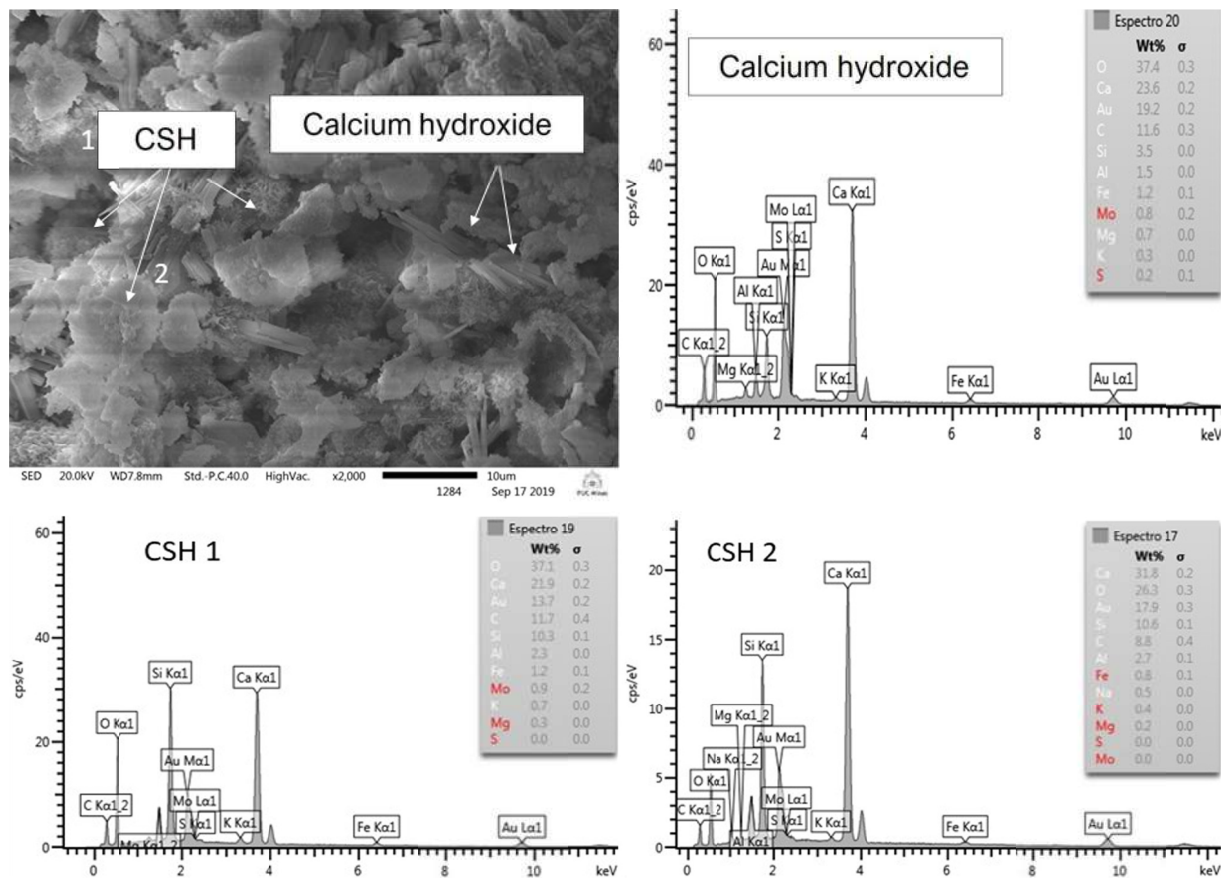
The presence of C-S-H (Figure 17) was found in the entire sample HB-A, visualized as clumps of particles, small equiaxed grains forming flakes. This predominant morphology is characterized as being of type III (Lea, 1971; Barnes & Bensted, 1983). It was also detected the presence of crystals of calcium hydroxide, Portlandite (CH), which is another product of C3S and C2S hydration.

Figure 17. In work A, mortar, 6500x, EDS - Calcium hydroxide

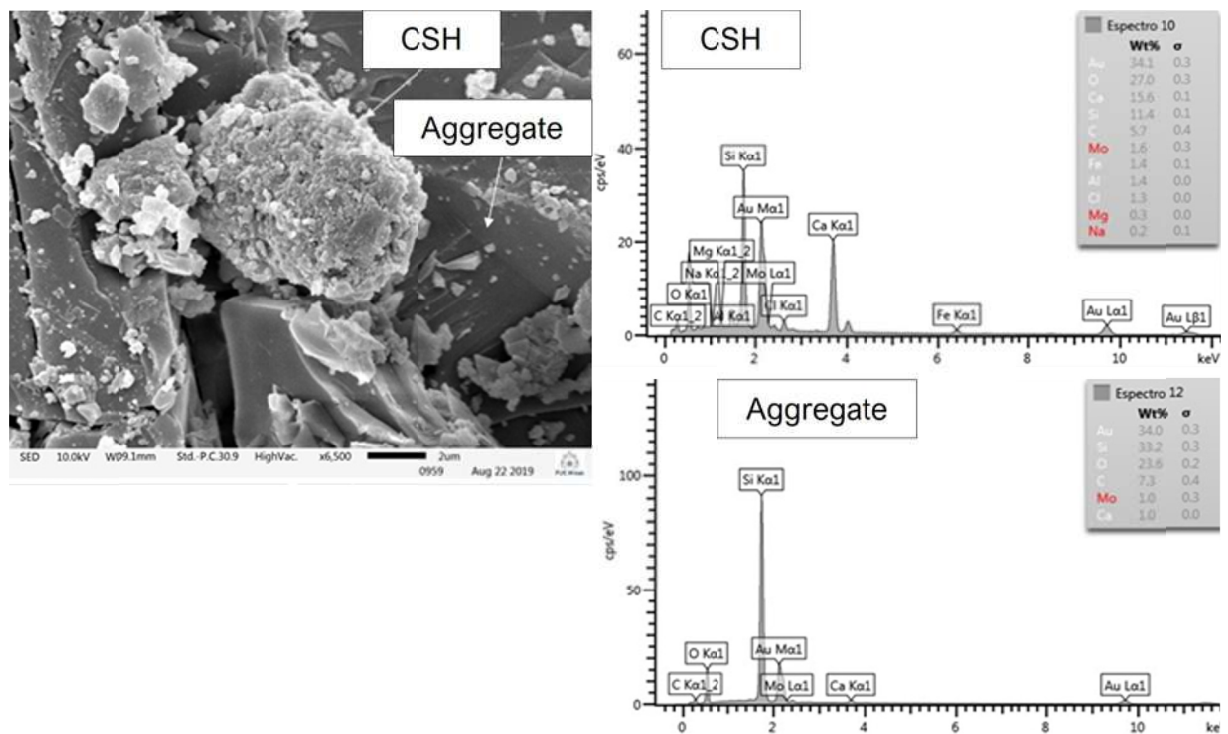
This presence of CH corresponds to the alkaline reserve that guarantees the passivity of the reinforcement contained in the concrete matrix (Figures 18 and 19). It is characterized by thin and elongated hexagonal plates (Neville, 2018), often only a few tens of micrometers wide (Harutyunyan et al., 2003), and clearly defined edges, usually arranged in large clusters around the aggregate (Diamond, 2004). A similar behavior was observed in the sample HB-B, where the presence of CSH bound to the aggregate was also identified.

Figure 18. In work B, Pillar, Mortar, 6500x - EDS CSH and Aggregate

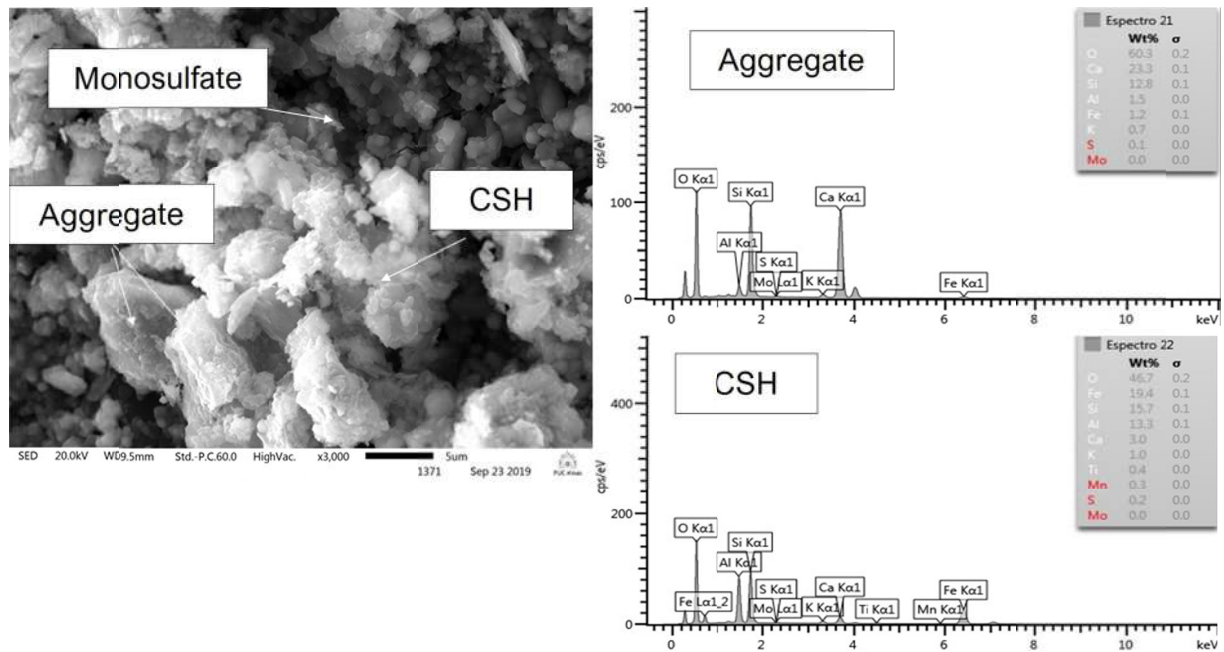
Figure 19. In work C, Beam, 3000x - EDS Quartz and CSH

In another micrograph of the sample HB-C (Figure 19), a grain of anhydrous cement was found, along with a C-S-H phase present in most of the sample (3000x magnification). Through the 5500x magnification, it is possible to identify the formation of C-S-H close to the aggregate that is present in the sample.

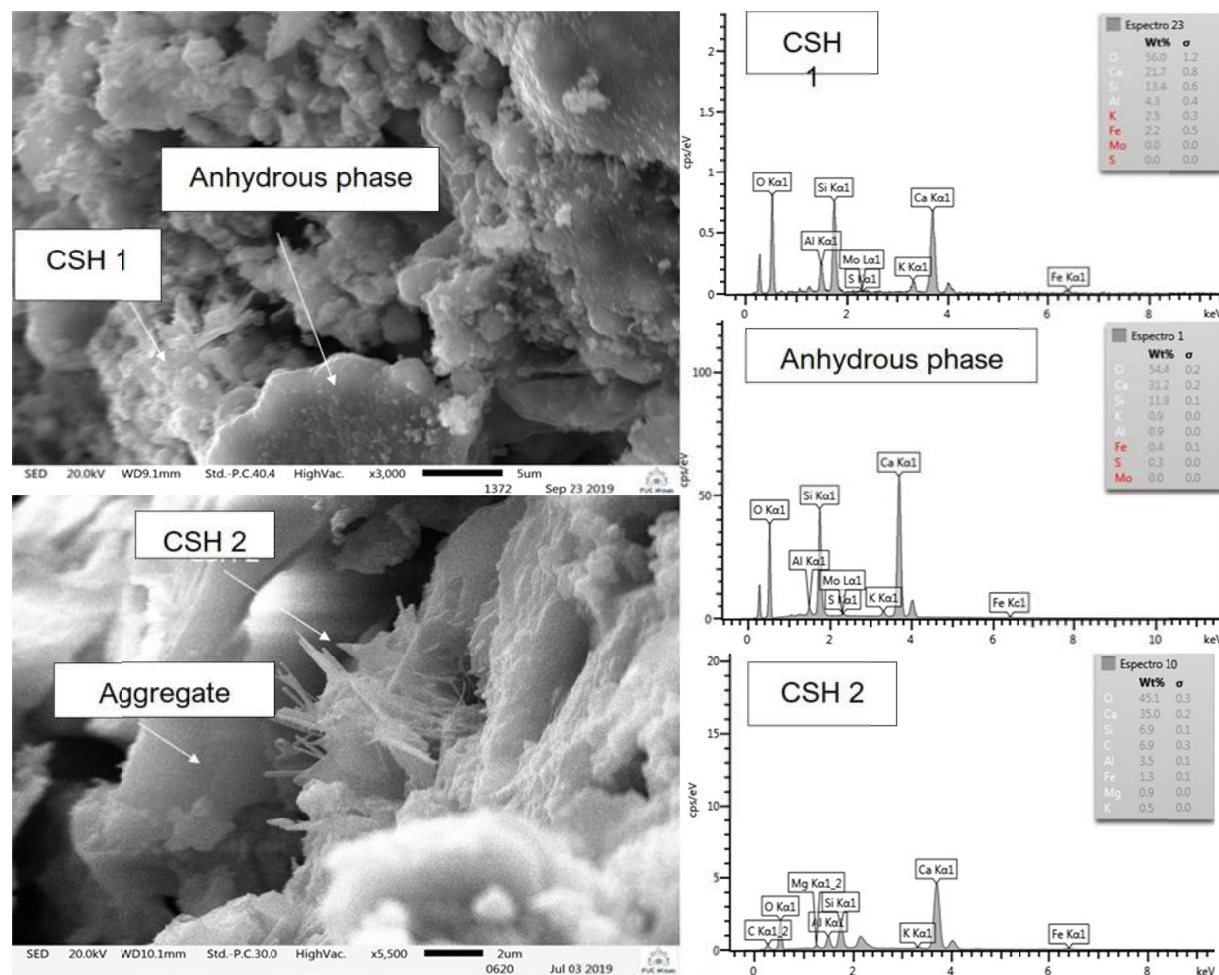
Regarding the sample HB-C (Figure 20) it was found a structure formed by rounded hydrated products, in the form of flakes, whose microanalysis indicated that some of them were hydrated calcium silicates, C-S-H and the others were unstable ettringite that was turning into monosulfate (MS) (Lea, 1971; Barnes & Bensted, 1983).

Figure 20. In HB-C, Beam under 3000x magnification, identifying the Anhydrous Phase; and microscopy of the foundation block, aggregates under 5500x magnification – EDS CSH and anhydrous phase
