Thermal Degradation of Chemically Treated *Shorea Parvifolia* Plywood

Thermal degradation of chemically treated plywood of *Shorea parvifolia* as the facing material in timber stud partition was investigated. The plywoods were treated with Dricon, Monoammonium Phosphate, Diammonium Phosphate and mixture of Borax and Boric Acid at 20% concentration. The cavity of the partition was filled with fibre insulating material. The fire resistance of the partitions was evaluated using 1.5 m by 1.5 m gas-fired furnace following the standard temperature-time curve set by the British Standard, BS 476 : Part 22:1987. The rating measures the integrity-ability to withstand collapse or sustained flaming and the insulation-ability to prevent excessive increase of temperature. In this study the best fire resistance rating time based on integrity failure was the partition using *Shorea parvifolia* plywood treated with Dricon (118 min.) followed by Diammonium Phosphate (116 min.), Monoammonium Phosphate (109 min.) and Borax and Boric Acid (97 min.) respectively. The untreated *Shorea parvifolia* plywood partition shows the weakest fire resistance rating of 95 min.

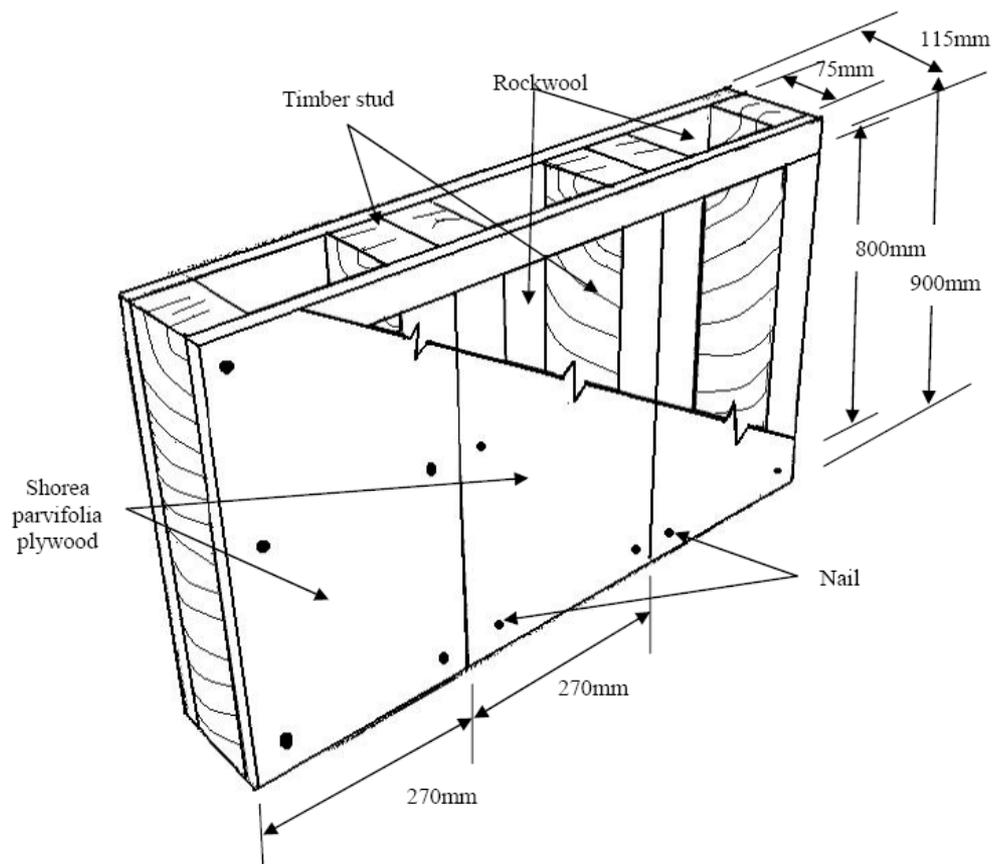
Figure 1. Isometric drawing view of the wall assembly

A timber stud partition system was constructed within a brick wall bonded together by cement and mortar. The overall size of the *Shorea parvifolia* plywood partition was 900 mm high by 810 mm wide by 106 mm thick built within a masonry brick wall inclusive of a 40 mm wide vertical gap along one edge to provide no lateral restraint to the specimen. Each *Shorea parvifolia* plywood panel was fixed on both sides to a vertical hardwood timber stud. The cavity of the partition was filled with 40mm thick Rockwool known as Fibertex with density of 100 kg m⁻³. The size of the plywood was 900mm x 270 mm x 18 mm. Three samples of *Shorea parvifolia* plywood panels were fixed vertically to the masonry brickwall. The *Shorea parvifolia* plywoods were predrilled and fixed to the frame with nominal nails at 300 mm centre to centre. Figure 1 shows the detailed drawings of the *Shorea parvifolia* plywood partition system.
